Technical Study of the Sofa Super Store Fire - South Carolina, June 18, 2007

**Technical Study of the Sofa Super
Store Fire - South Carolina, June 18,
2007**

*Fire Research Division
Engineering Laboratory
National Institute of Standards and Technology*

March 2011

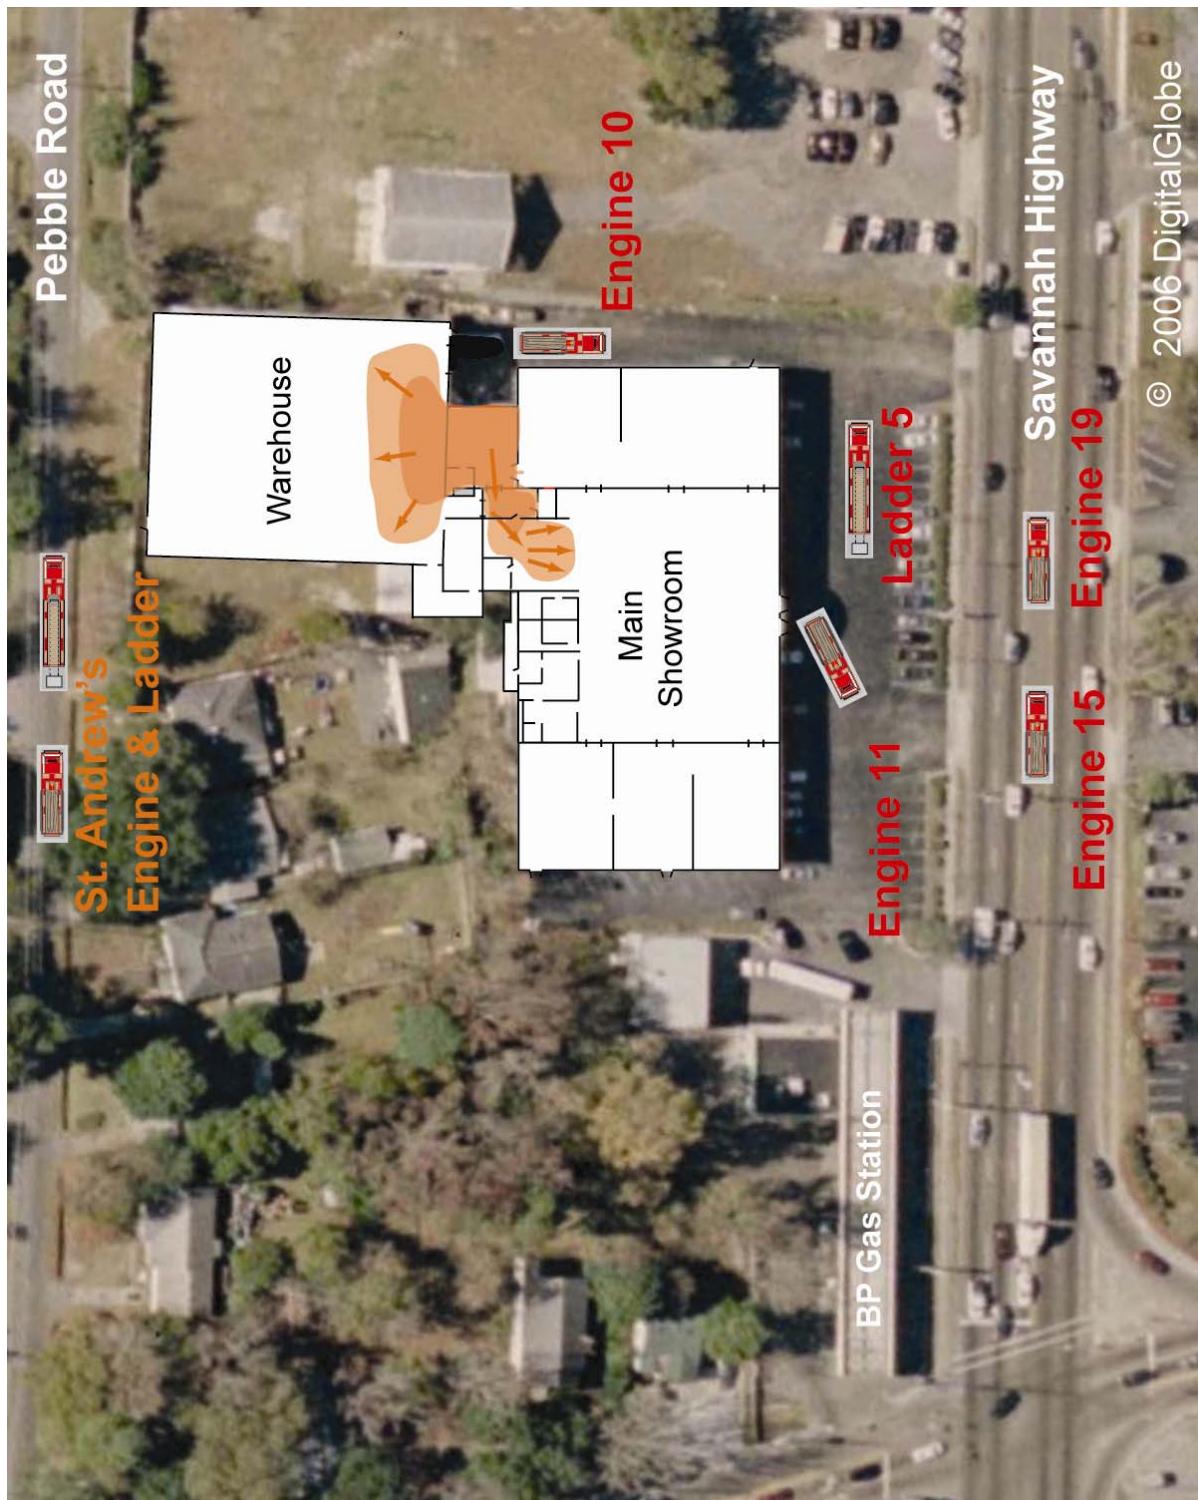
Figure 2-7. Fire was beginning to spread into the rear of the main showroom through the holding area and through the shared metal wall of the warehouse. This was estimated to occur at about 7:31 p.m. Background image used with permission of DigitalGlobe. Enhancements by NIST.

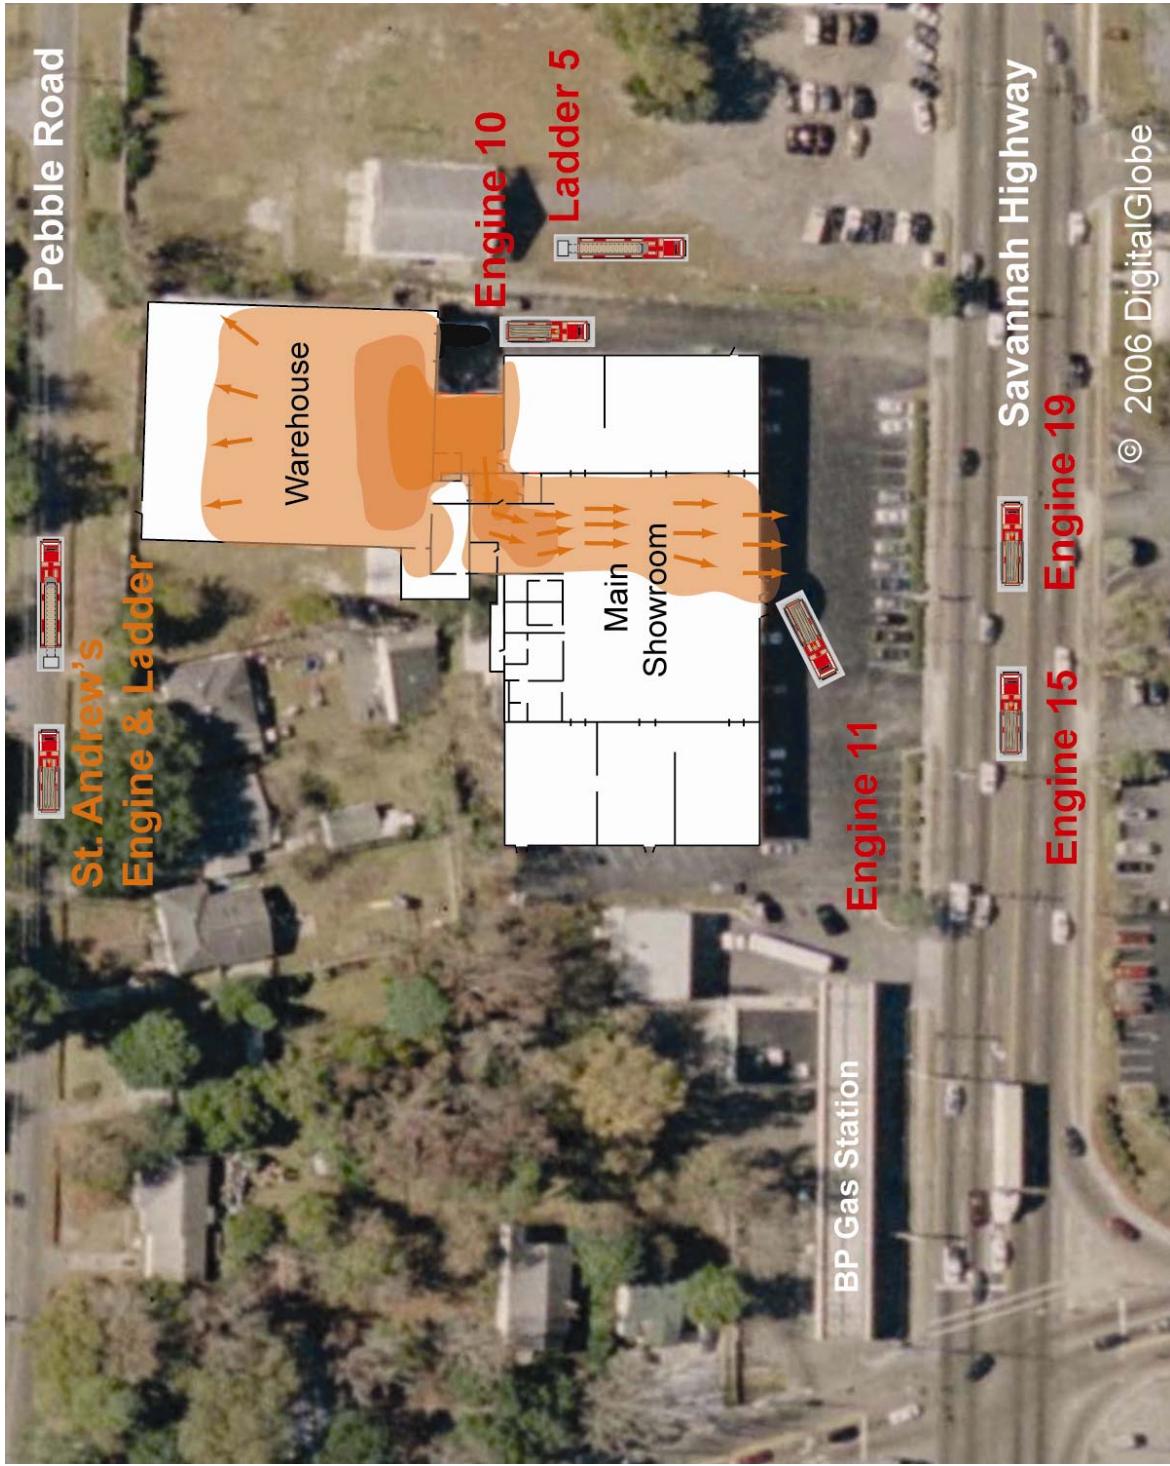
Figure 2-8. Fire spread rapidly from rear of main showroom to the front of the main showroom. Fire continued to spread towards rear of warehouse. This occurred by about 7:36 p.m. Background image used with permission of DigitalGlobe. Enhancements by NIST.

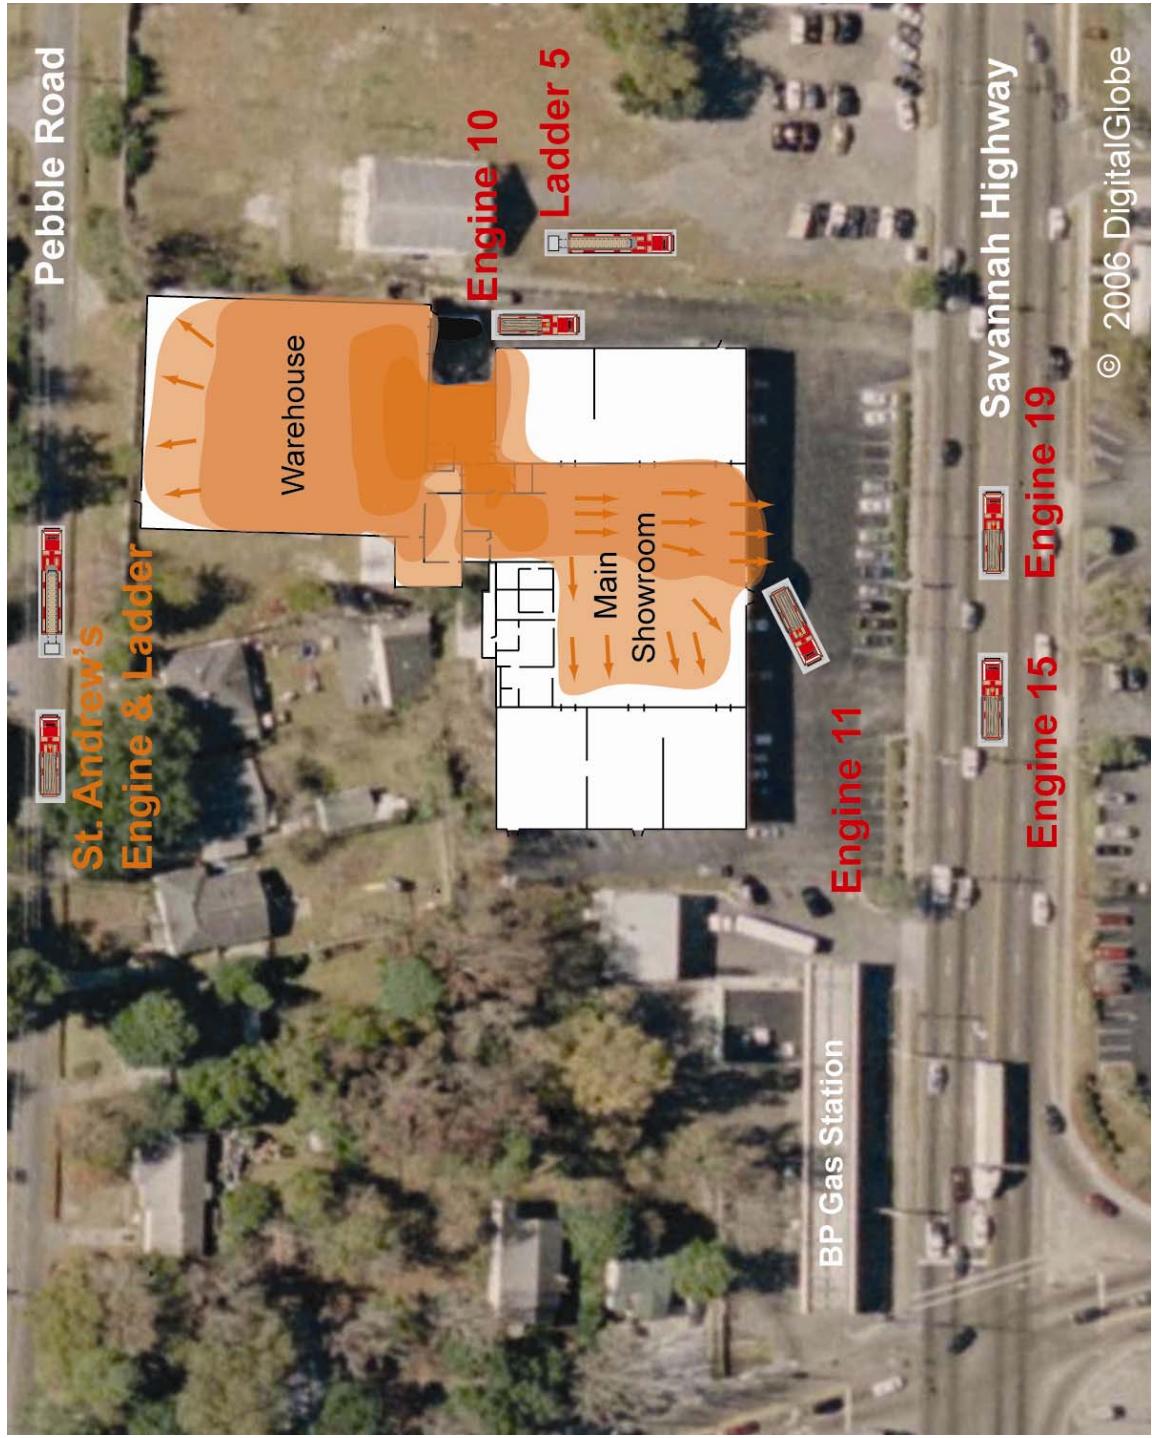
Figure 2-9. Fire spreading to east side of main showroom. This occurred by about 7:37 p.m. Background image used with permission of DigitalGlobe. Enhancements by NIST.

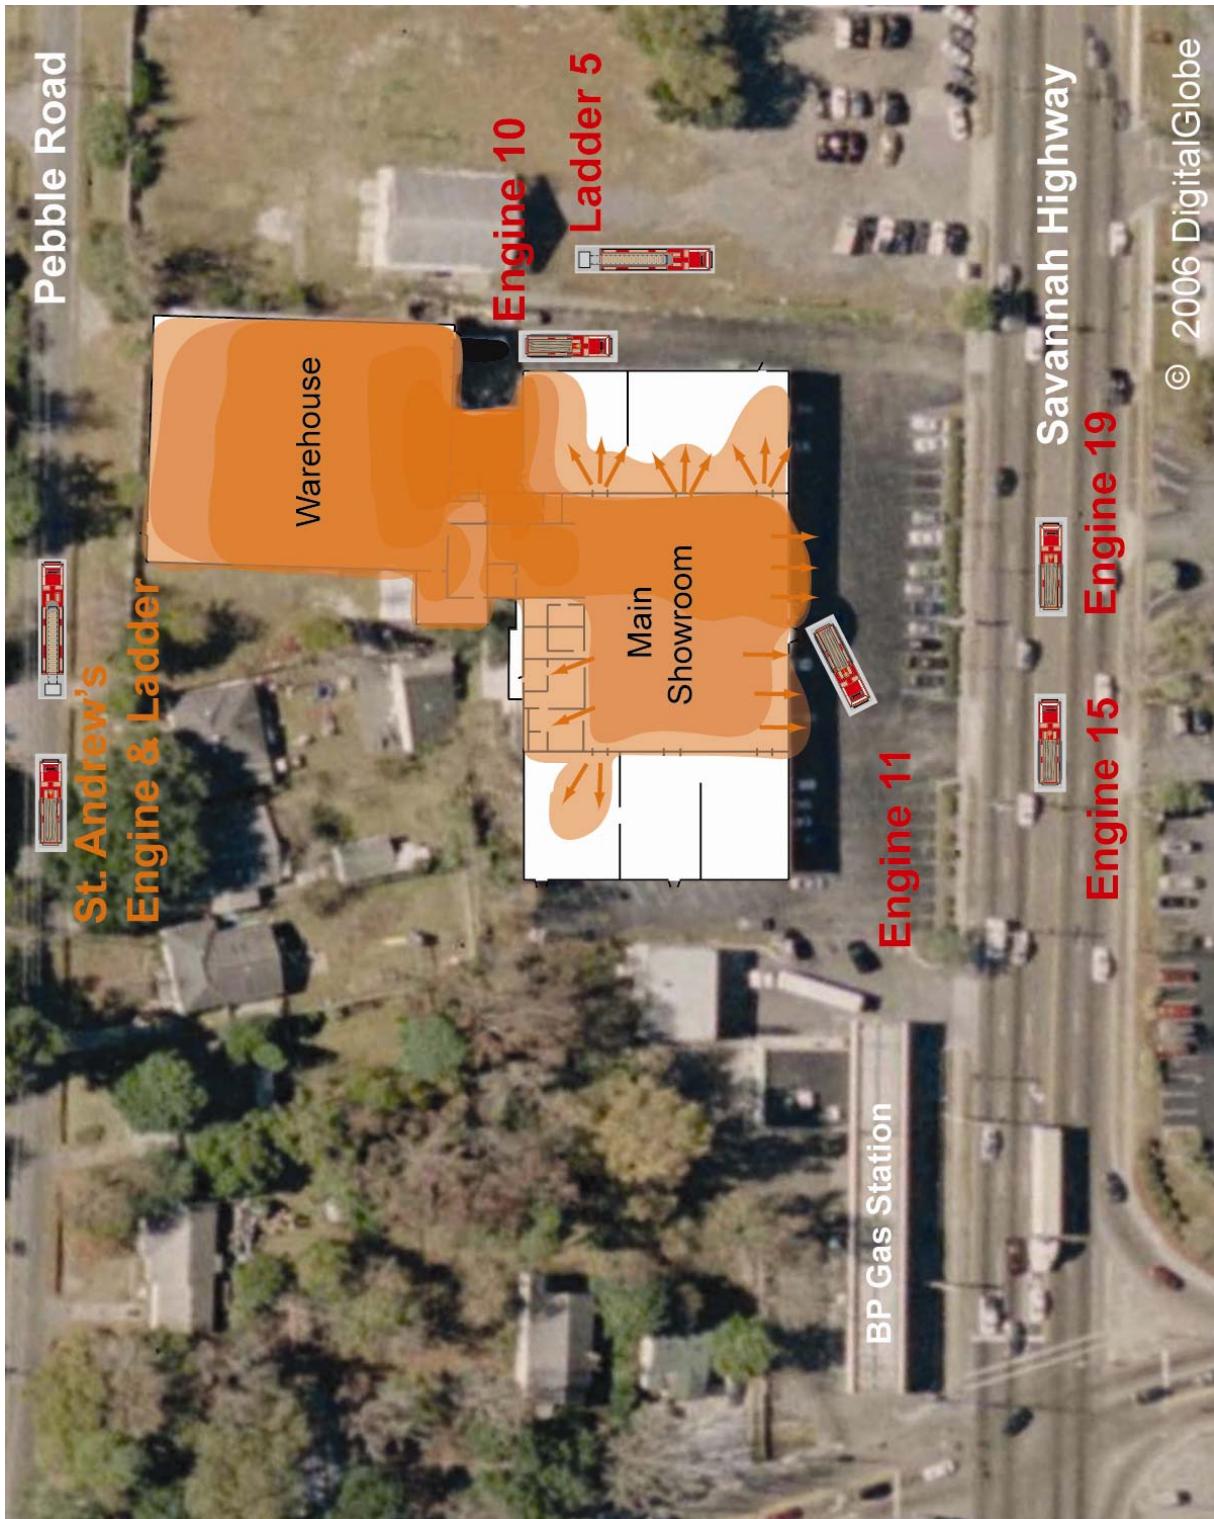
Figure 2-10. Fire spreading to west showroom and the rear of east showroom. This occurred by about 7:38 p.m. Background image used with permission of DigitalGlobe. Enhancements by NIST.

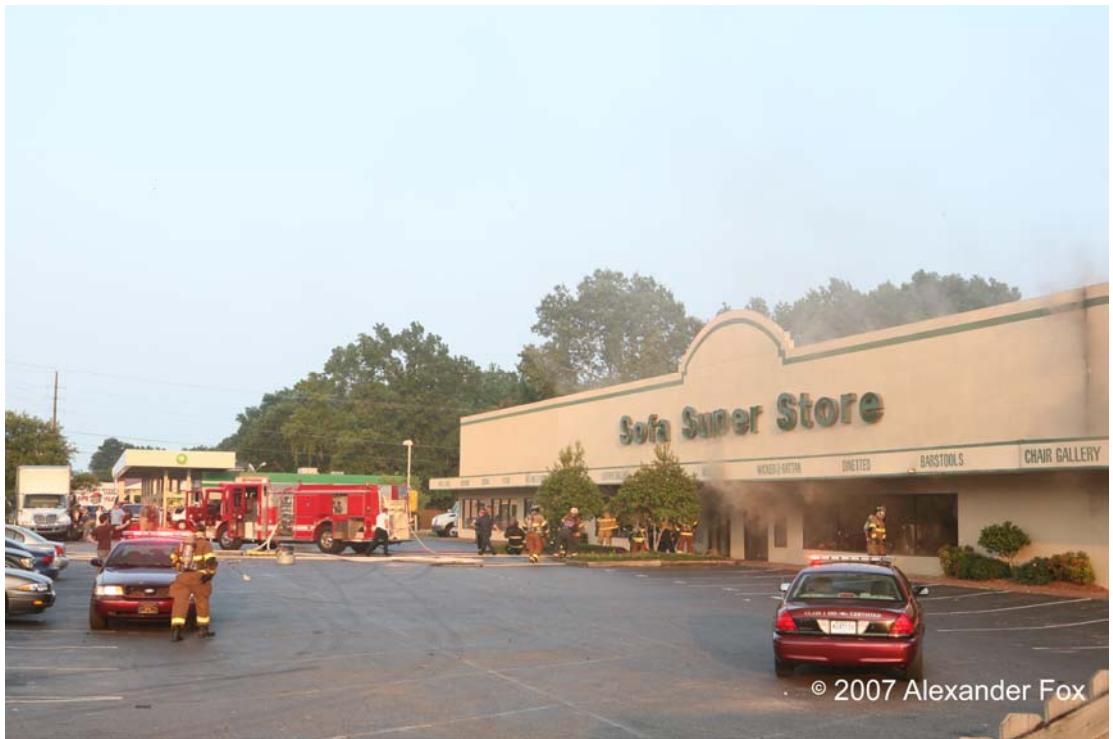
Figure 3-7. Light brown smoke began to flow out of broken front windows. Photo taken at approximately 7:36 p.m. Photo used with permission of Alexander Fox.

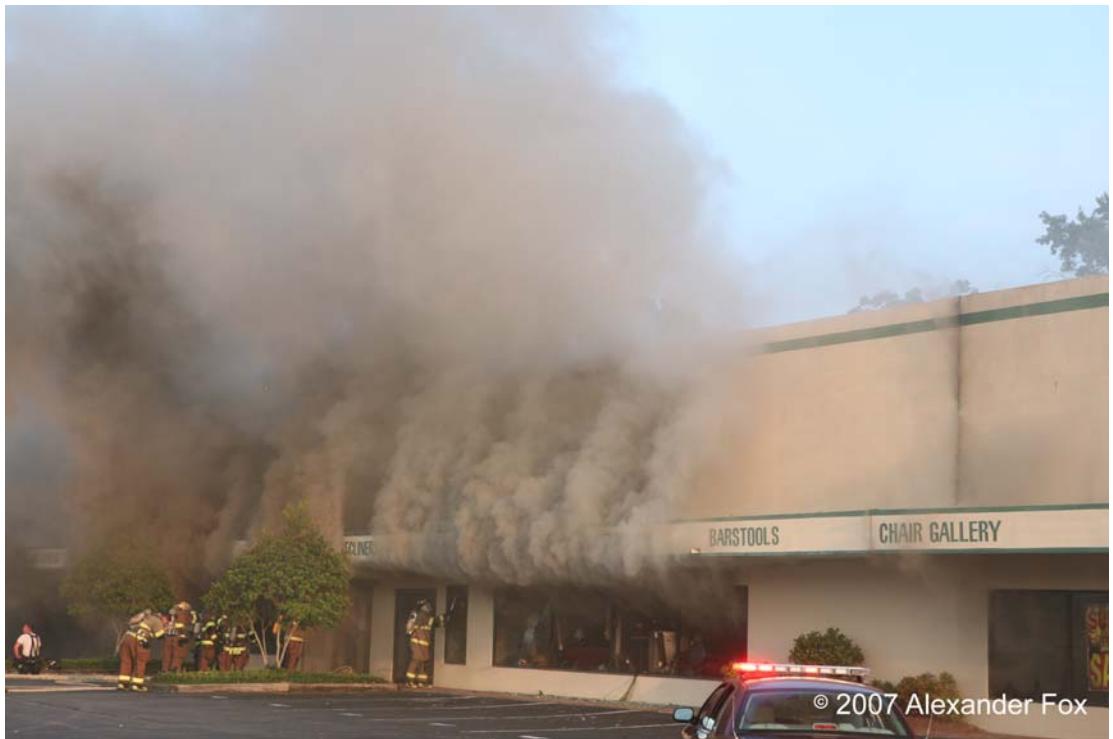
Figure 3-8. Additional smoke moved out of broken windows. Photo taken at approximately 7:36 p.m. Photo used with permission of Alexander Fox.

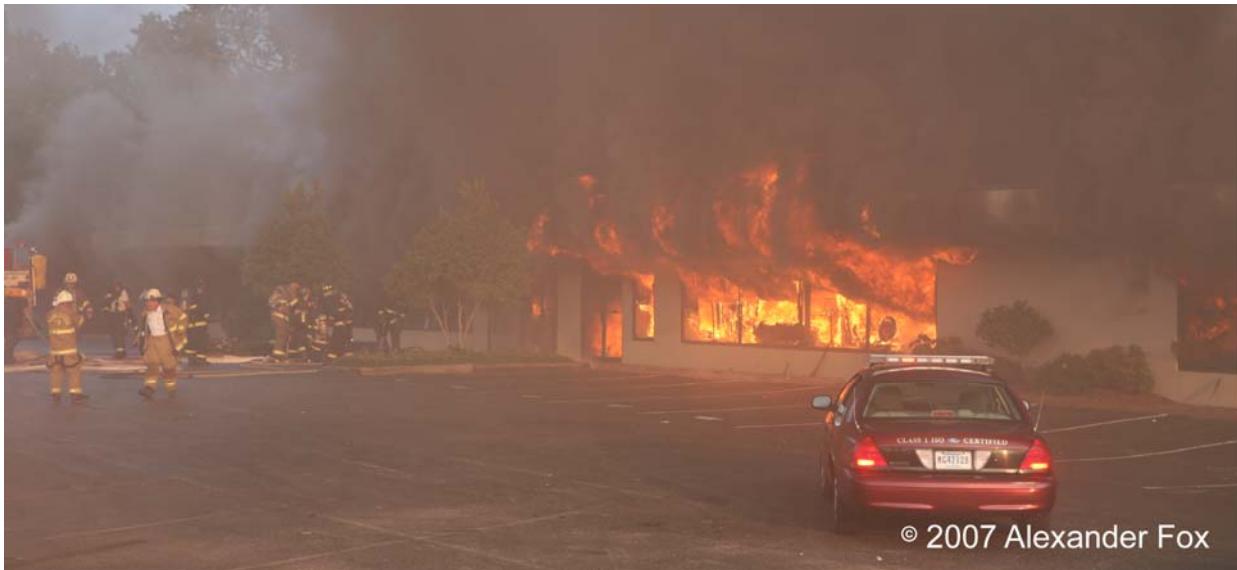
Figure 3-9. Black smoke and flames flowed out of front windows as fire spread to the main showroom. Photo taken at approximately 7:38 p.m. Photo used with permission of Alexander Fox.

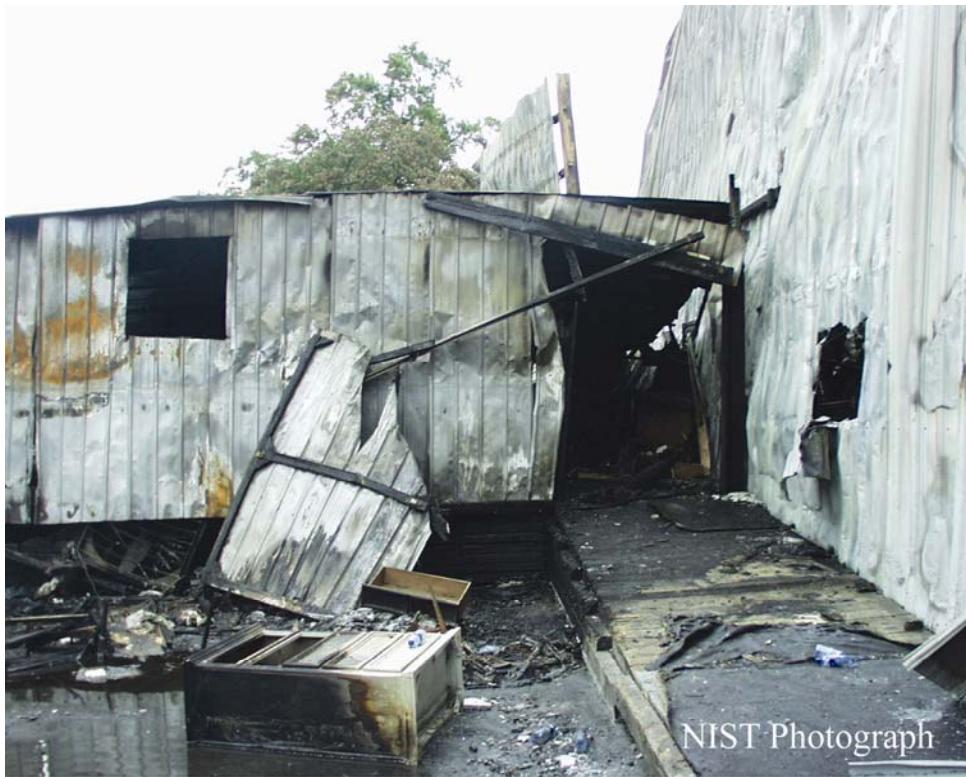
Figure 4-7. Photograph showing the outside of the loading dock. This was identified as the area of fire origin.
