Lieutenant and Fire Fighter Die and 13 Fire Fighters injured in a Wind-driven Fire in a Brownstone — Massachusetts

A summary of a NIOSH fire fighter fatality investigation

March 2, 2016

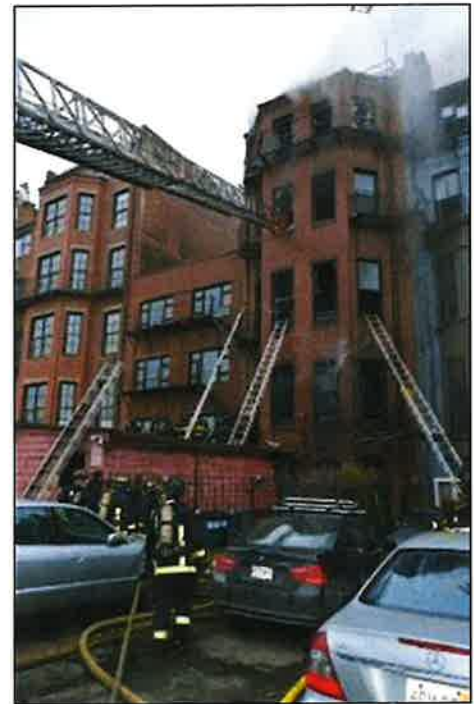
A view of fireground worker leaving the rear door of the attached shed open while investigating the smoke detector activation. The conditions became untenable for the fire fighters from Engine 7. They moved out of the building to the landing of the front steps. Also, the interior door at the top of the basement stairs was open, the front exterior doors were left open by an occupant fleeing the fire, and a rear basement door or window failed. Once the rear door or window burned through, this created an unrestricted flow path from the basement to the first floor plus the floors above, thereby triggering a rapid progression of fire conditions. This trapped the officer and fire fighter from Engine 33 in the basement. The fire, heat, and smoke through the basement and first floor created untenable conditions on both floors. Due to the intense heat and fire conditions, the 1¾-inch attack hose burned through. Command then ordered the building to be evacuated. Approximately 1 minute later, the Engine 33 lieutenant called Command and said they were running out of water. The dispatcher replied, "OK Engine 33, we are going to get you water." Command immediately called a second alarm for Box 1579. Several companies tried to make entry into Side Alpha from both the basement and the first floor of the structure, but were pushed back by heavy fire and smoke. Crews pushed through the Side Bravo exposure to initiate fire attack on Side Charlie. Crews took a 2½-inch hoseline into the basement apartment on Side Charlie. Approximately 15 minutes later, crews located the fire fighter from Engine 33 in the kitchen area of this apartment. The fire fighter was removed from the apartment and immediately taken to an ambulance for transport to the hospital. The fire fighter from Engine 33 was pronounced dead at the hospital. After the fire fighter was removed, conditions changed and the structure became fully involved. Crews were removed from the structure and the strategy was changed to defensive operations. Once the fire was completely knocked down and conditions allowed fire fighters to safely re-enter the structure, a search was made for the lieutenant of Engine 33. The lieutenant was found at the bottom of the stairs near the entrance to Apartment #10 in the basement. The lieutenant was pronounced dead at the scene.
