**NIOSH**  
Fire Fighter Fatality Investigation  
and Prevention Program

*A summary of a NIOSH fire fighter fatality investigation*

March 2, 2016

### *Lieutenant and Fire fighter Die and 13 Fire Fighters injured in a Wind Driven Fire in a Brownstone - Massachusetts*

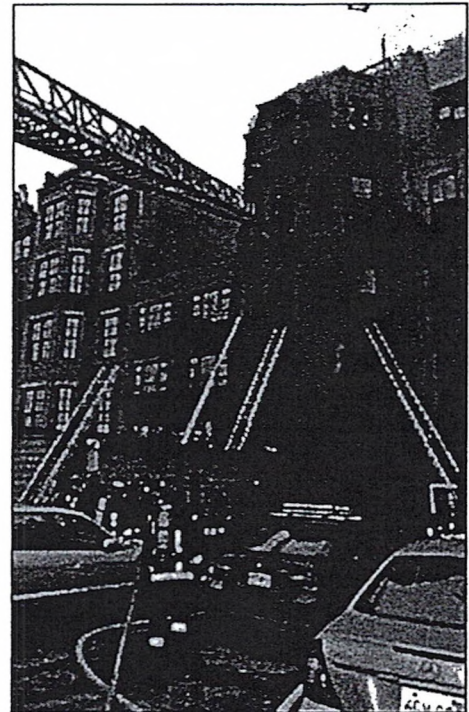
A view of fireground worker leaving the rear door of the attached shed open while investigating the smoke detector activation. The conditions became untenable for the fire fighters from Engine 7. They moved out of the building to the landing of the front steps. Also, the interior door at the top of the basement stairs was open, the front exterior doors were left open by an occupant fleeing the fire, and a rear basement door or window failed. Once the rear door or window burned through, this created an unrestricted flow path from the basement to the first floor plus
