**Nine Career Fire Fighters Die in Rapid Fire Progression at Commercial Furniture Showroom — South Carolina**

Fire Fighter Fatality Investigation and Prevention Program

A summary of a NIOSH fire fighter fatality investigation

February 11, 2009

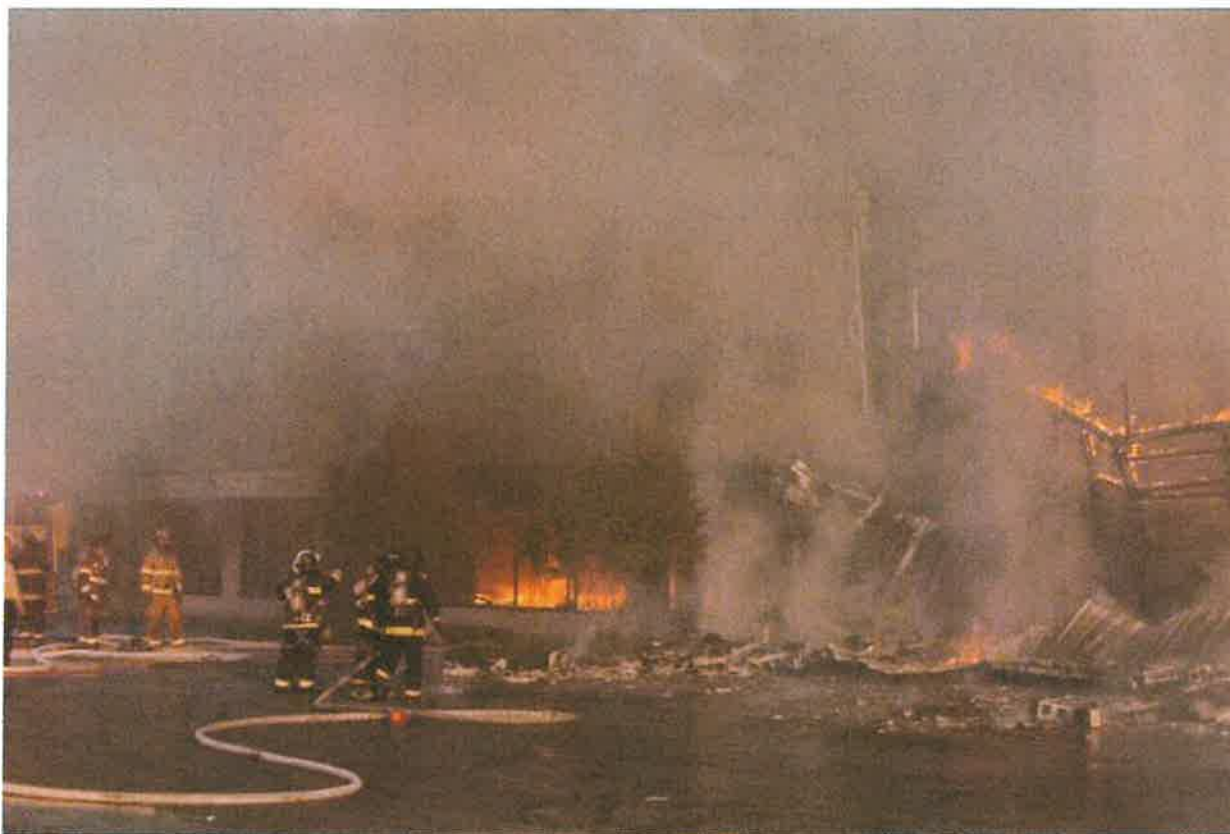
**Photo A-4: Time approximately 1951 hours. Front façade beginning to collapse. (Photo courtesy of the Charleston Post and Courier.)**

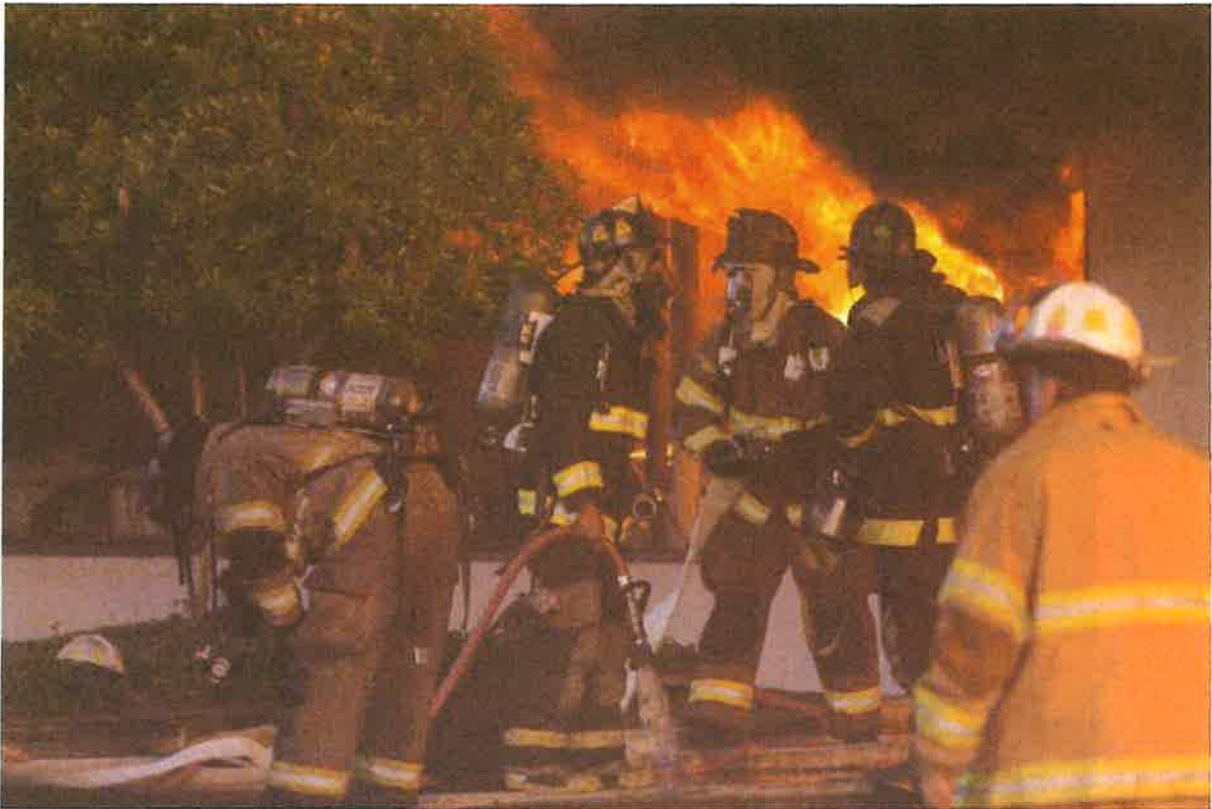
**Photo A-3. Time approximately 1939 hours. Fire fighters near front entrance to showroom. Note lack of water pressure on the red booster line and the 2 ½" hand line. Also note lack of gloves and hood. (Photo courtesy of the Charleston Post and Courier.)**

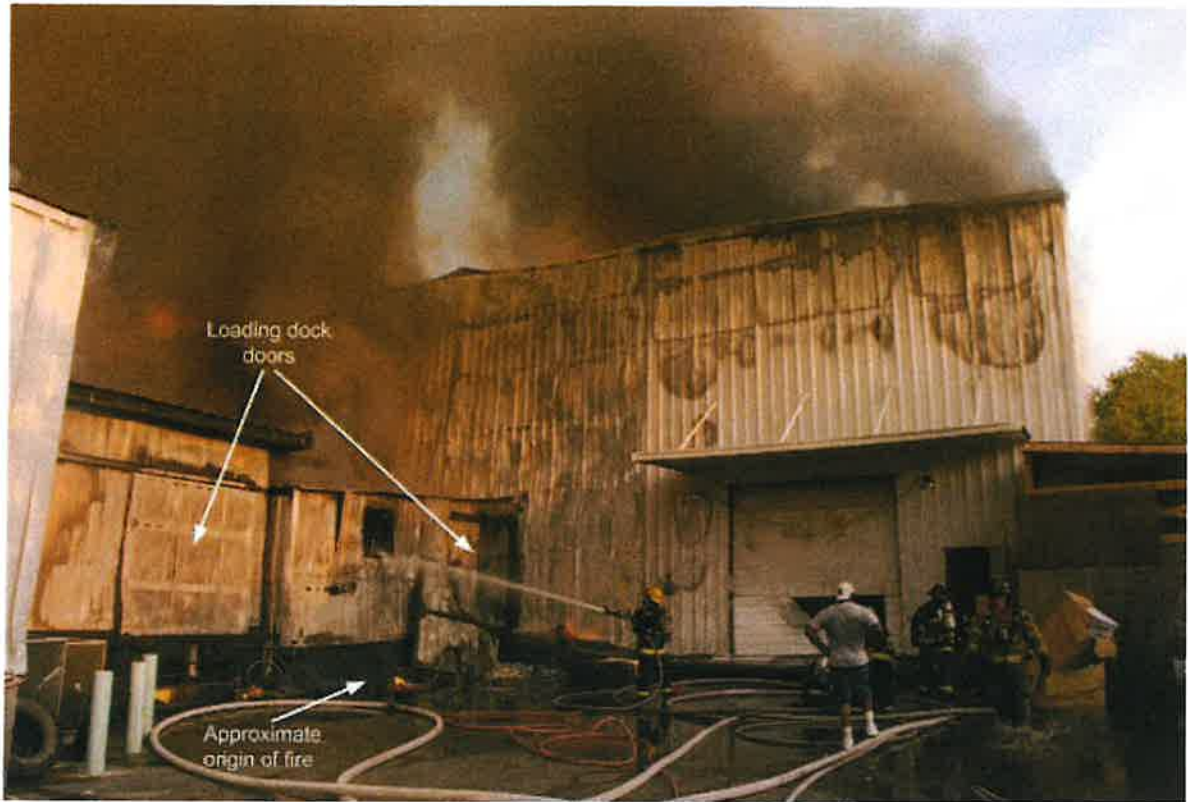
**Photo A-2. Time is approximately 1936 hours. Loading dock area approximately 20 minutes after first crews arrived on scene. There is heat damage to metal siding on loading dock and warehouse. There are two Loading dock doors. There is an approximate origin of fire in the corner. (Photo courtesy of Police Department, Bill Murton, photographer.)**

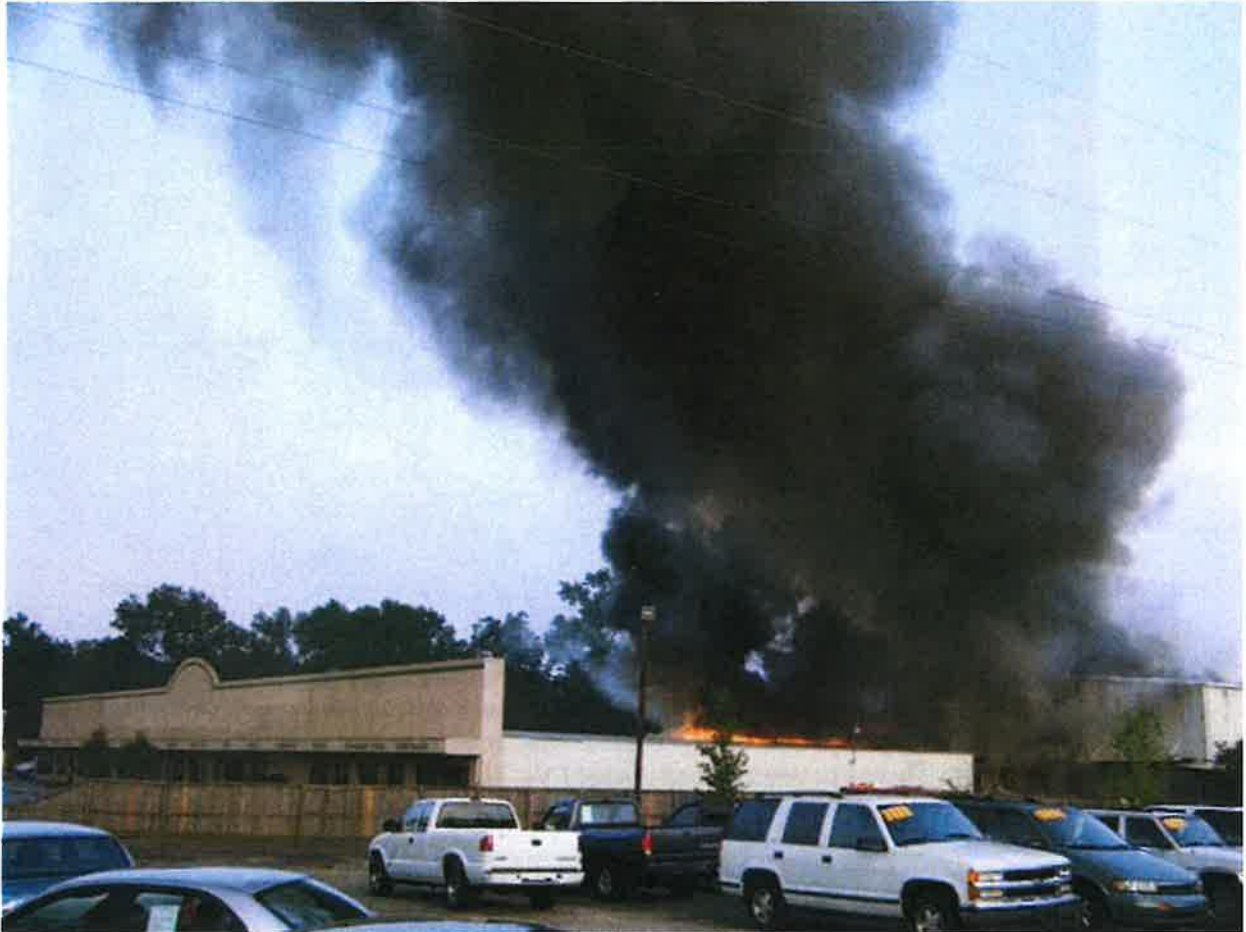
**Photo A-1. Time is approximately 1923 hours. Fire is visible over showroom roof. Smoke is dark gray in color and becoming turbulent. The flames may not have been visible from front parking lot or close to the building on the D-side. (Photo courtesy of Dan Folk.)**

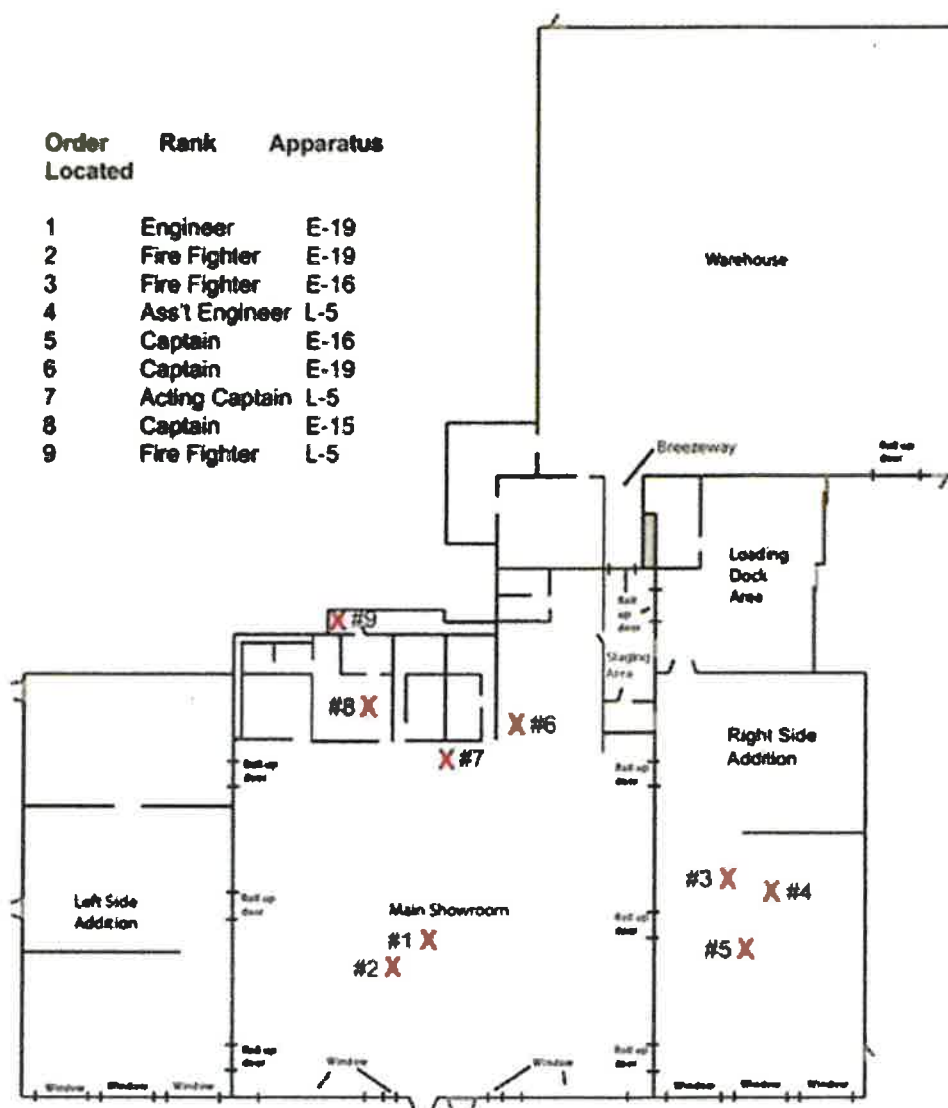
**Diagram 4. Approximate Location of 9 Victims. Victims 1, 2, 6 and 7 are located in the Main showroom. Victims 3, 4, and 5 are located in the Right Side Addition. Victims 8 and 9 are located behind the main Showroom.**

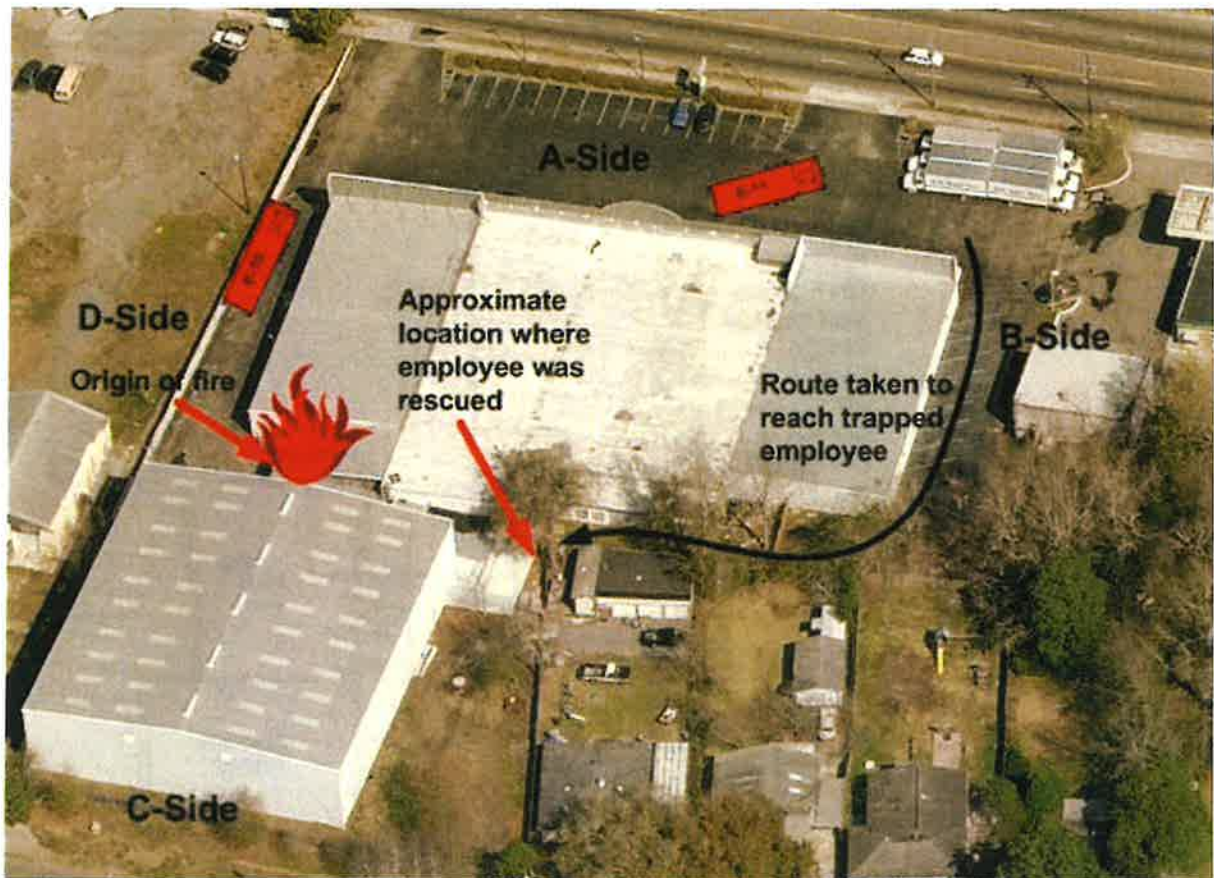
**Diagram 3: Note location where mutual aid crew cut through exterior wall to extricate male employee trapped inside the warehouse. From aerial photo taken in 2007.**

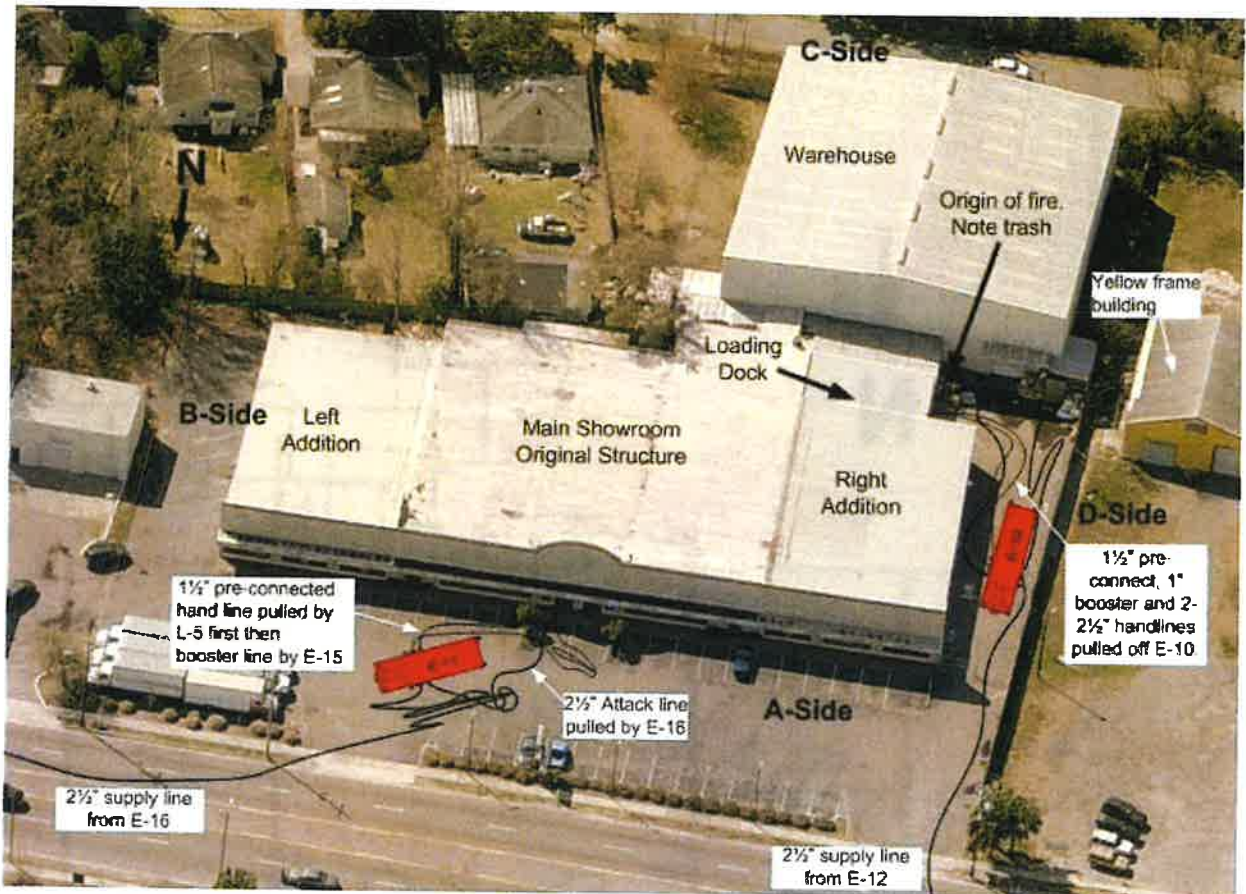
**Diagram 2. Location of Engine 10 and Engine 11, supply lines and hoselines pulled at different times during the incident. Note accumulation of trash at loading dock on the day photo was taken, 3 months prior to the incident. Note the absence of ventilation ductworks or other roof penetrations over the showroom, thus no path for smoke and hot gases to escape. From aerial photo taken in March 2007 (copyright Pictometry International – used with permission of Pictometry)**

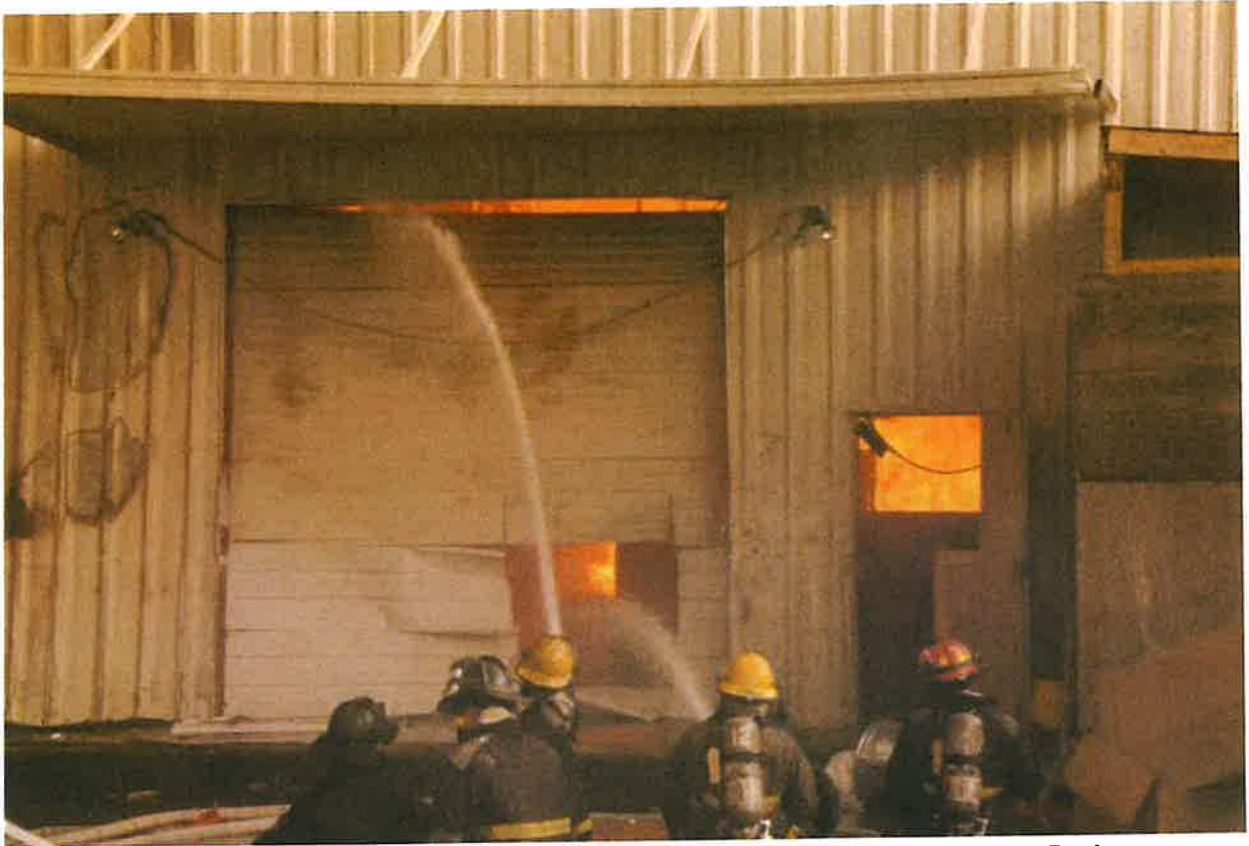
**Photo 10.** Time approximately 1942 hours. Engine 10 and Engine 12 crews battle fire in warehouse from outside. *(Photo courtesy of police department, Bill Murton, photographer.)*

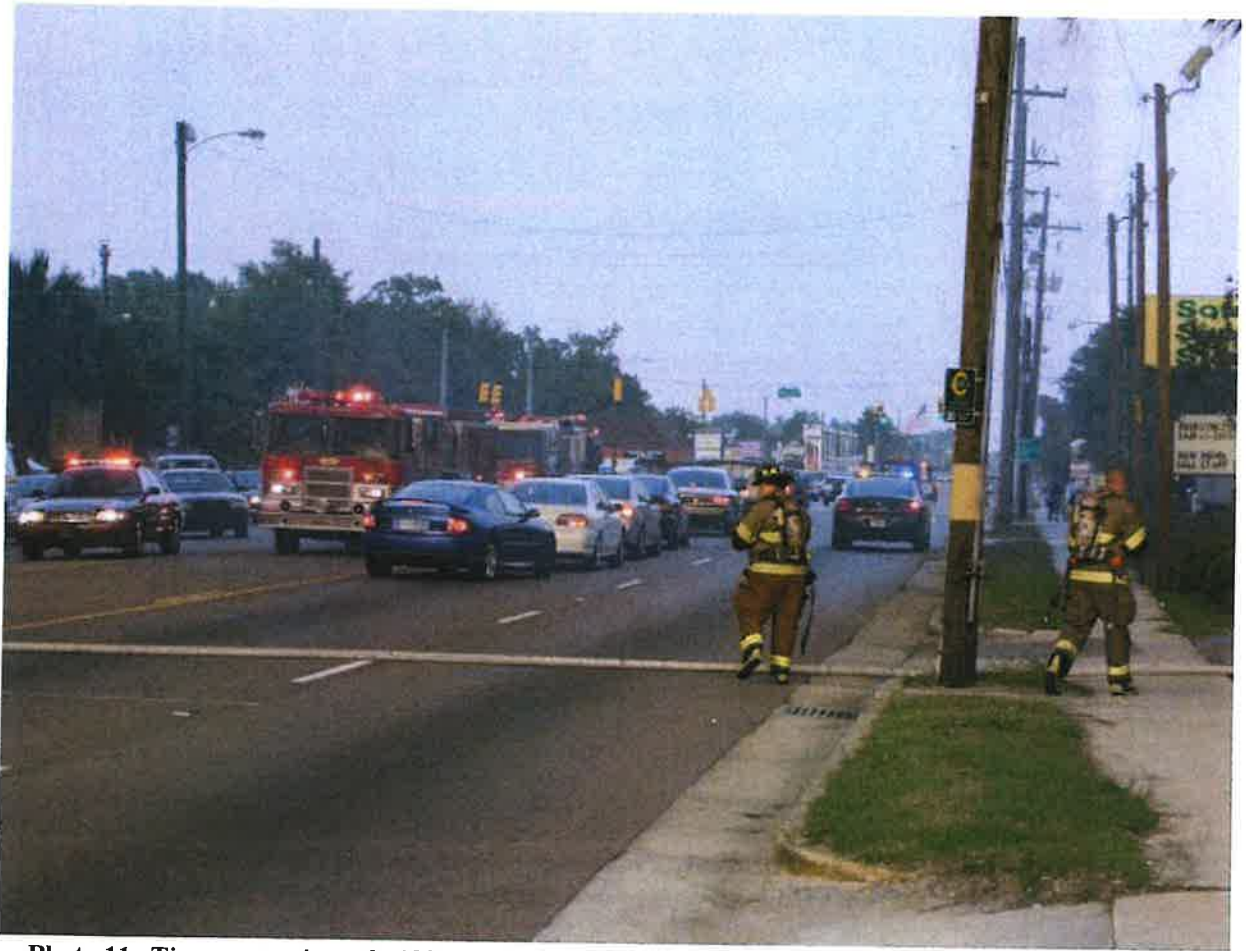
**Photo 11. Time approximately 1925 hours. Note traffic on major highway in front of incident site driving over 2 ½ inch supply line. The hoseline runs from Engine 12 (to left of photo) to Engine 10 (to right of photo). Photo shows mutual aid crew members arriving on scene. (Photo courtesy of Dan Folk.)**

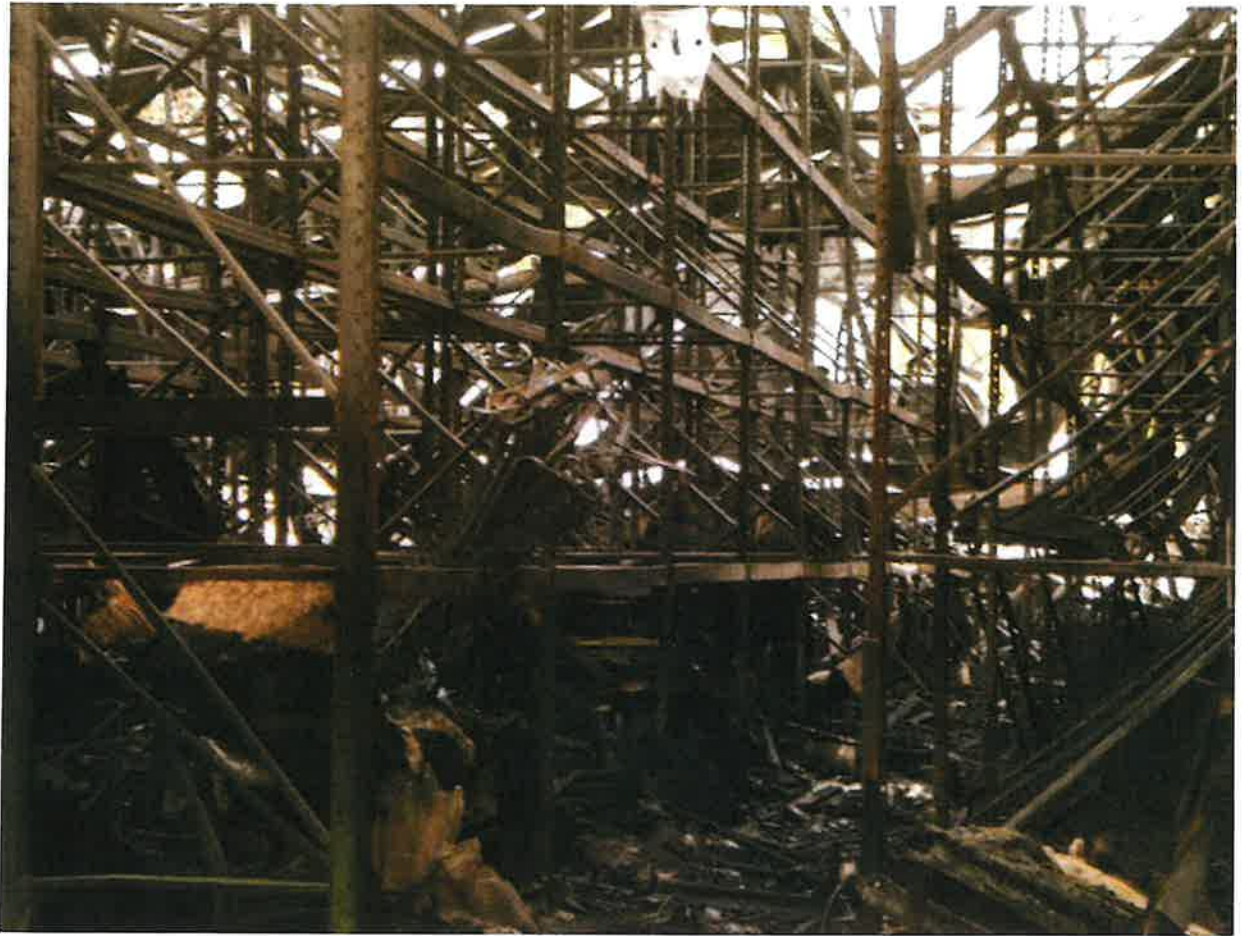
**Photo 9. Storage racks in warehouse post fire. Storage racks were filled with various furniture and mattress items. Note the extent to which the storage racks filled the warehouse which gives an indication of the volume of merchandise and the fuel load inside the 15,600 square foot warehouse. The warehouse measured approximately 130 ft. by 120 ft. and was 29 ft from floor to roof. (Photo – NIOSH.)**

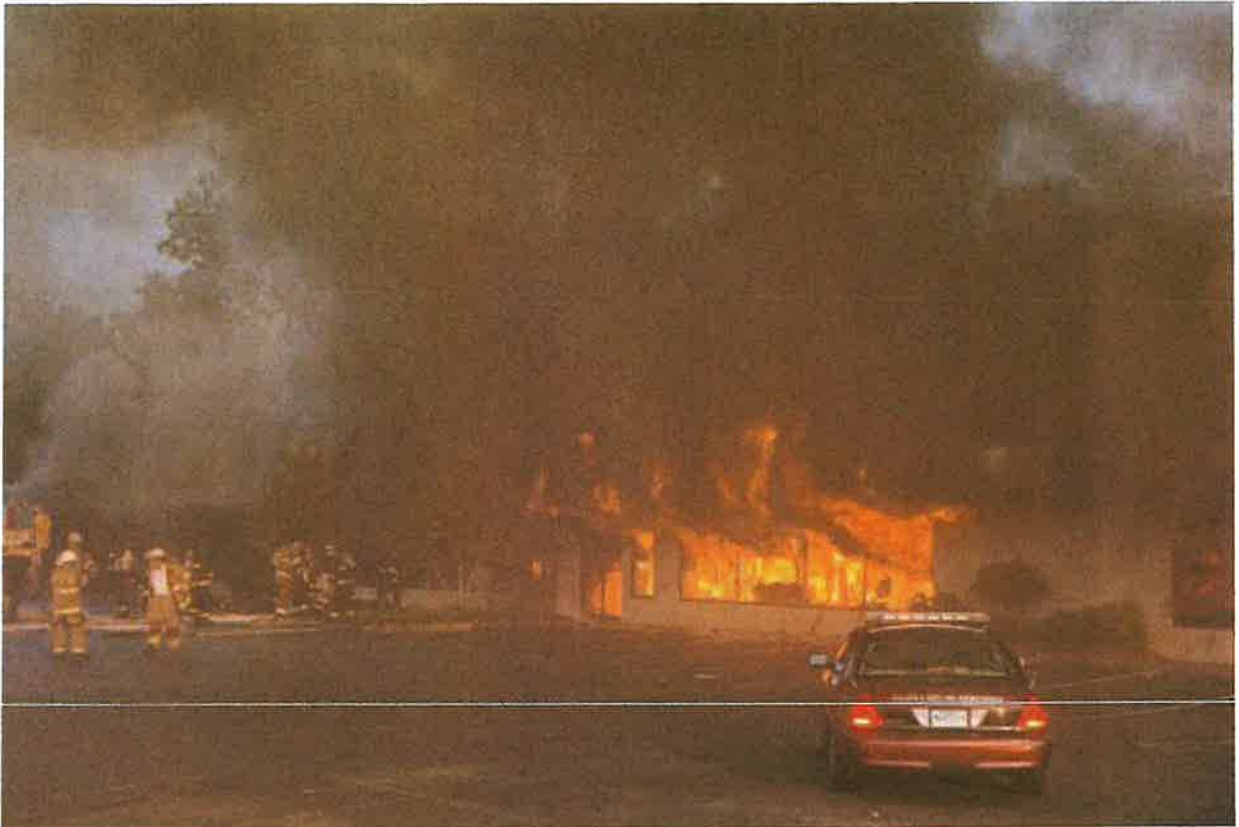
**Photo 8. Time approximately 1938 hours. Photo taken less than a minute after rescue crews are forced out of the showroom by the interior conditions. Note fire rolling out the showroom windows. (Photo courtesy of the Charleston Post and Courier.)**

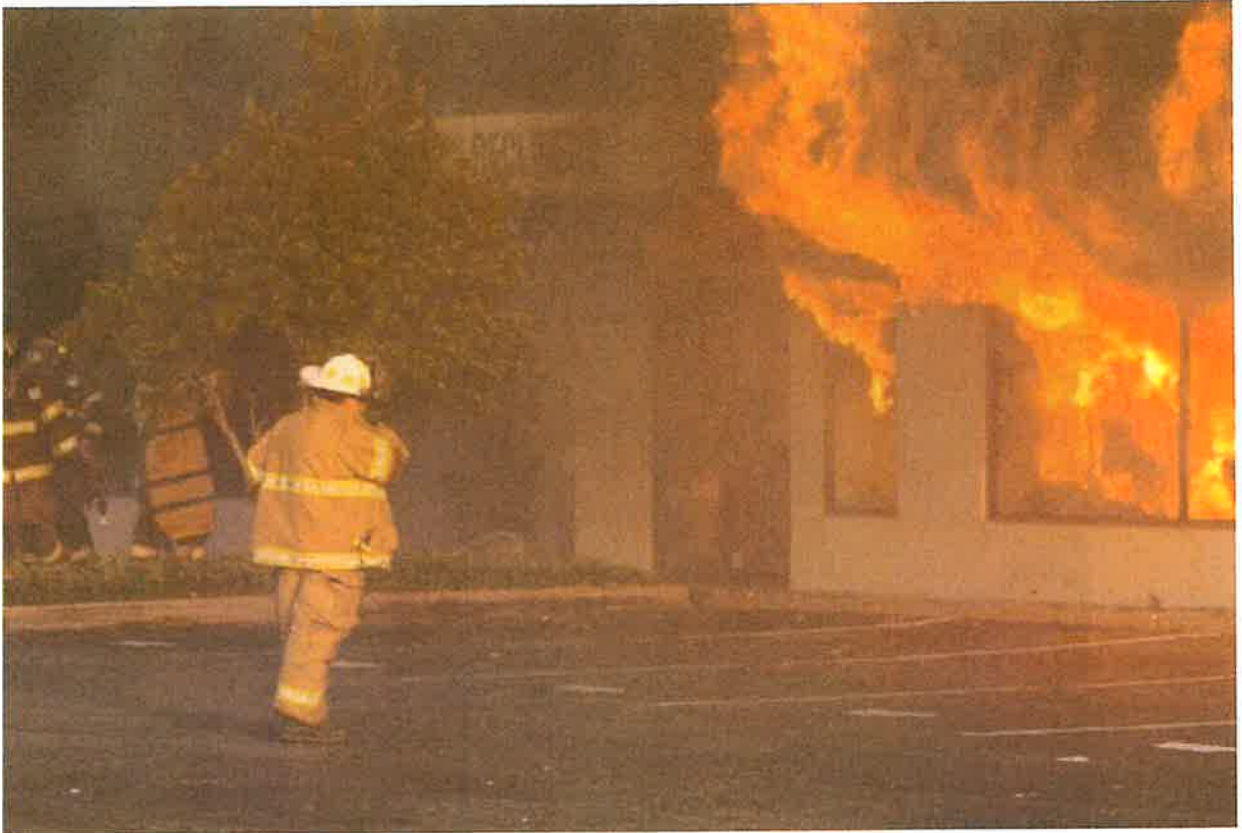
**Photo 7. Time approximately 1938 hours. Photo shows conditions at front of showroom just before the interior search and rescue attempts were halted due to the interior conditions.**

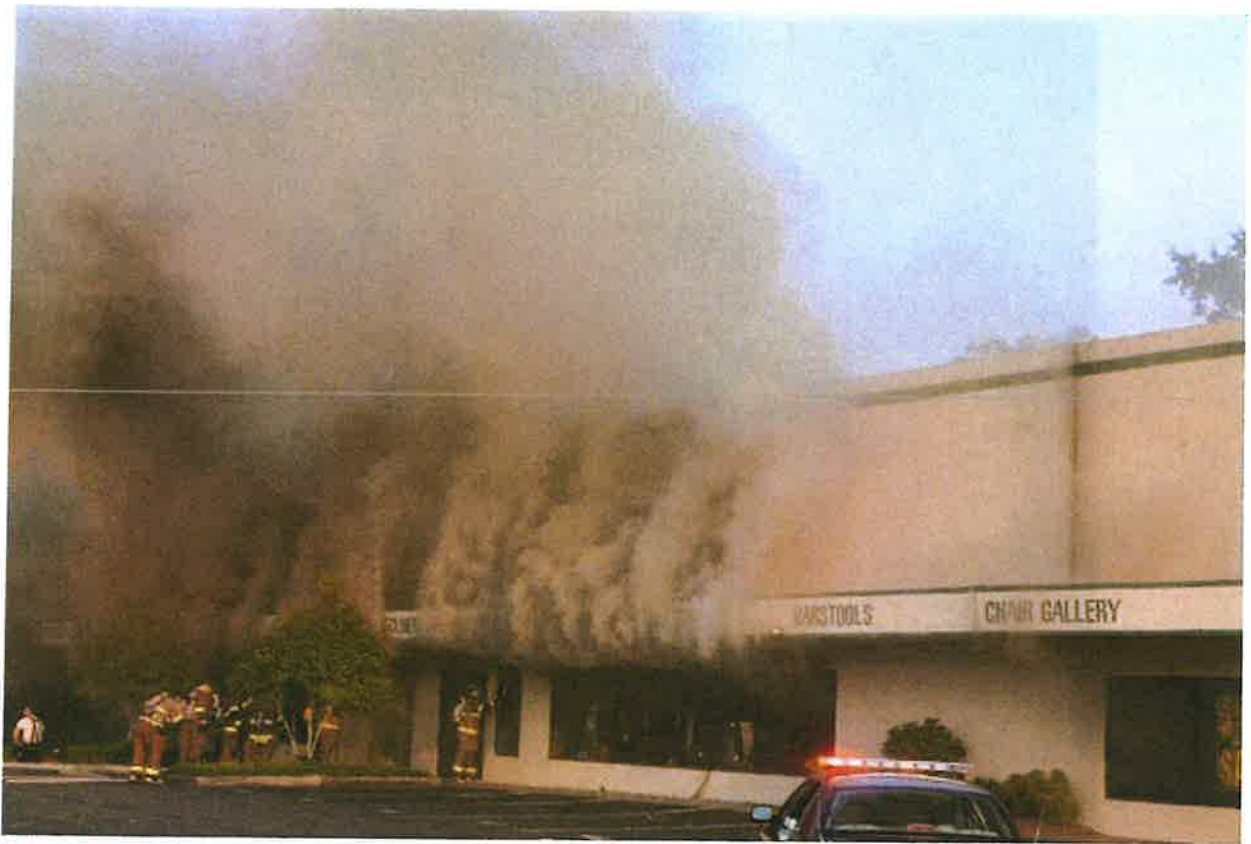
**Photo 6. Time approximately 1936 hours. Note turbulent dark gray smoke rolling out of the showroom as the front windows are being knocked out. Mutual aid crew is assembling for search and rescue attempt. (Photo courtesy of Associated Press, Alexander Fox, photographer.)**

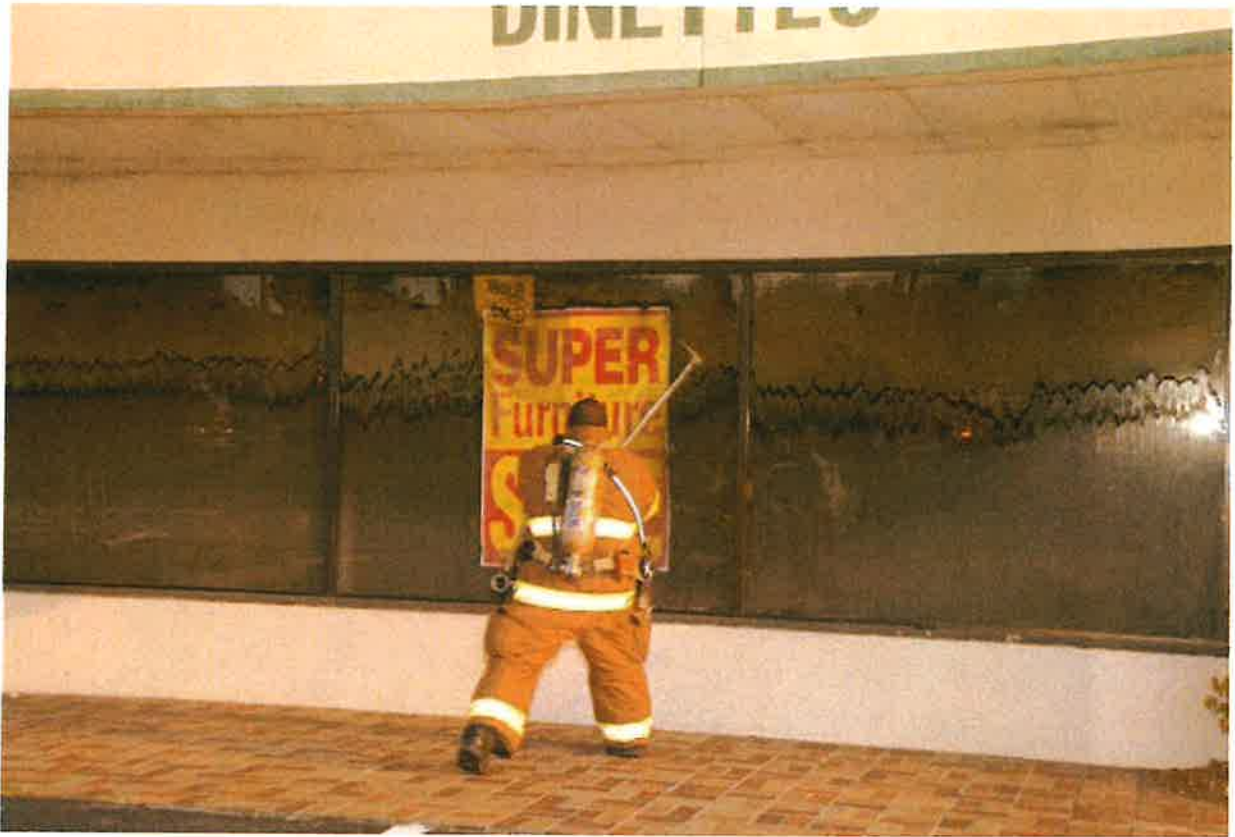
**Photo 5. Time approximately 1935 hours. Mutual aid fire fighter breaking showroom front window. Photo taken just prior to mutual aid department making rescue attempt in front showroom. Note the heavy tar stains on the windows indicating the smoke inside the showroom is rich with flammable products of incomplete combustion. (Photo courtesy of Police Department, Bill Murton, photographer.)**

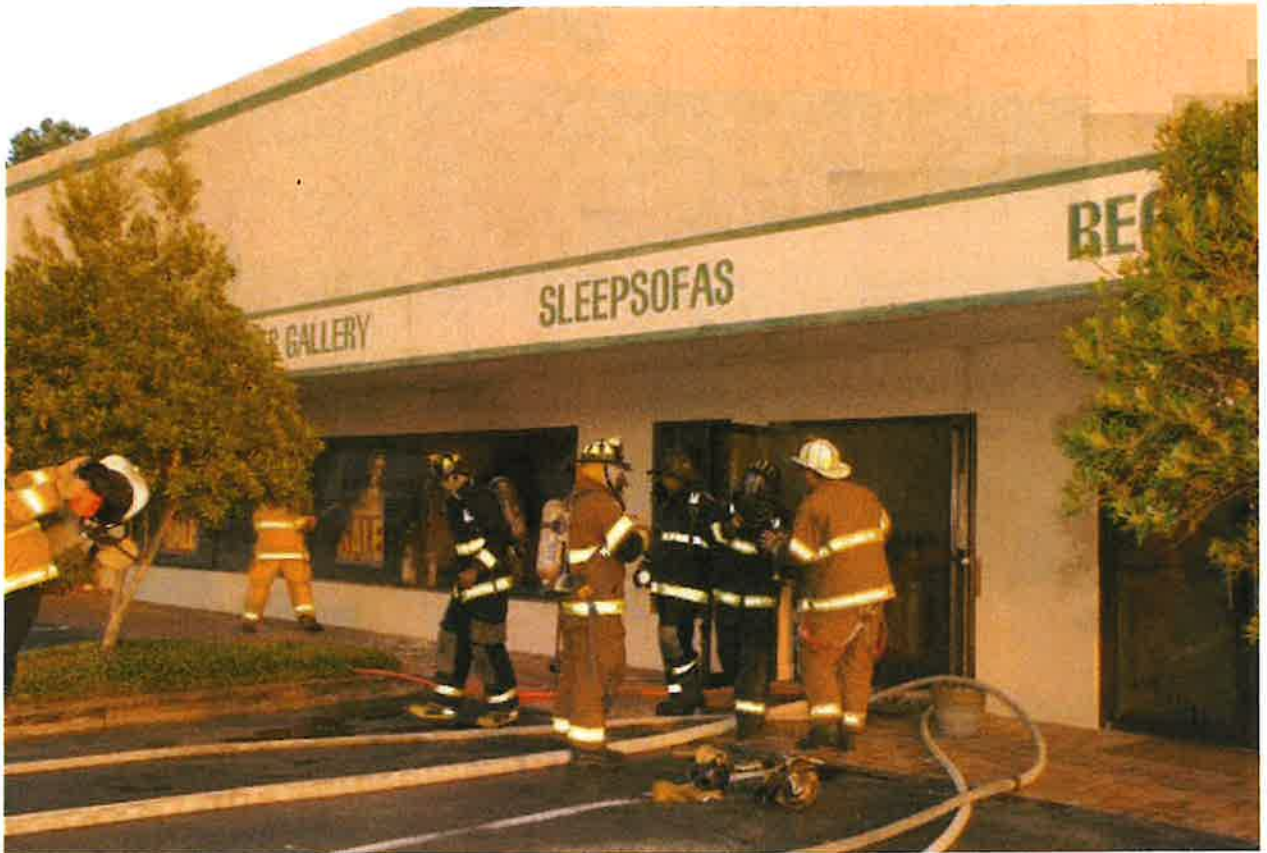
**Photo 4. Last surviving members of the initial attack crews exit showroom at approximately 1935 hours. (Photo courtesy of Police Department, Bill Murton, photographer.)**

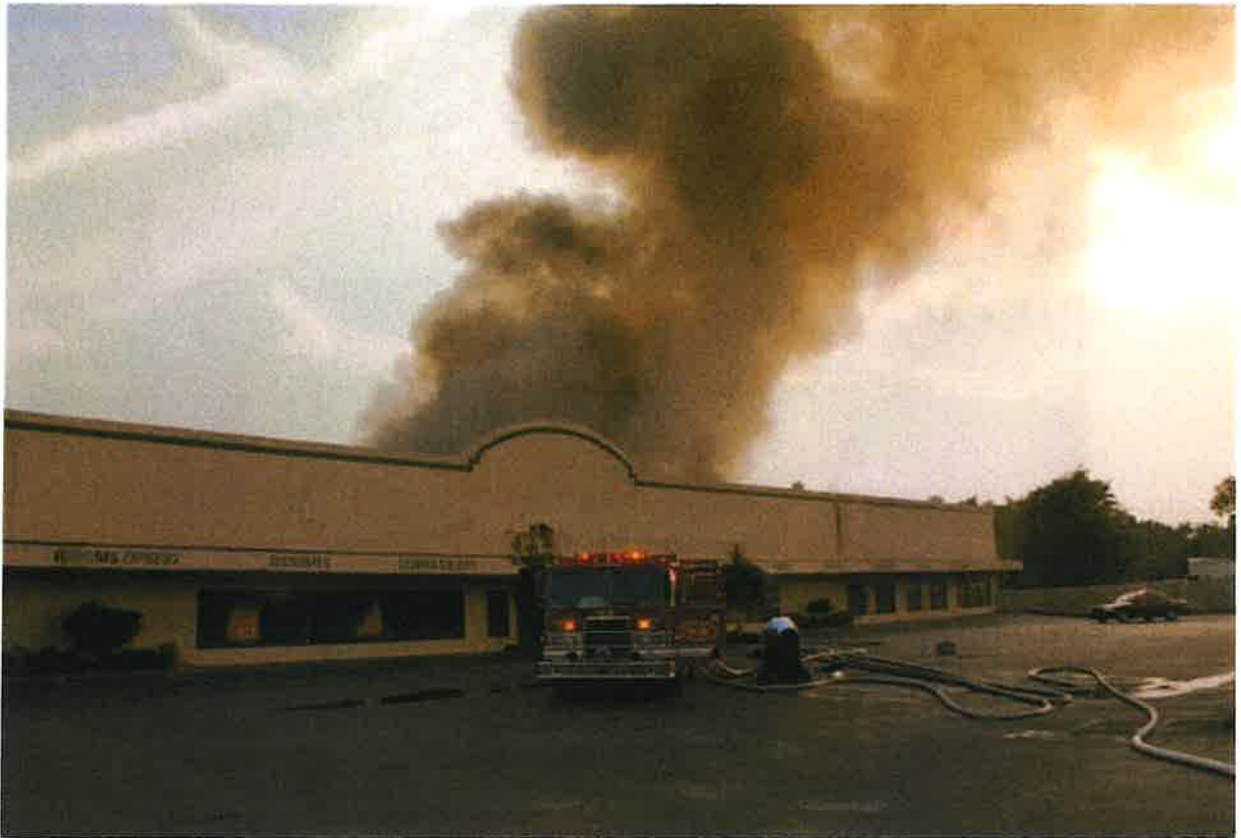
**Photo 3. Time approximately 1934 hours. Note lack of any fire personnel in front of structure. At this point, the E-11, L-5, E-16, E-15, E-19, and E-6 crews are inside the showroom. Also note how the color of smoke column appears different from previous photo which may be due to the angle of the photograph and position of the sun. (Photo courtesy of Police Department, Bill Murton, photographer.)**

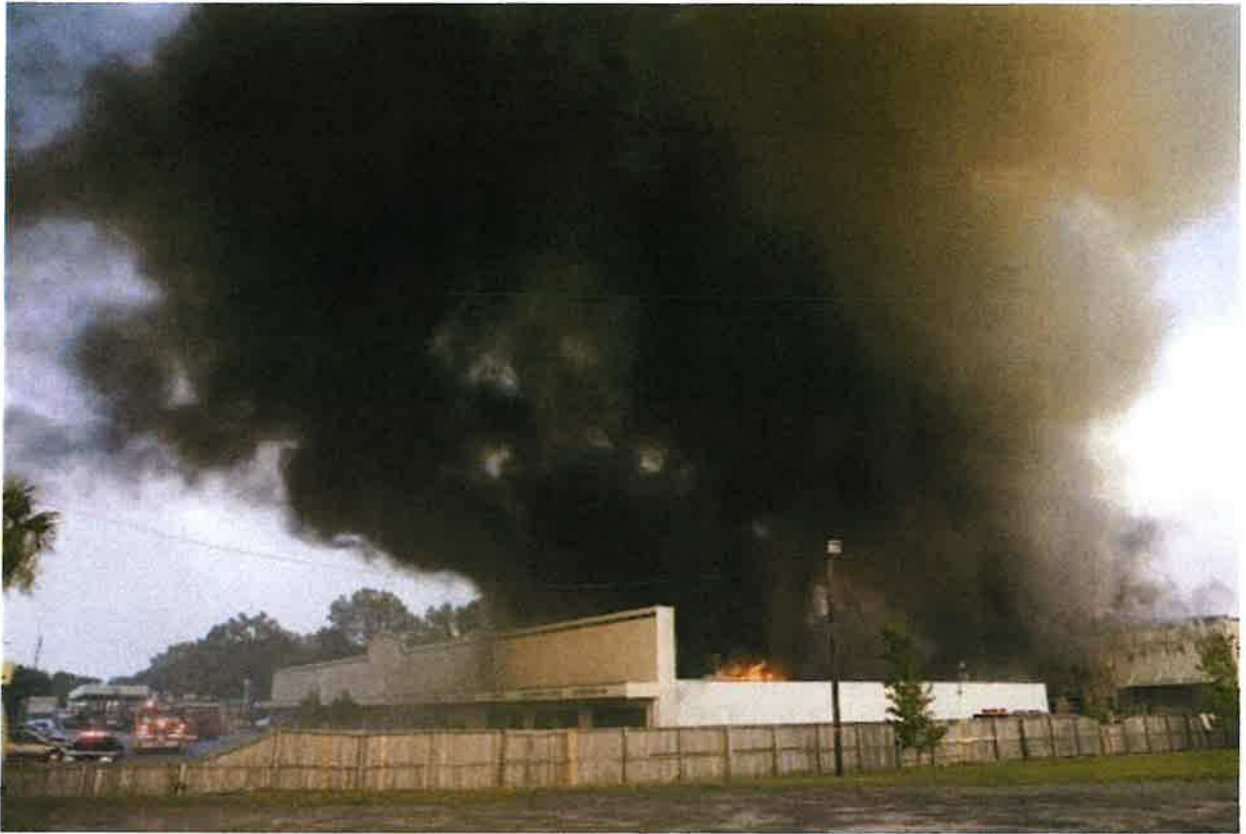
**Photo 2. Time approximately 1930 hours. Note how smoke has changed to dark black color indicating it is rich with products of incomplete combustion. Note Ladder 5 and Engine 11 in front of structure as well as fire department vehicle in lower left corner. The top of Engine 10 is just visible over the fence at the lower right. (Photo courtesy of Associated Press, Alexander Fox photographer.)**

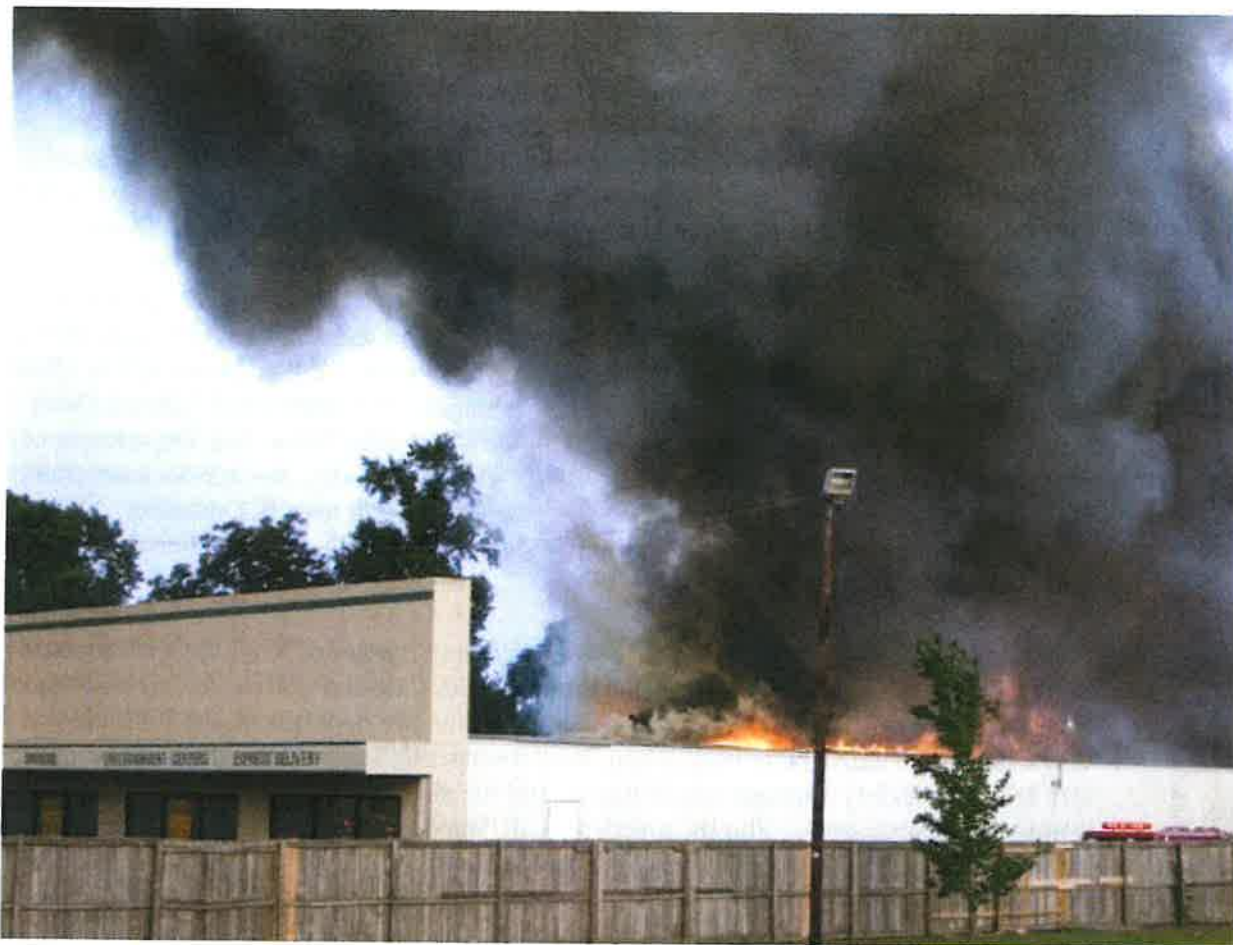
**Photo 1. Time approximately 1924 hours. Fire is visible over showroom roof. Smoke is dark gray in color and becoming turbulent. The flames may not have been visible from front parking lot or close to the building on the D-side. (Photo courtesy of Dan Folk.)**
