NASA TM X-64086

TEST OF LOX COMPATIBILITY FOR ASPHALT
AND CONCRETE RUNWAY MATERIALS

John F. Kennedy Space Center
Kennedy Space Center, Fla. 32899

December 1973

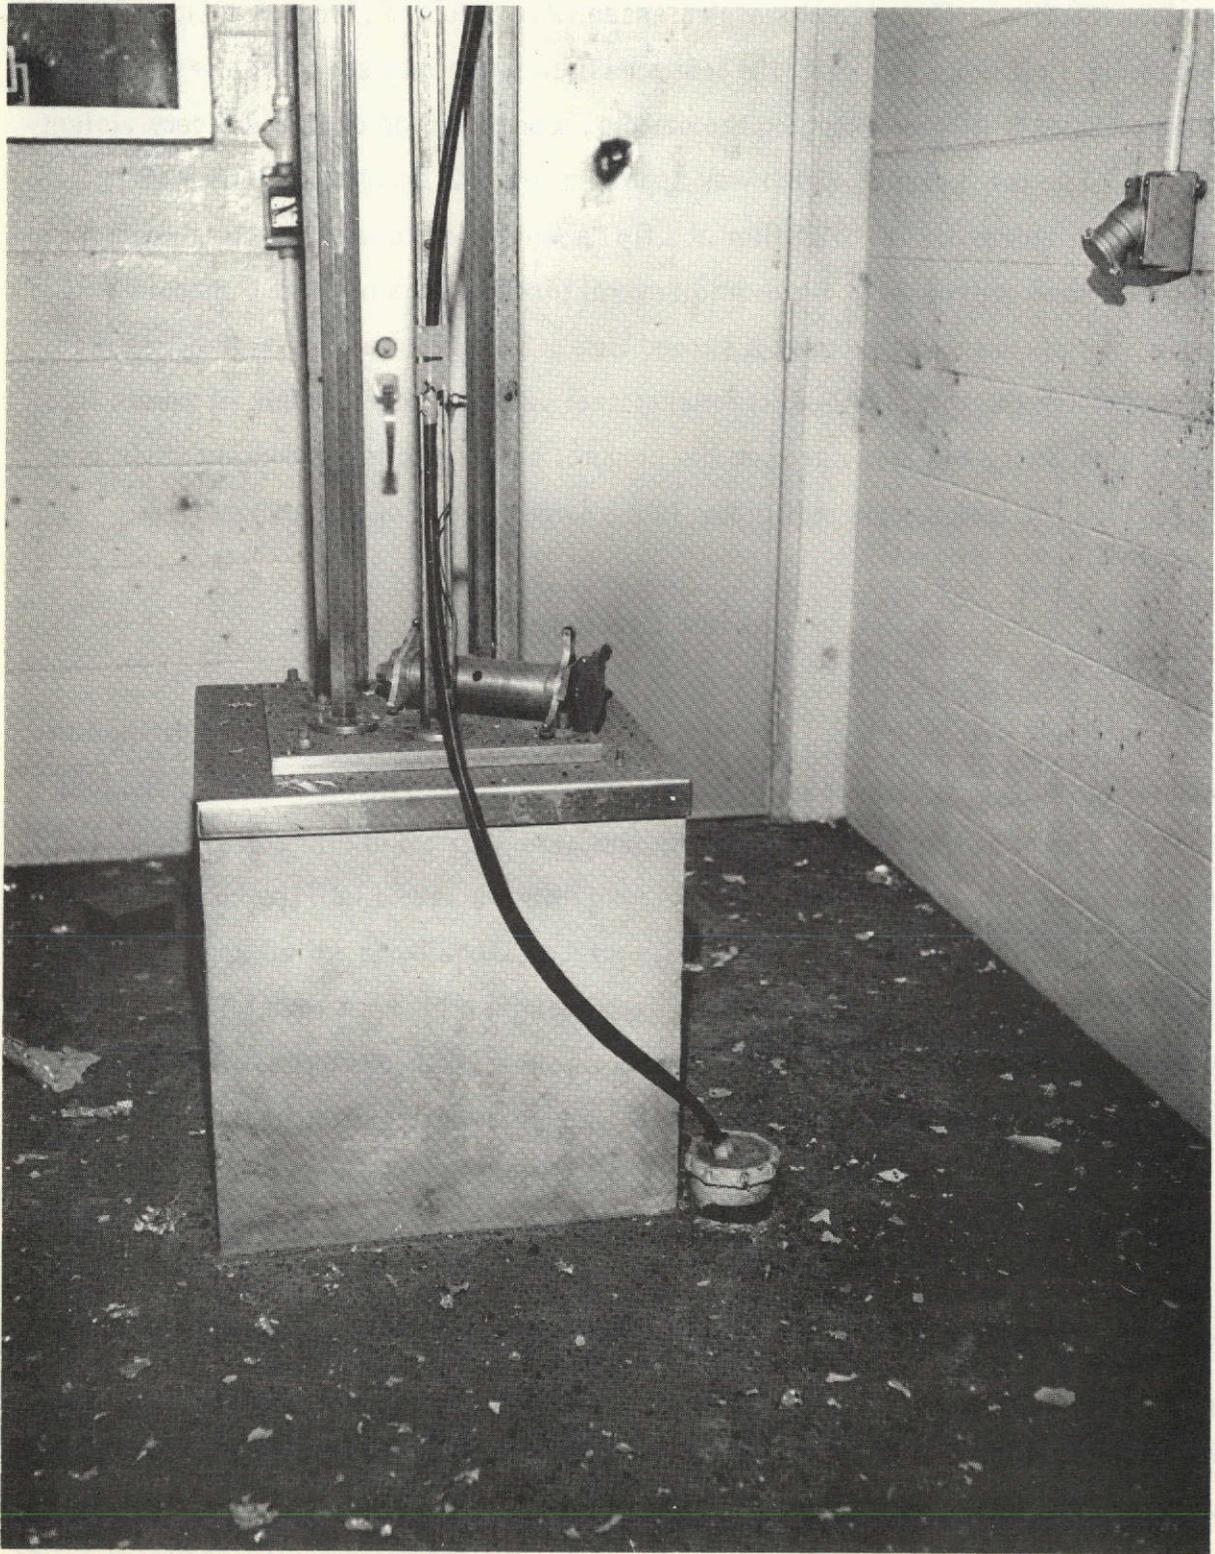
Figure 1. LOX Impact Test Cell after LOX/Asphalt Reaction.

a violent reaction. The second sample, essentially a cube 7.5 cm on a side, failed to react on the first drop; however, the test specimen broke into several pieces. Without adding additional LO_2 or changing the sample, a second drop produced a very violent reaction. The last sample, which was approximately 12 cm by 12 cm by 7.5 cm (immersed in approximately 0.5 liter of LO_2) again failed to react on the first drop; but, like the second specimen, it broke into several pieces. Again without changing the sample, the plummet was dropped a second time. This time another violent reaction occurred which threw a 5.89-kg stainless steel backup plate a couple of meters into an aluminum door, and also damaged the plummet spider and four mounting studs (see Figure 1). The test sample was blown into a large number of tiny pieces.

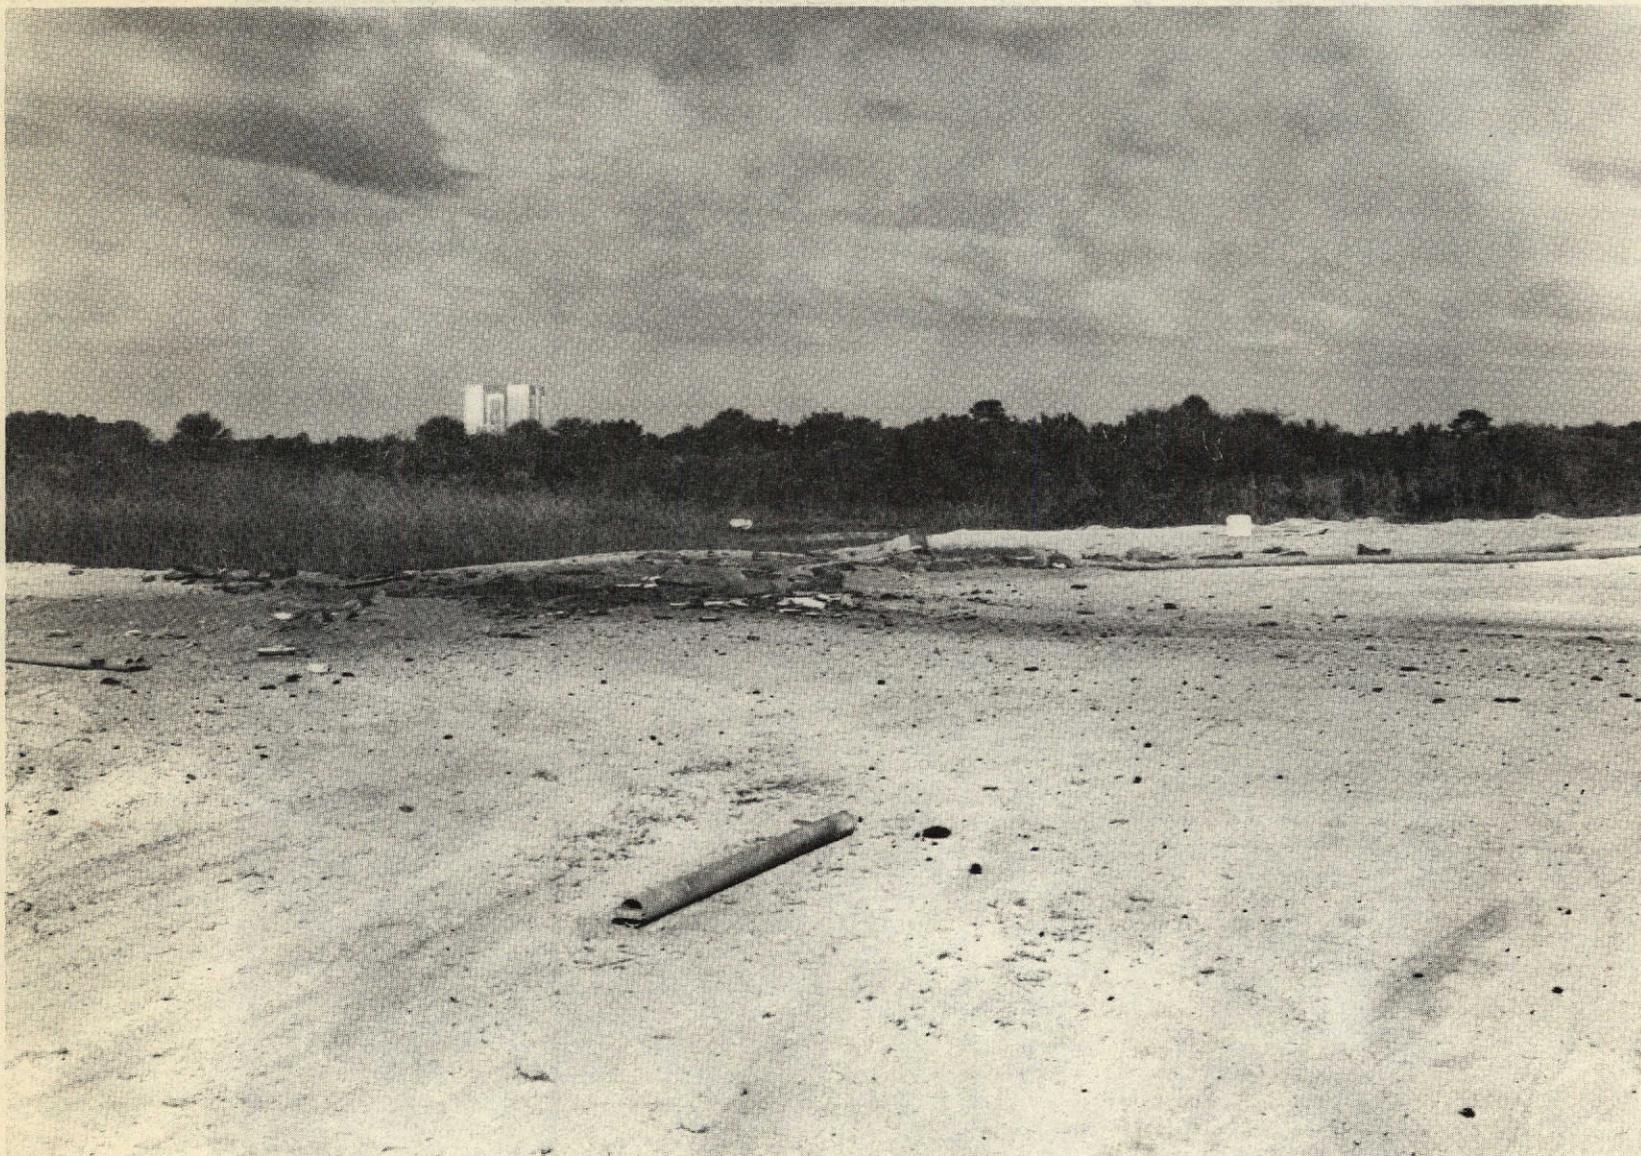
Figure 6. General View, Impact Site after Detonation.

Sixth Trial, Impact. - The test stand was then removed, and a trench about 50 cm long, 10 cm wide, and 1.2 cm deep was chiseled in the asphalt. In the position where the second plummet would strike, an additional cavity was excavated to accommodate a 2.5-cm thick aluminum block, 9 cm wide and 10 cm long. The block was firmly seated with its top surface slightly below the level of the slab surface. A mixture of broken old and new asphalt pavement, ranging from small pea size to large nut size, was piled in the trench and tamped by foot. The pile was from 1 to 2 cm above the slab surface. The test stand was then repositioned. No change was made in the plummet tips, but a striker pin, consisting of a 1.2-cm threaded rod about 22 cm long, with a 7.5-cm teflon disc at the top was placed on the asphalt under the third plummet, with the disc inside the tube to support it. Figure 5 shows the impact points prepared for this trial. Beer cans were positioned as shown in Figure 2. LO_2 was allowed to flow for 10 minutes, the camera switch was activated, and the first plummet was released, with no reaction. The second plummet was then released, and a detonation occurred. The test stand was destroyed, and it is estimated that pieces of it rose 30 meters in the air. When the test site was inspected, it appeared that a reaction had occurred over the entire slab surface, but only a small proportion of its material has been consumed to an estimated depth of 2.5 cm. The reaction appeared to have initiated at two points, above and below the aluminum block. The plummet tip impression in the aluminum block was several times deeper than one made by simply dropping the plummet from the same height. A cavity was found in the asphalt under the position occupied by the aluminum block. It was found that the camera had not been actuated by the switch, and no film of the reaction is available. Still photographs were made of the debris in situ. Figures 6 and 7 show the impact site. In Figure 7, the outline of the asphalt slab can be seen. Fragments have been assigned identification numbers 1 through 33. Figure 8 shows fragments 16, 17, and 18 at a distance of approximately 30 meters from the impact point. Figure 9 shows fragment 15, approximately 9 meters from the impact point. Figure 10 shows a plummet, fragment 28, approximately 12 meters from the impact point. Figure 11 shows a leg, fragment 22, approximately 47 meters from the impact point. Although the holding pond was contaminated, two objects were retrieved from it: the first plummet, and the

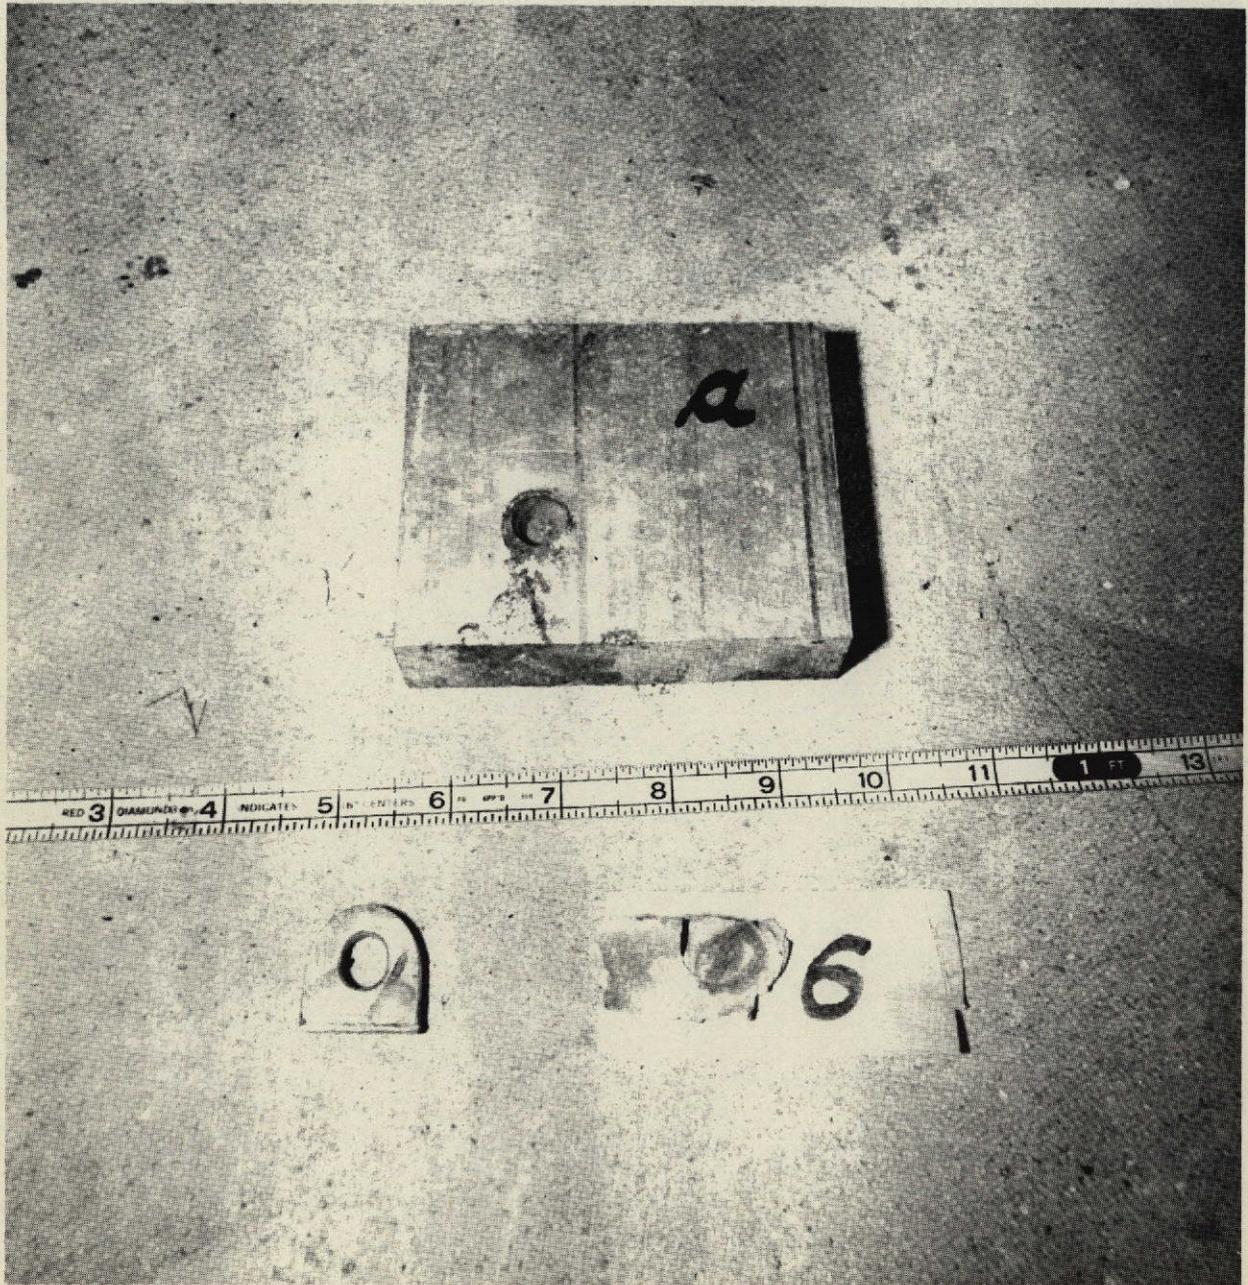
Figure 12. Aluminum Block.

aluminum block which had been placed under the second plummet. The block (a, Figure 12) was approximately 18 meters at 92° from the impact point. The plummet was approximately 33 meters at 94° from the impact point. The fragments were then located, collected, weighed, photographed, and plotted on a map. Figures 13 through 19 are photographs made at that time showing representative fragments. Figure 20 is a map of the area, showing the position of fragments after the detonation. Table 2 shows the weights, distances, and azimuths for the fragments. In the last trial, three conditions were different from those of the previous trials: first, the asphalt had dried out during a dry, warm weekend before this trial, while all other trials had been made after wet slabs were sponged dry; second, asphalt at the point of impact was broken, presenting a larger surface area; and third, an aluminum block was placed beneath the broken asphalt at the point of impact.
