The Dakar Ammonia Accident: Analysis of the Worst Incident at an Anhydrous Ammonia User

Dharmavaram, S.,
Air Products, Allentown, PA, U.S.A.

Pattabathula, V.,
S.V.P. Chemical Plant Services, Brisbane, Australia

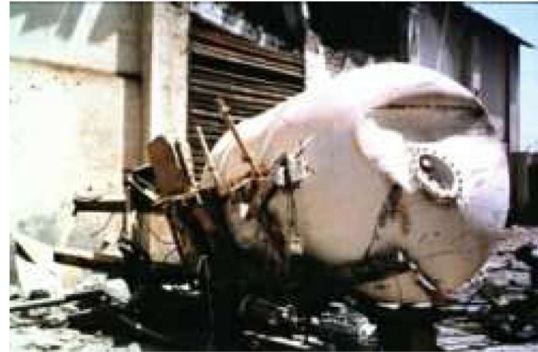
Around 1:30 to 2:00 PM (during shift change), on March 24, 1992, the tank suddenly burst open along the middle with the two portions propelled in different directions. The collision from the tank contacting the buildings caused significant damage and debris (Fig. 4 – 6). The chassis and axle from the truck were found up to 200 meters away beyond the facility boundary. Anhydrous ammonia from the tank was released almost instantaneously, and heavy, dense clouds spread well beyond the facility into the industrial and

Figure 4. Front of the Tank View 1 [1]

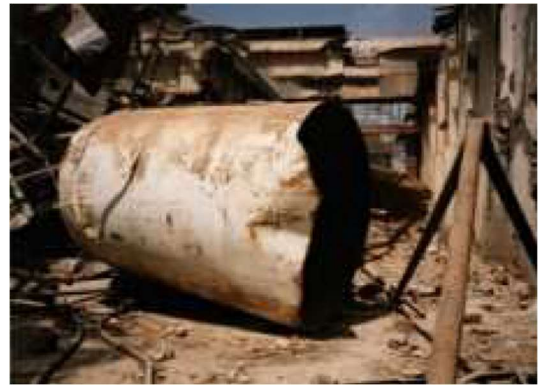
Figure 5. Front of the Tank View 2 [1]

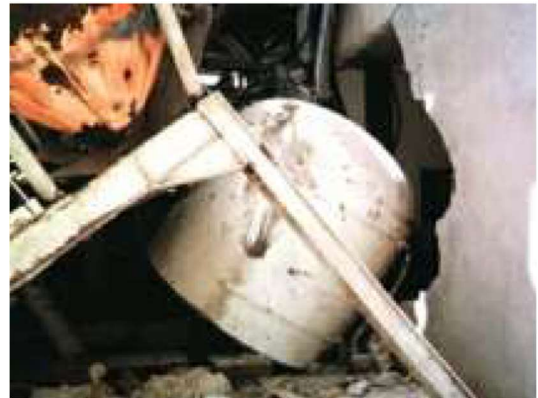
Figure 6. The rear of the tank [1]

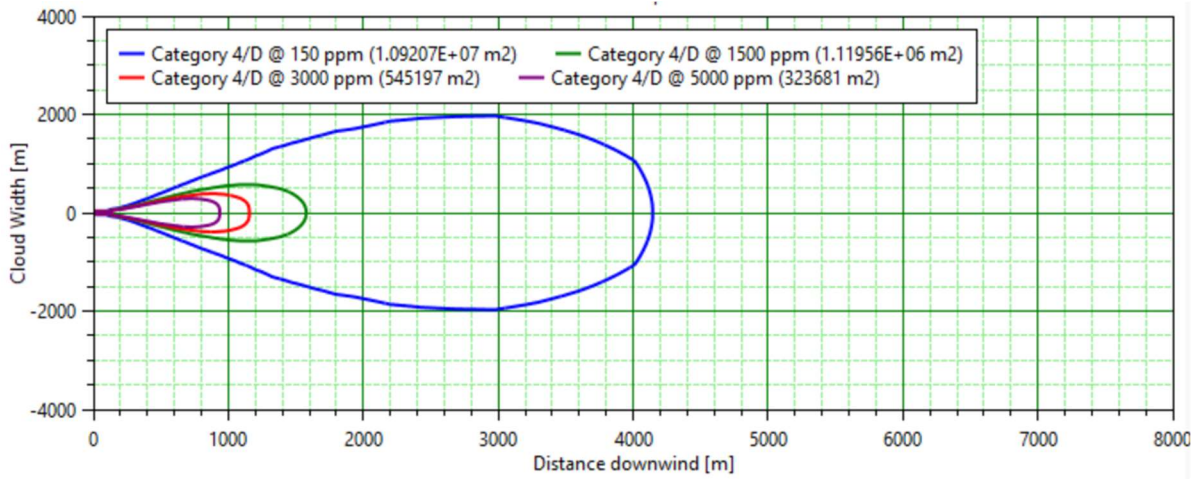
The maximum footprint generated by the instantaneous release of 22 tonnes is shown in Figure 7. The injury concentrations (ERPG-2) extend to more than 4 km and with a width of about 4 km. The distance to ERPG-3 is about 1.5 km, the zone within which there might have been serious injuries and fatalities. The cloud would have been visible only up to a 900 m. Figure 8 shows an estimate of distances for the higher probability of fatalities. Up to a distance to almost 200 m, the probability of fatality is 100%, and then it drops to 0.1% by 500 m, primarily because the exposure time is shorter for an instantaneous release.

Figure 7. Maximum Footprint for the Instantaneous Release of 22 tonnes

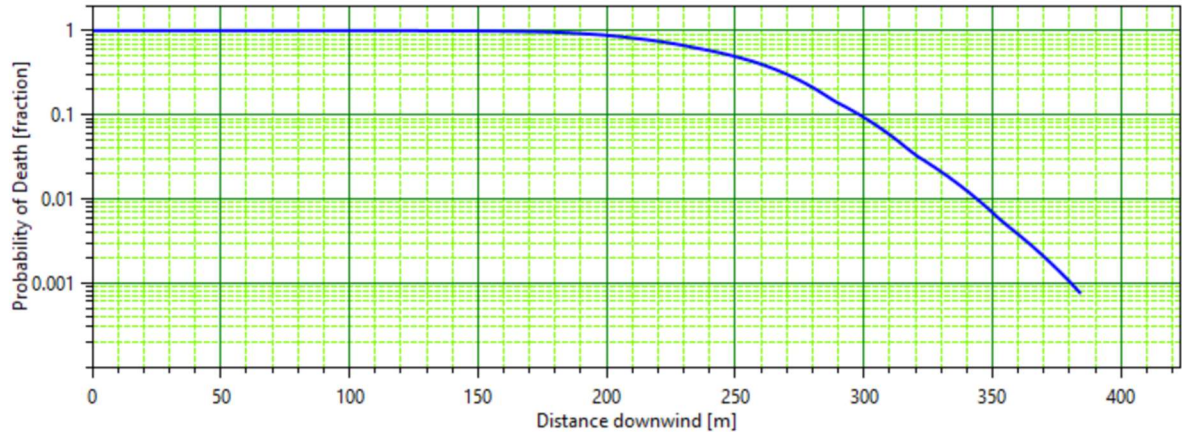
Figure 8. Probability of fatality vs Distance for the Instantaneous Release of 22 tonnes

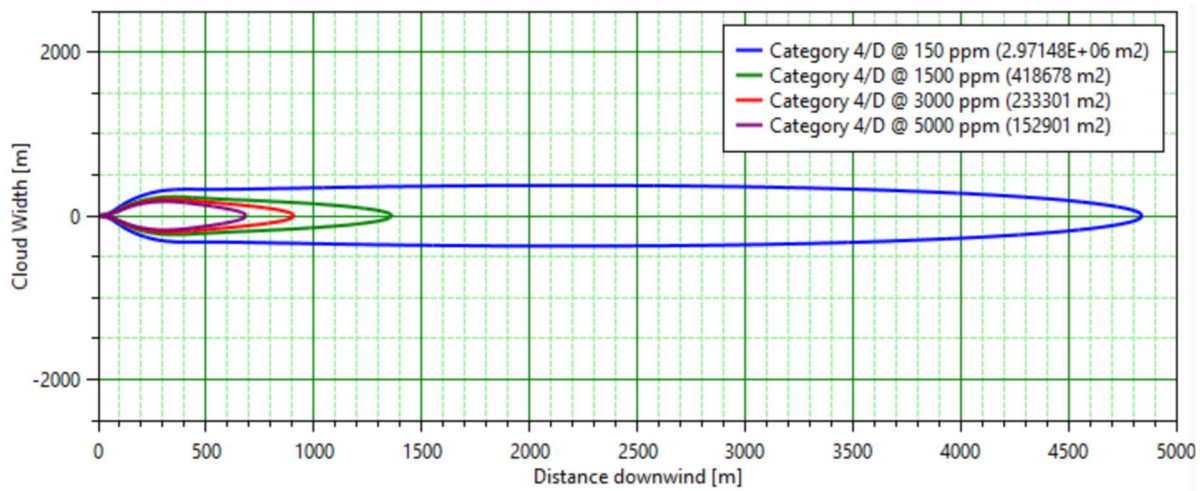
The maximum footprint generated by the continuous release from a 3-inch hole (e.g., hose failure) is shown in Figure 9. The plume is narrower (less than 1 km), but the injury concentrations (ERPG-2) extend to almost 5 km. The distance to ERPG-3 is less than 1.5 km, again the zone where there might have been serious injuries and fatalities. The visible range would have also been around 900 m. Figure 10 shows an estimate of distances to a high probability of fatalities. Up to a distance of almost 400 m, the probability of fatality is 100%.

Figure 9. Maximum Footprint for the Continuous Release from a 3-inch hose

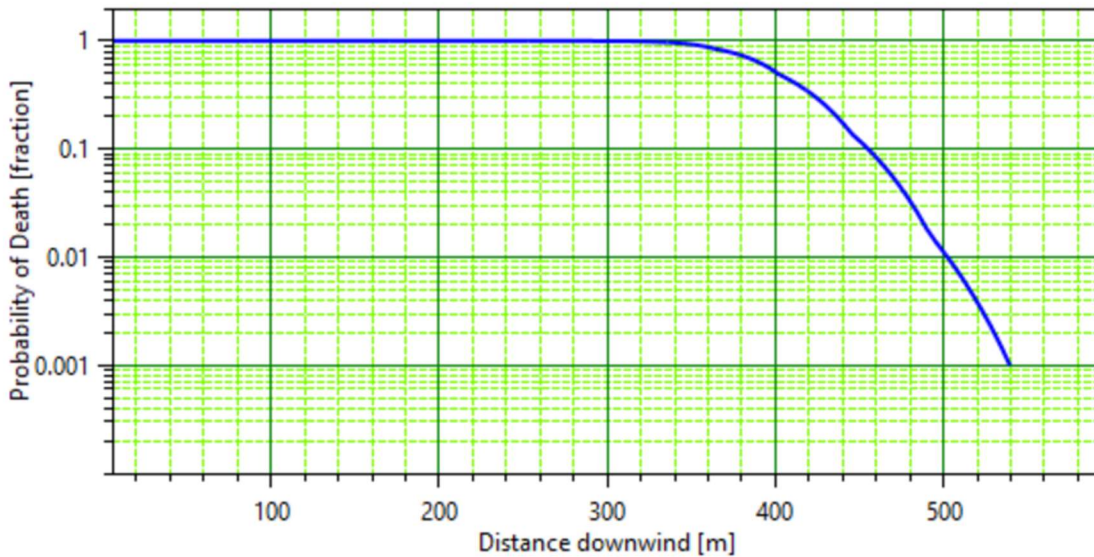
Figure 10. Probability of fatality vs Distance for the Continuous Release from a 3-inch hose
