Technical Study of the Sofa Super Store Fire - South Carolina, June 18, 2007

**Technical Study of the Sofa Super
Store Fire - South Carolina, June 18,
2007**

*Fire Research Division
Engineering Laboratory
National Institute of Standards and Technology*

March 2011

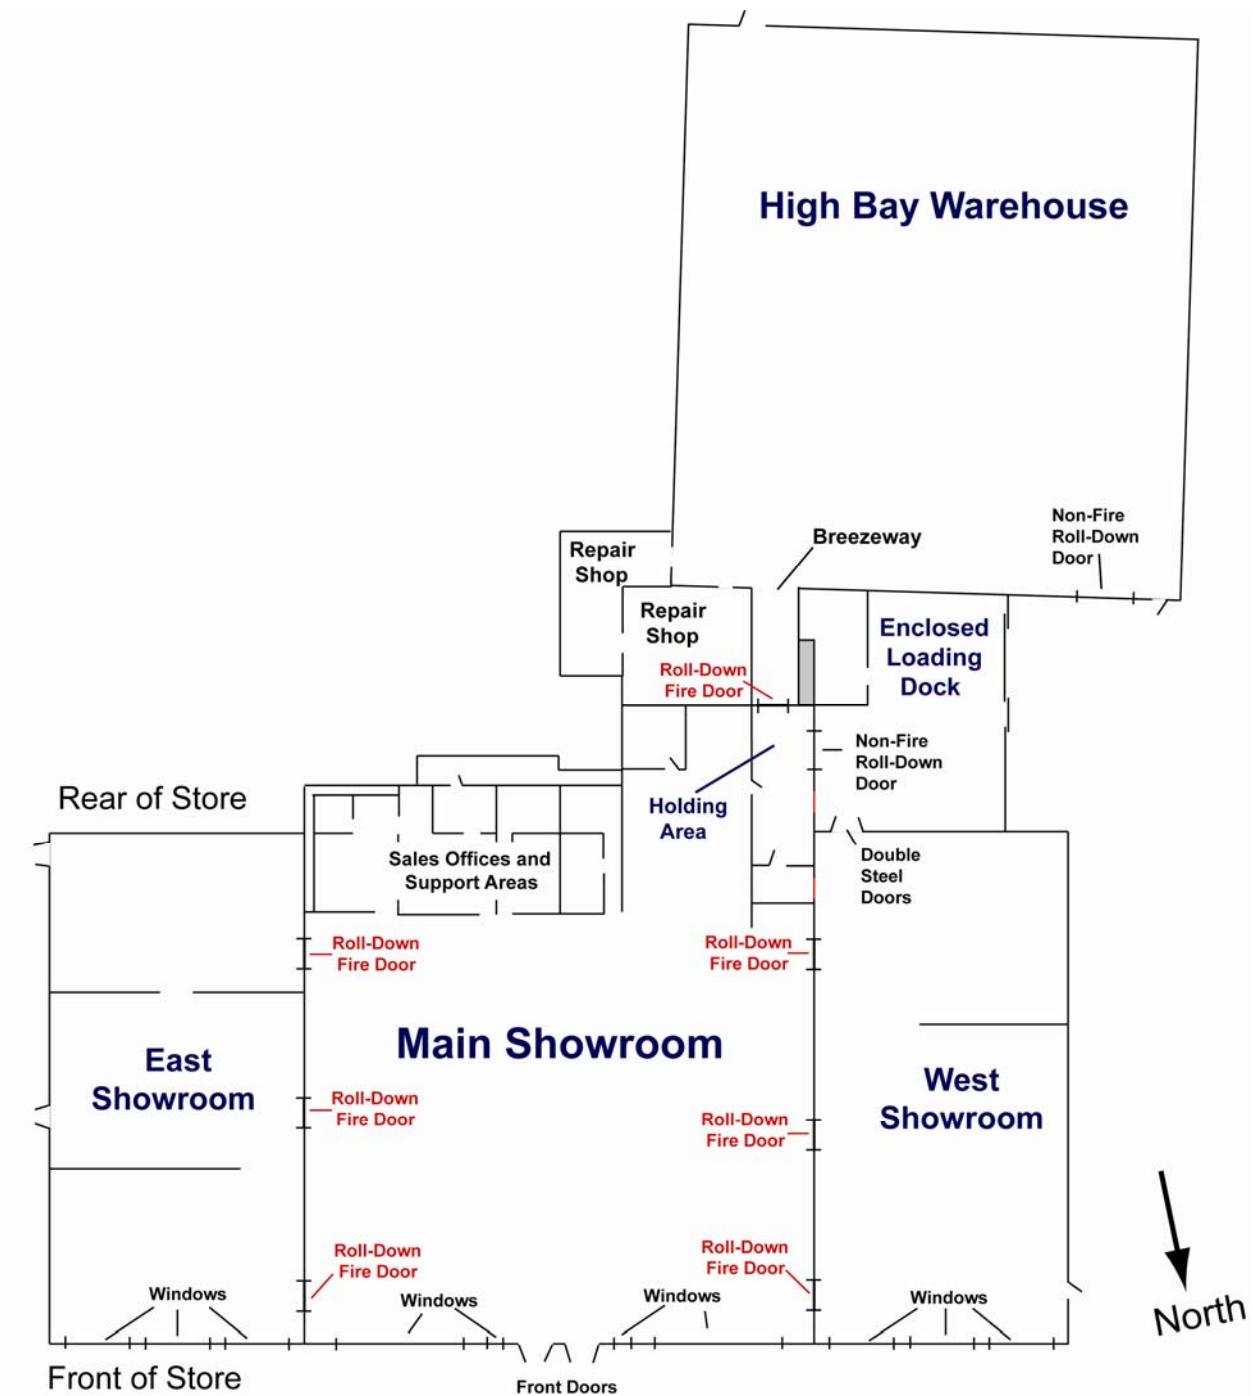
Floor Plan of Sofa Super Store.

Fire was observed at rear of store at 6:56 p.m. The fire began in trash outside the loading dock and spread into the enclosed loading dock. Fire department arrived at 7:11 p.m., less than four minutes after being dispatched. From the loading dock, the fire spread through the merchandise holding area to the rear of the main showroom, then to the front of the main showroom, and then into the west and east showrooms. At the same time, the fire spread into the holding area and through a metal wall into the warehouse.

The extremely rapid spread of fire through the main and west showrooms trapped six fire fighters in the main showroom and three fire fighters in the west showroom. Although the intense heat from the fire

weakened the light weight steel trusses and led to the partial collapse of the roof, the coroner's report indicated that the fire fighters died from thermal burns and/or smoke inhalation, not from compression type injuries that would have been associated with the collapse.

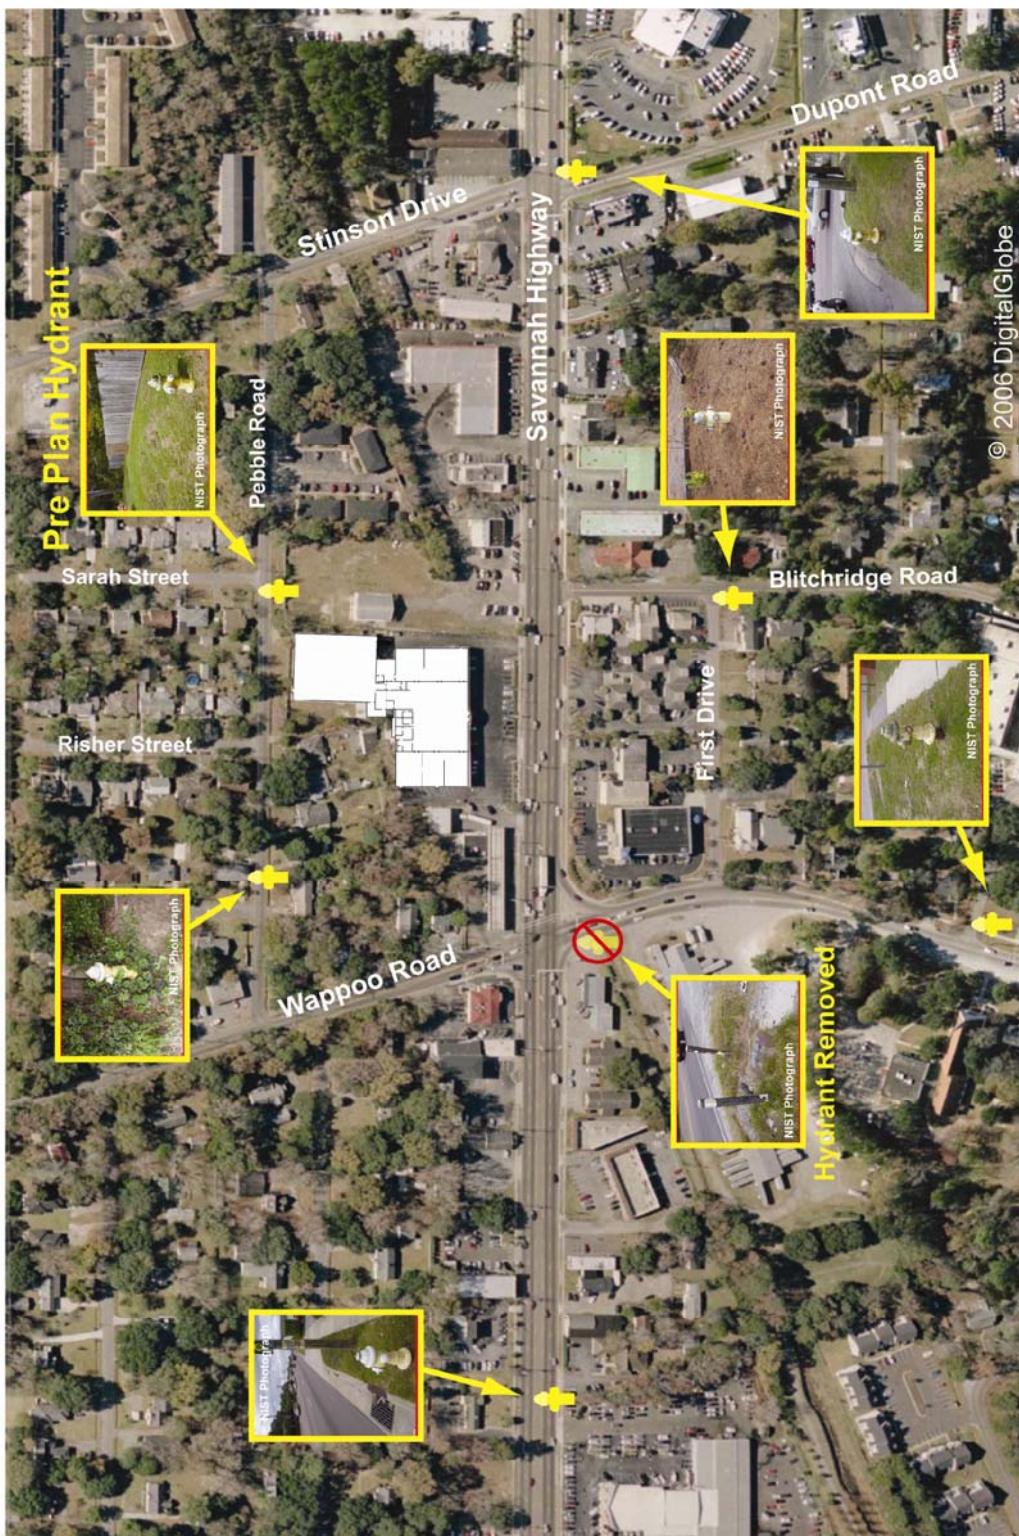
The area in which the Sofa Super Store was located had immediate access to a municipal hydrant system to support fire ground operations. Water hydrants were located along Savannah Highway to the west and east of the store, on Pebble Road behind the store, and at Blitchridge and Wappoo Roads to the north of the store. The location of the six hydrants is shown in Figure 1-17. Each hydrant typically had a pair of 6.4 cm (2.5 in) outlets and a single 10.2 cm (4 in) outlet.

Figure 1-17. Location of fire hydrants near Sofa Super Store. Hydrant identified during pre-plan inspection was on Pebble Road (upper right of figure). Hydrant at corner of Savannah Highway and Wappo Road had been removed and not replaced (center left of figure). Background image used with permission of DigitalGlobe. Enhancements by NIST.

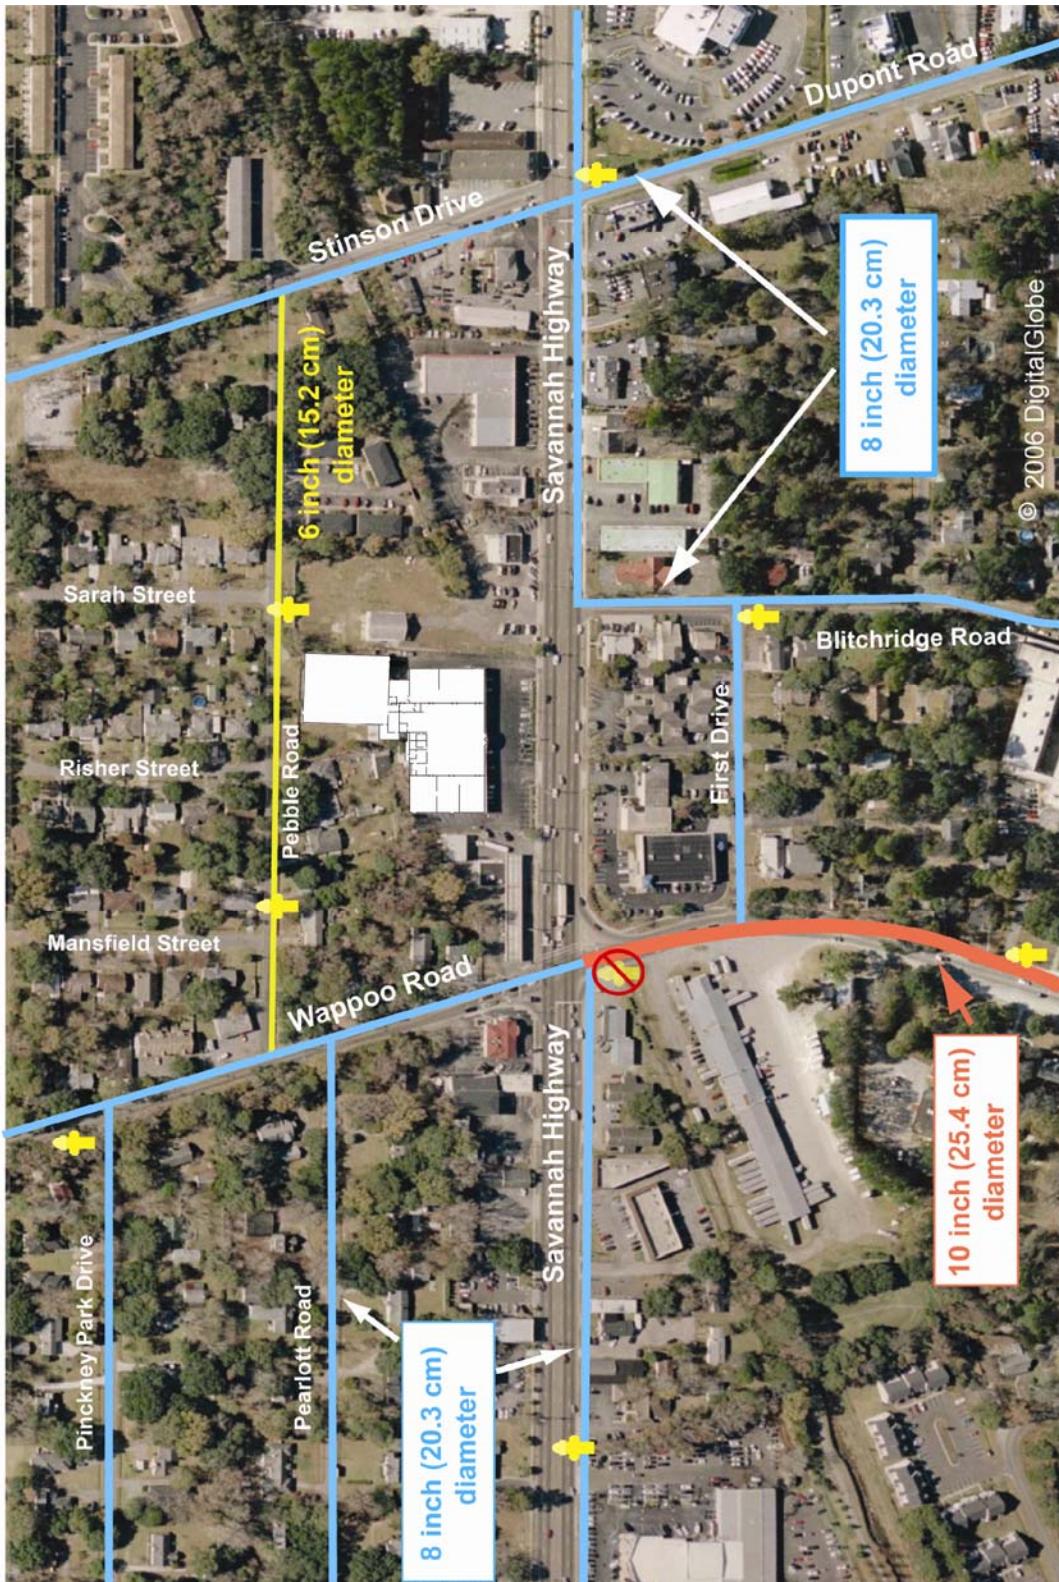
Water supply lines, 20.3 cm (8 in) diameter, were located along Savannah Highway, Stinson Drive, Dupont Road, First Drive, and Blitchridge Road (Figure 1-18). A smaller supply line, 15.2 cm (6 in) diameter, ran south of the warehouse along Pebble Road. On Wappo Road, the water line was 20.3 cm (8 in) south of Savannah Highway and 25.4 cm (10 in) north of Savannah Highway.

Figure 1-18. Water supply lines near Sofa Super Store. Hydrants behind store on Pebble Road were on 15.2 cm (6 in) diameter lines while hydrants located along Savannah Highway were on 20.3 cm (8 in) diameter lines. Background image used with permission of DigitalGlobe. Enhancements by NIST.

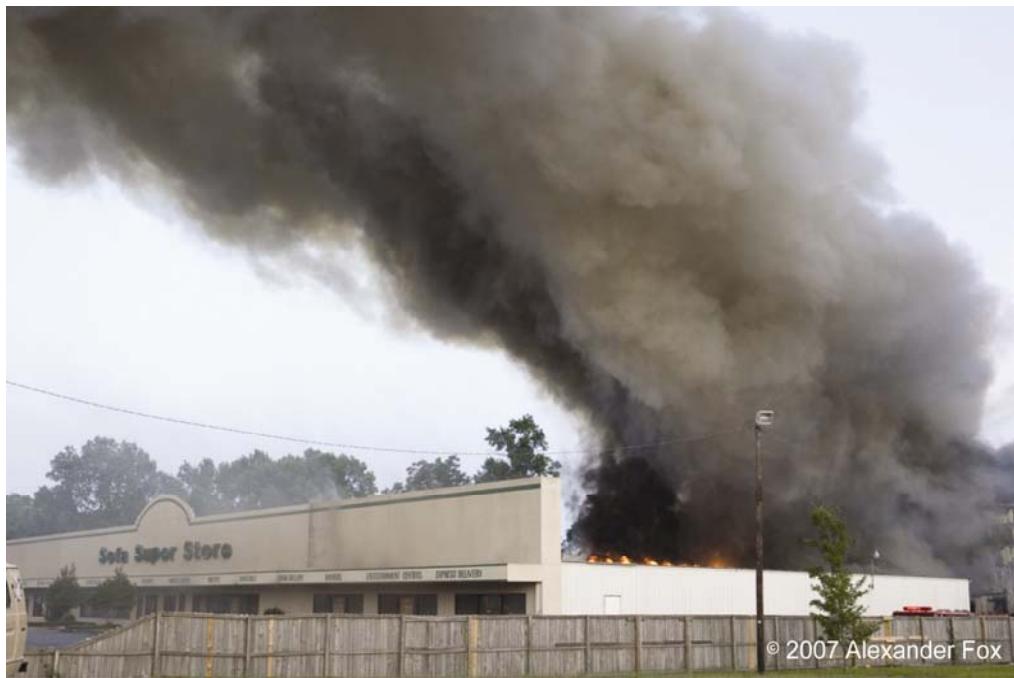
Photographs taken during the early stages of the fire show heavy smoke and flames exiting at the roof level. Figure 4-6 shows a photograph taken at 7:28:15 p.m. This photo shows heavy smoke venting from the loading dock and rear of the main showroom. Flames are also visible and appear to be coming from the roof of the main showroom. Because it was not possible to determine the exact location or size of the holes in the ceiling and roof, several holes were used in the simulations to represent the ventilation that took place. Table K-4 summarizes the ventilation conditions used in the simulations.

**Figure 4-6. Photograph showing the north and west sides of the showroom.
Photo was taken at 7:28:15 p.m.**

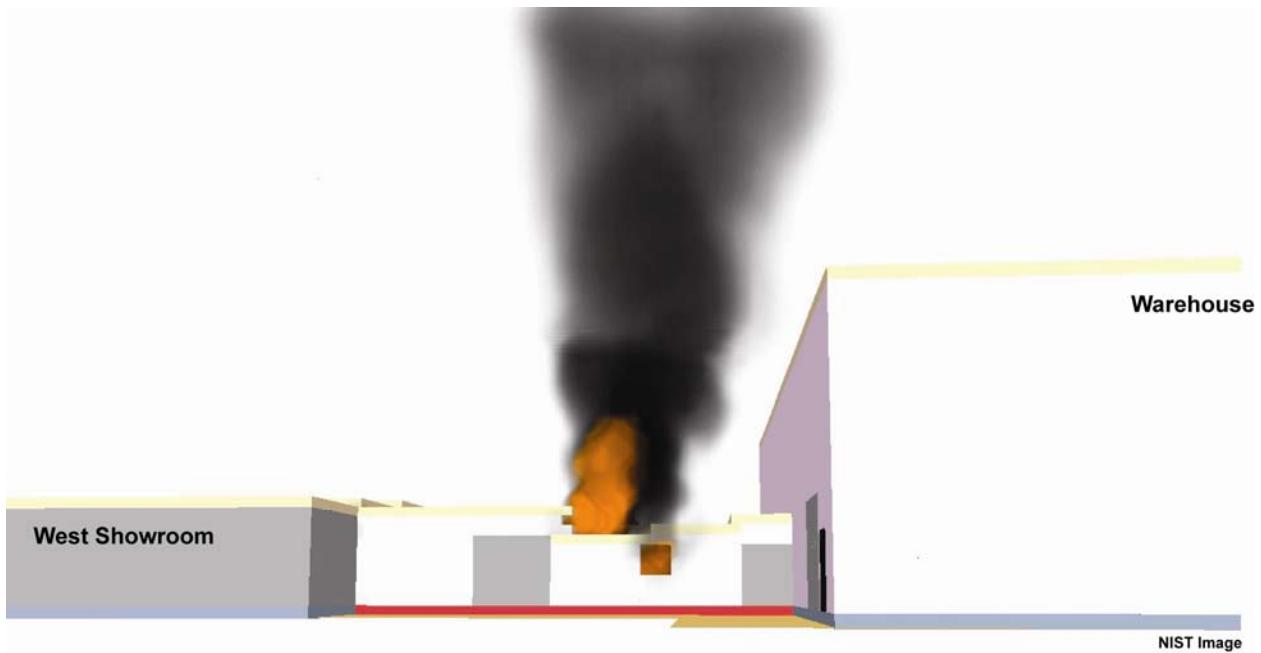
Figure 4-11. Rendered image showing the west side of the loading dock 110 s into the simulation.

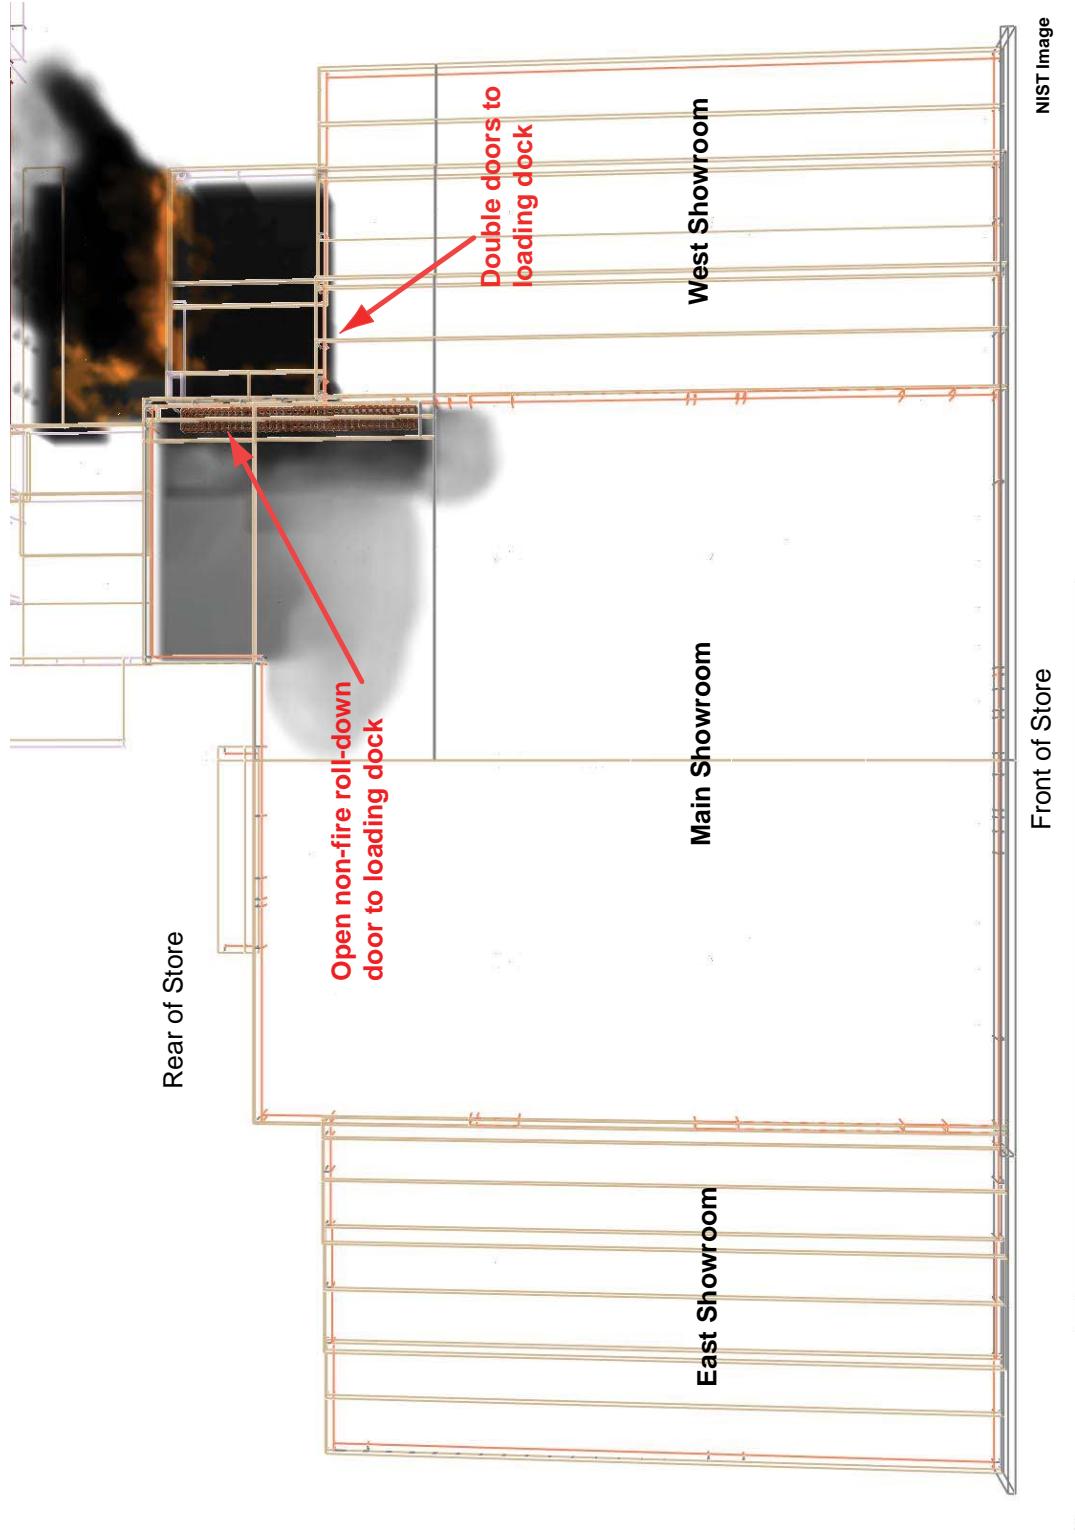
Figure 4-12. Smoke filling in void space above main showroom. Image was rendered 110 s into the simulation.

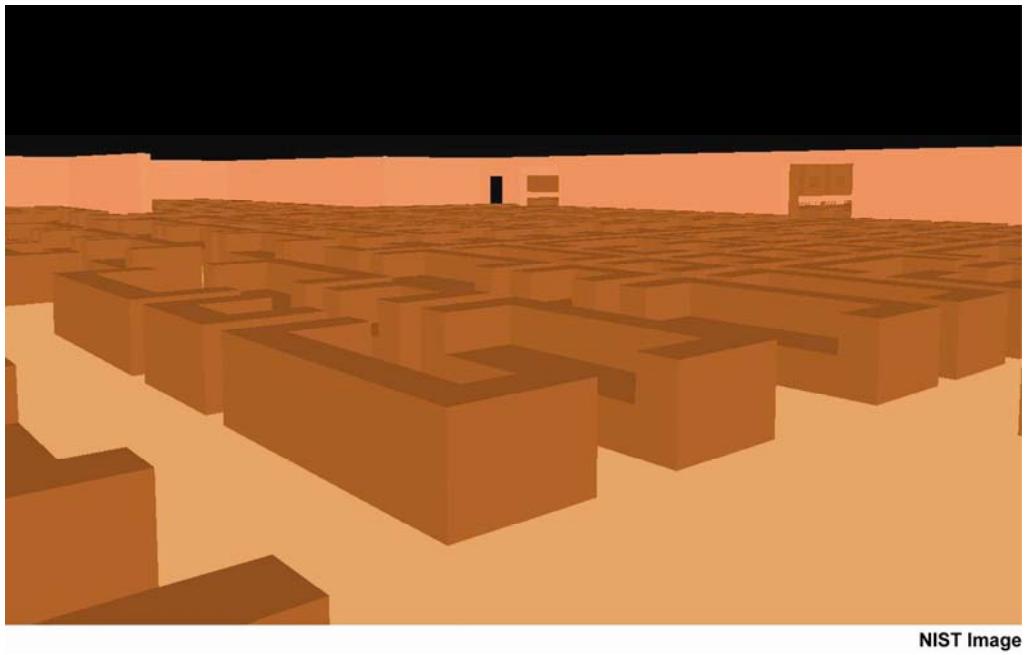
The AC and E-10 captain entered the main showroom and initially observed clear conditions. Figure 4-13 shows an image of the main showroom, from the perspective of a person standing at the front entrance and facing south west, toward the holding area. This image was rendered 80 s into the simulation (7:12:13 p.m.), approximately the time the Assistant Chief entered the showroom and observed clear conditions.

Figure 4-13. Image rendered 80 s (7:12:13 p.m.) into the simulation from inside the main showroom, near the entrance. View is toward the south west corner of the main showroom.

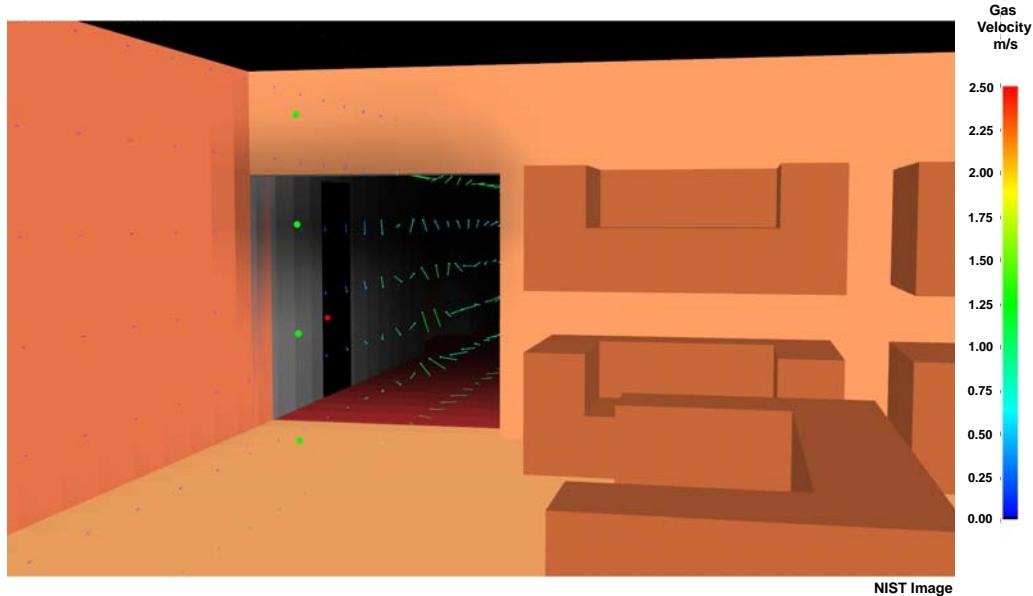
Figure 4-14. Image rendered 145 s (7:13:18 p.m.) into the simulation from the west showroom, near the double doors that lead to the loading dock. Arrows indicate direction and relative speed of air moving from the showroom into the loading dock (The relative speed is proportional to the length of the arrow, i.e. longer arrows indicate higher relative speeds and color scale indicates velocity magnitude).

Figure 4-15 shows a rendered image of the double doors from inside the west showroom at 145 s, 1 second after they were opened. The arrows or velocity vectors indicate that the air was flowing from the rear of the west showroom into the loading dock just after the doors were opened.

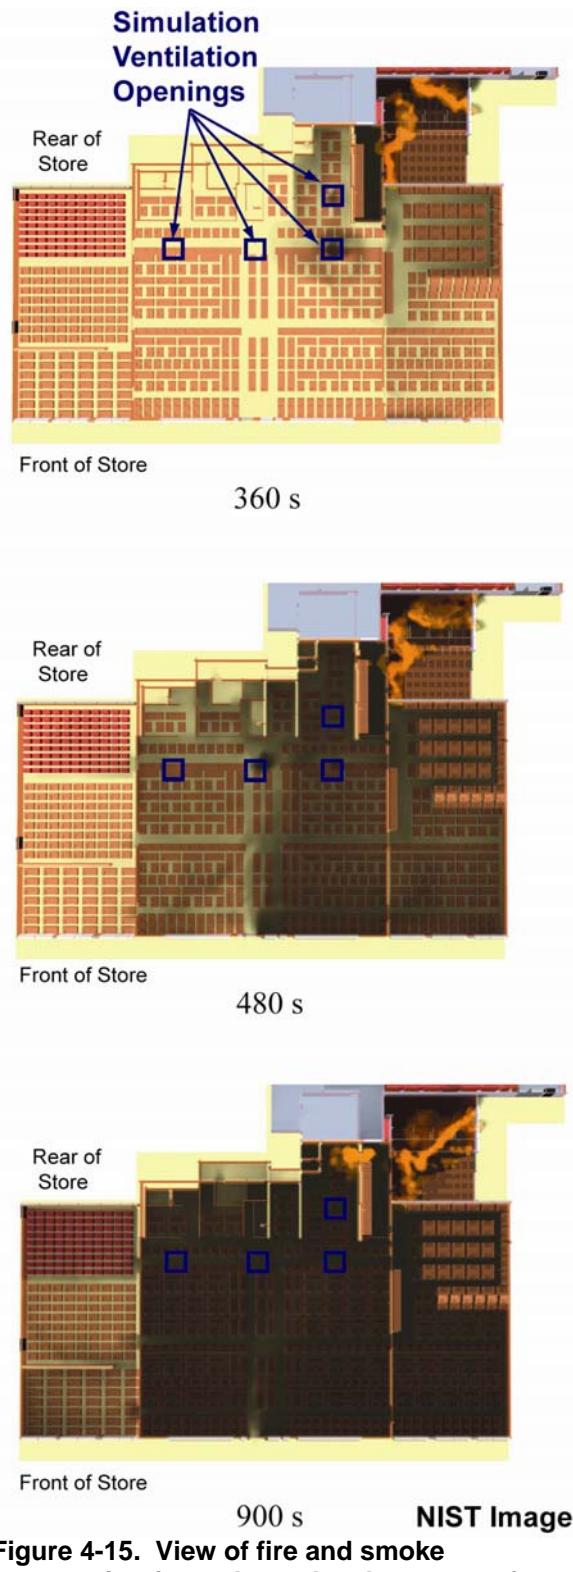
Smoke penetration through the ceiling was modeled by creating an opening in the rear of the main showroom when the adjacent temperature reached 50°C. Figure 4-15 shows the progression of fire and smoke below the ceiling level (2.6 m) throughout the loading dock, holding area and showrooms between 300 s (7:15:53 p.m.) and 900 s (7:25:53 p.m.). The images in this figure have been clipped down to the level of the ceiling in the showrooms.

At 300 s (7:13:53 p.m.) there is light smoke in the rear of the main and west showrooms. Initially, smoke in the west showroom entered through the double doors while the smoke in the main showroom entered through the ceiling. The ventilation openings in the ceiling in the main showroom (blue colored squares in Figure 4-15) opened between 261 s (7:15:14 p.m.) and 976 s (7:27:09 p.m.).

By 600 s (7:20:53 p.m.), the smoke layer had permeated the west and main showrooms, and there was evidence of a “tunneling” as fresh air was being pulled into the front door to supply oxygen. This is consistent with the account of Engineer 6, who entered the structure at approximately 7:24 p.m. (787 s) and reported a tunnel of clear space that extended several feet inside the showroom as fresh air was being pulled through the open door. Beyond this space he reported heavy smoke conditions. By 900 s (7:25:53 p.m.), the fire in the rear of the main showroom had grown to approximately 23 MW.

Figure 4-15. View of fire and smoke progression from above the showrooms from 300 to 900 s (7:15:53 p.m. to 7:25:53 p.m.). The images are clipped to view conditions below the ceiling.

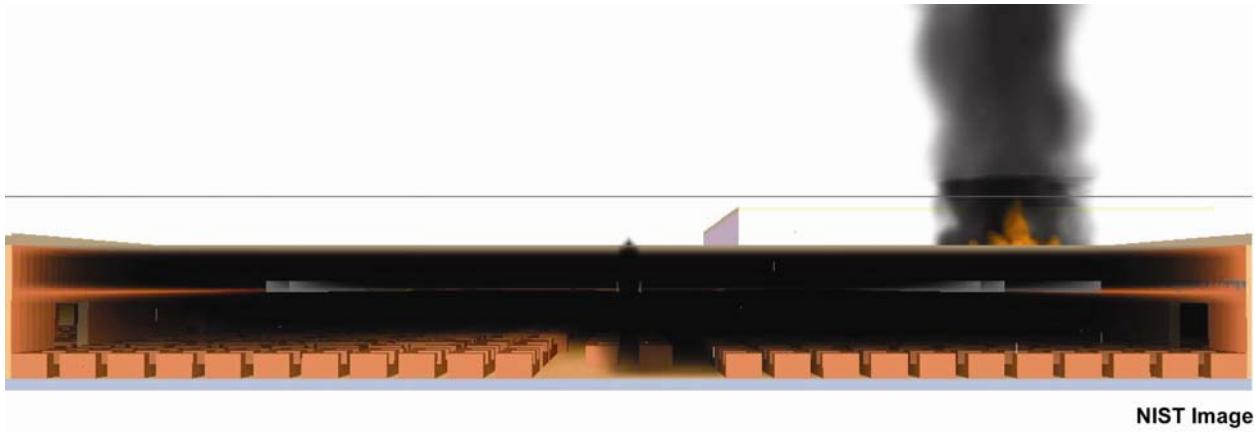
Figure 4-16. Model rendering of view inside the front of the main showroom at 487 s (7:19:00 p.m.).

self-contained breathing apparatus (SCBA) face pieces. Figure 4-16 shows an image of the front of the main showroom, with the front wall removed, at 487 s. This image shows that smoke had filled the void space above the ceiling and banked down to the showroom floor. Conditions on the east side, including the area near the entrance, are not as severe. However, as one progresses toward the rear and west, conditions degrade significantly.

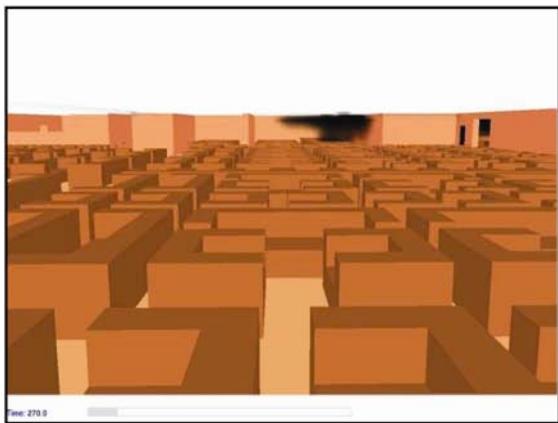
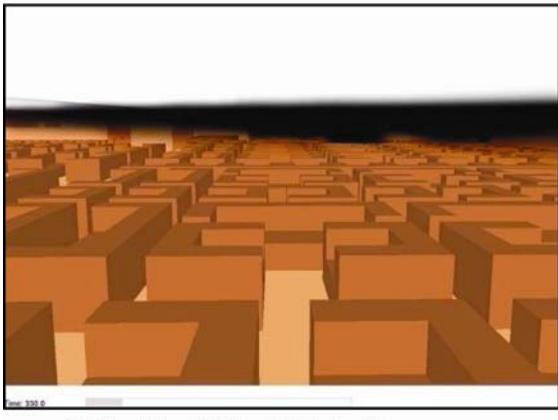
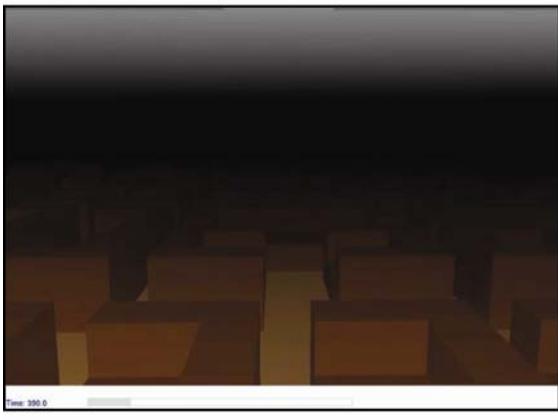
Figures 4-17 and 4-18 show smoke filling in, respectively, the main and west showrooms from the perspective of someone at the front of the room. The sequence in Figure 4-17 begins at 270 s (7:15:23 p.m.), after smoke began penetrating the ceiling. The sequence in Figure 4-18 begins at 270 s (7:15:23 p.m.). In both showrooms, conditions deteriorate considerably within a 120 s span.

Figure 4-17. Smoke progression inside the west side of the main showroom between 270 s to 390 s (7:15:23 p.m. to 7:17:23 p.m.).

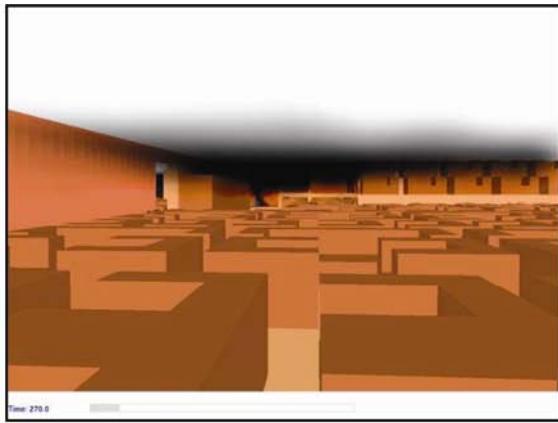
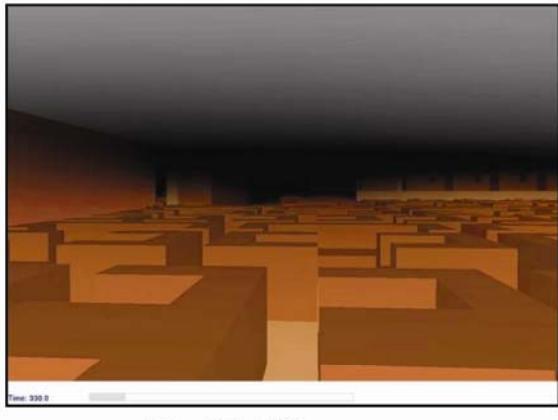
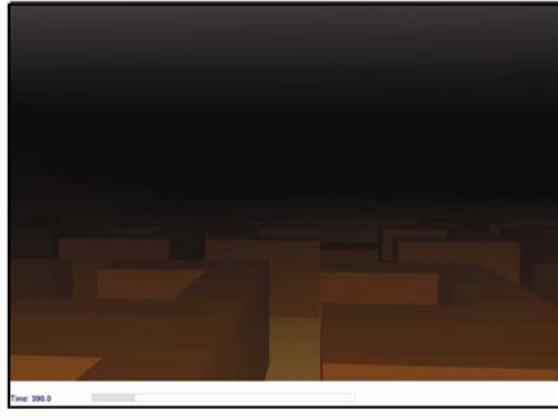
Figure 4-18. Smoke progression inside the west showroom between 270 s to 390 s (7:15:23 p.m. to 7:17:23 p.m.).

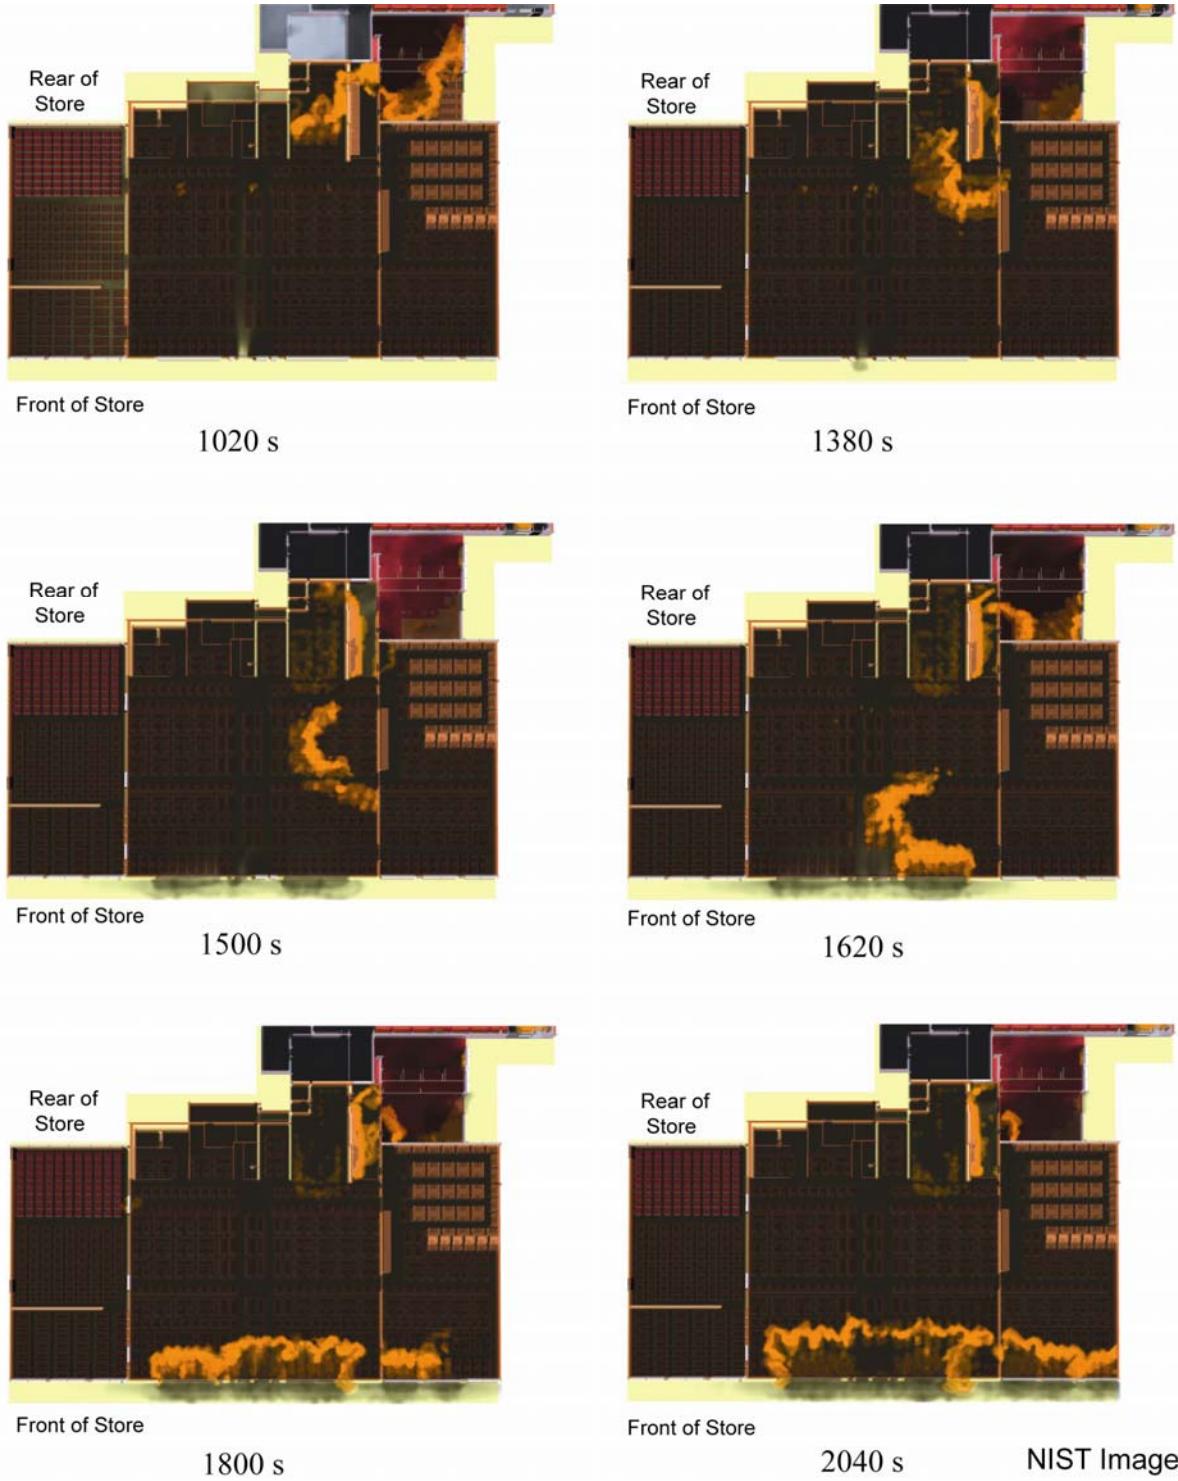
At 1020 s (7:27:53 p.m.), the fire in the main showroom reached about 70 MW and had begun moving forward toward the front of the showroom. Figure 4-19 shows the progression of fire and smoke throughout the loading dock, holding area and showrooms between 1020 and 2040 s. The front windows were vented during the period between 1457 through 1530 s (7:35:10 through 7:36:23). Fire reached the front of the main showroom at approximately 1540 s (7:36:33 p.m.) and spread across the west side of the main showroom by 1590 s (7:37:23 p.m.). By 1680 s (7:38:53 p.m.), the fire had moved into the front of the west showroom. This is consistent with the image in Figure 4-23, where the fire is visible in the west showroom through the window opening.

Figure 4-19. View of fire (orange color indicates stoichiometric boundary) and smoke progression from above the showrooms from 1020 s to 2040 s (7:27:53 p.m. to 7:44:53 p.m.). The images are clipped to view conditions below the ceiling.

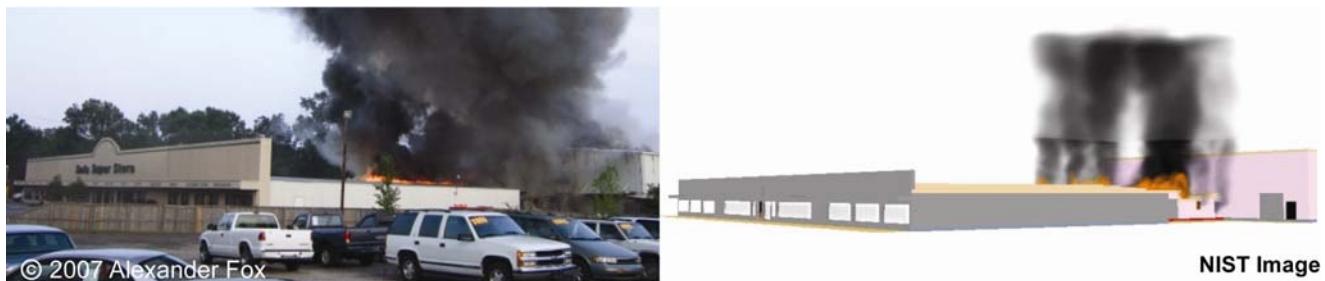
Figures 4-20 through 4-24 show comparisons of the fire and smoke progression with available photos at various times during the critical time between 7:23 p.m. and 7:45 p.m. (740 s through 2040 s). Figure 4-20 shows one of the earliest photos that were obtained of the fire, taken at 7:23:16 p.m. (743 s). At this time the fire was still mainly concentrated in the loading dock and holding area. Although the showrooms were charged with smoke, there was no smoke pushing out the open door at the front of the store. The fire had impinged on the underside of the roof over the holding area and flames were visible from the exterior at the roof level. At 1530s (7:36:23 p.m.), shown in Figure 4-21, the main sections of the front windows had been broken out and smoke was pushing out the front of the main showroom. At this

Figure 4-20. Comparison between photo and rendered image from the simulation at 743 s (7:23:16 p.m.). The view is of the north west corner of the structure.

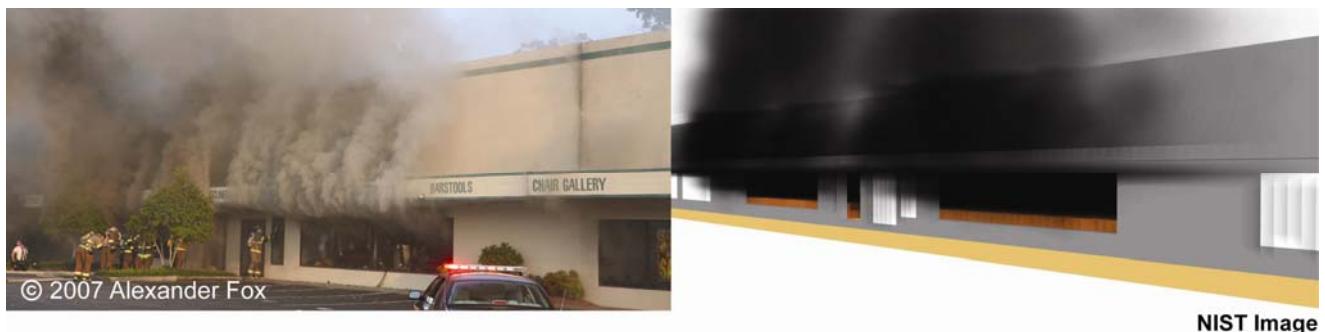
Figure 4-21. Comparison between photo and rendered image from the simulation at 1530 s (7:36:23 p.m.). The view is of the front of the main showroom.

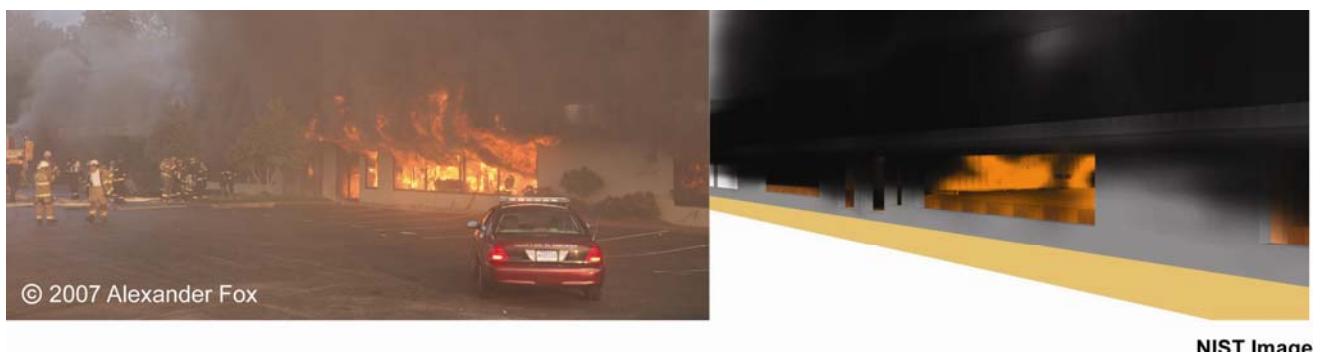
time, flames were not yet visible from the exterior through the front windows. By 1655 s (7:38:28 p.m.), shown in Figure 4-22, fire had reached the front of the main showroom and had stretched across the west side of the main showroom. At 1686 s (7:38:59 p.m.) flames were visible inside the west showroom, Figure 4-23, and the first window in this side had failed. By 1884 s (7:42:17), shown in Figure 4-24, fire had stretched across the front of the west showroom and two of the three windows were broken out.

Figure 4-22. Comparison between photo and rendered image from the simulation at 1655 s (7:38:28 p.m.). The view is of the front of the main showroom.

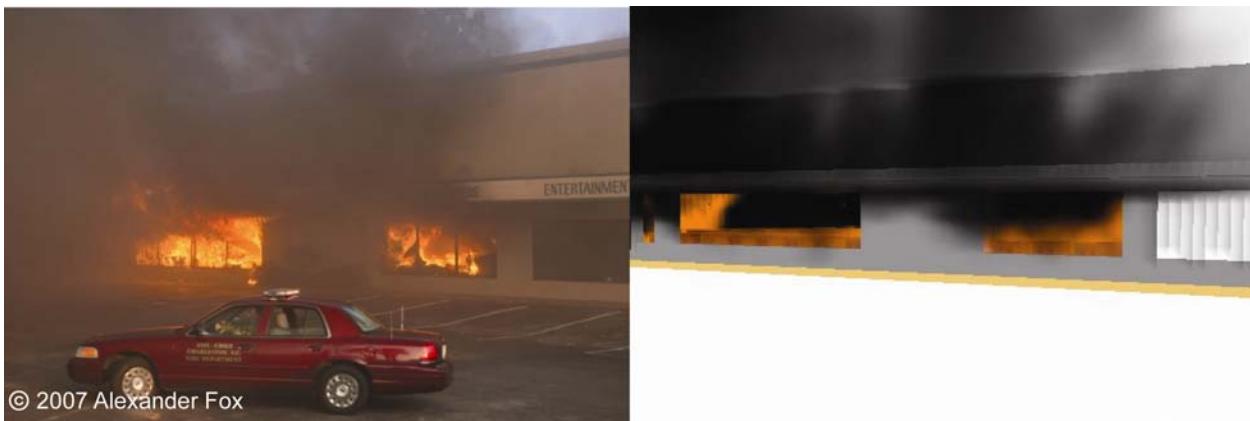
Figure 4-23. Comparison between photo and rendered image from the simulation at 1686 s (7:38:59 p.m.). The view is of the front of the main and west showrooms.

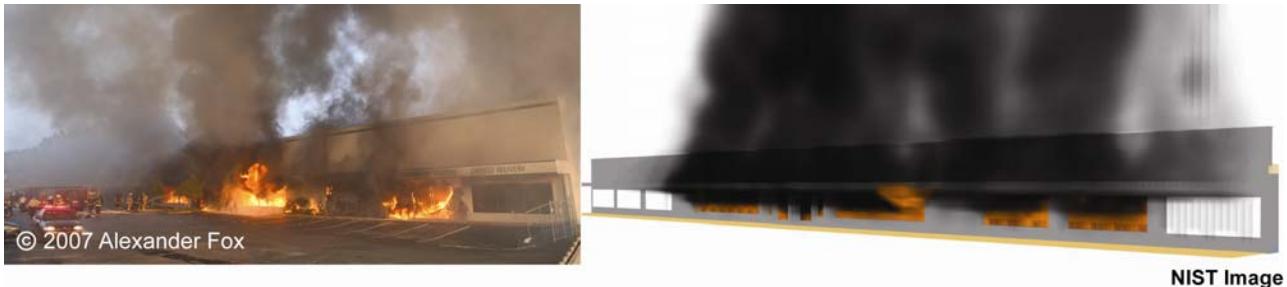
Figure 4-24. Comparison between photo and rendered image from the simulation at 1884 s (7:42:17 p.m.). The view is of the front of the main and west showrooms.

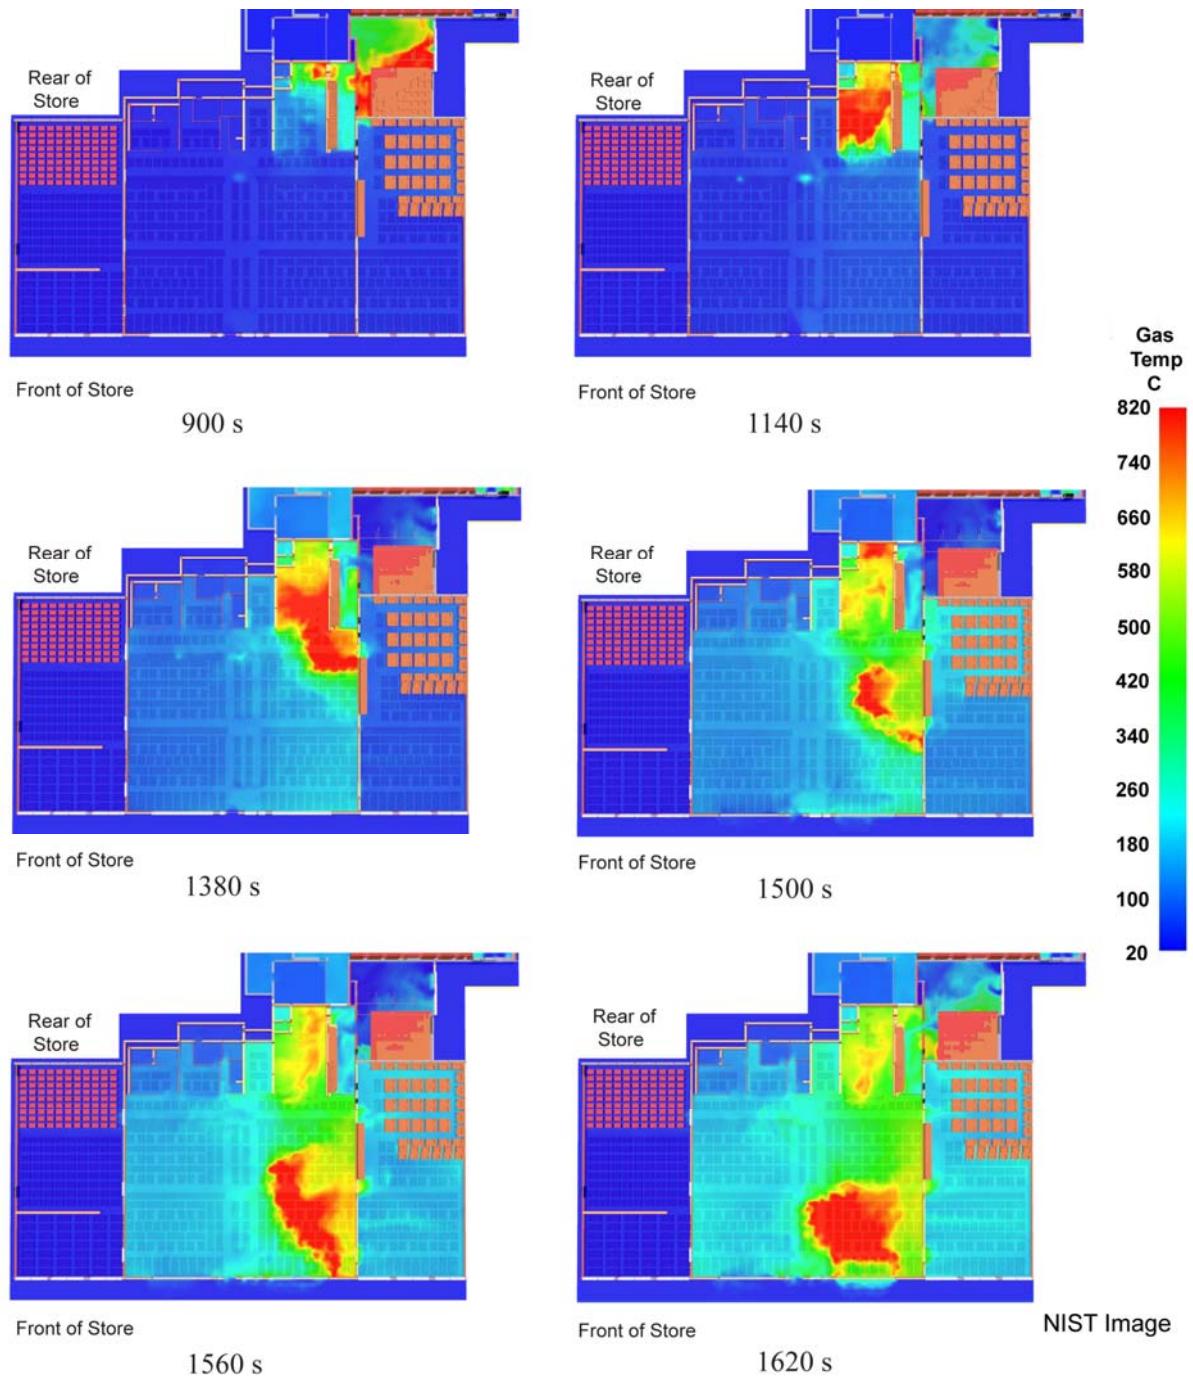
Figure 4-26 shows a series of images with a temperature slice 1.5 m (5 ft) from the floor rendered at a range of times between 900 s through 1620 s (7:25:53 p.m. through 7:37:53 p.m.). These images show the progression of the elevated temperatures from the loading dock, into the holding area, and eventually into the main showroom. Temperatures above 100 °C (approximately indicated by the border between dark blue and light blue) are first observed in the holding area approximately three minutes into the simulation. Note that the double doors separating the west showroom from the loading dock were opened at 144 s, but the temperature in the west showroom remained low even as fire was spreading into the holding area.

Figure 4-26. Temperature slices located 1.5 m (5 ft) above the floor.

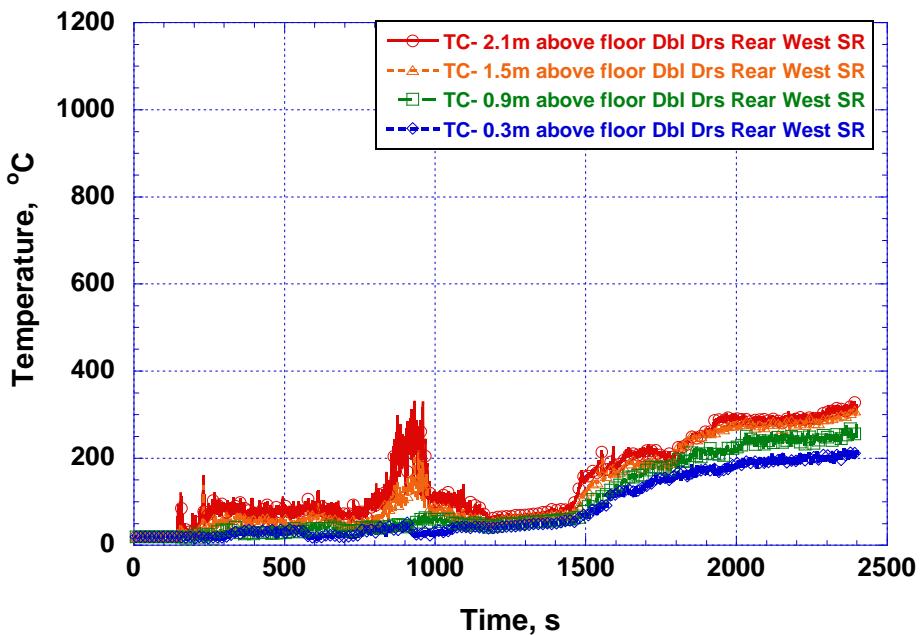
Figure 4-27 shows a chart of temperatures recorded in the west showroom, near the double doors. The data are from sensors located 0.3 m (1 ft), 0.91 m (3 ft), 1.52 m (5 ft), and 2.13 m (7 ft) from the floor. Figure 4-27 shows that temperatures remained below 100 °C through approximately 750 s (7:23:23 p.m.). The fire was positioned near the double doors to the loading dock; however, during the early stages much of the heat was venting through the loading dock roof and later through the main showroom roof. Air was being pulled through the doorway to feed oxygen to the fire in the loading dock and holding area. There was a surge in temperature in the upper layer lasting several minutes caused by fire progression into the showroom. At 900 s (7:25:53 p.m.), a section of the roof above the holding area was removed and this resulted in the subsequent temperature drop. Temperatures dropped below 100 °C, but as the fire increased in the main showroom the temperatures in both showrooms began to rise quickly. A second temperature surge, which began at approximately 1460 s (7:35:13 p.m.), was due to the fire entering the west showroom through the open roll-down door as it moved to the front of the main showroom. It should be noted that the focus of suppression efforts was in this area of the showroom, and that the simulation does not take this into account.

Figure 4-27. Temperatures at different elevations, 0.3 m (1 ft), 0.9 m (3 ft), 1.5 m (5 ft), and 2.1 m (7 ft) in rear of west showroom near double doors.

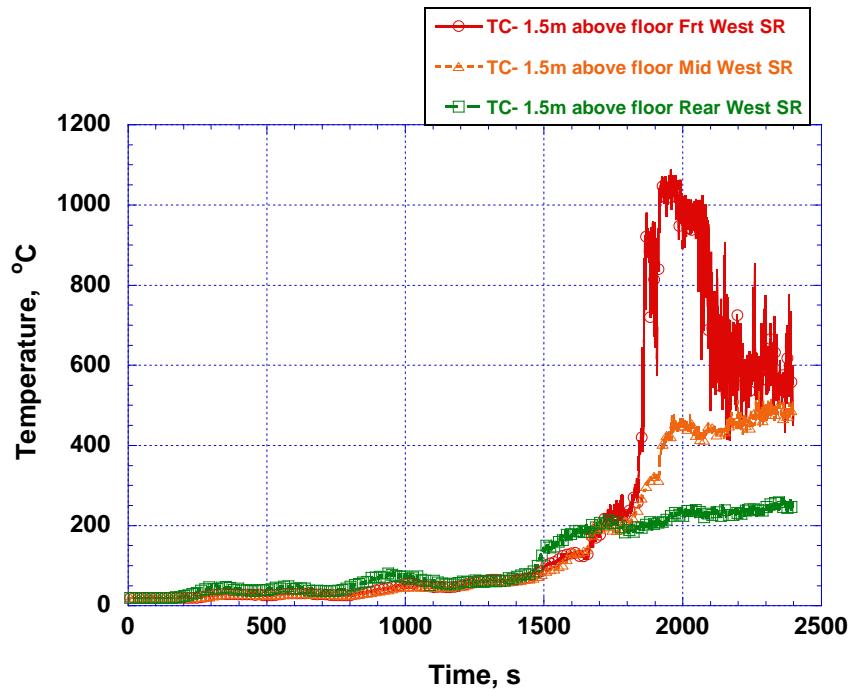
Figures 4-28 through 4-30 show charts of temperatures recorded at the locations throughout the main and west showroom as indicated in Figure 4-25. All data in these charts were recorded 1.5 m (5 ft) above the floor. Figure 4-28 shows temperatures in the west showroom. Temperatures in the west showroom remained relatively low, below 100 °C, until the fire began moving toward the front of the main showroom. The temperature at the rear sensor surpassed 120 °C at 1350 s (7:33:23 p.m.). As the fire in the main showroom continued to move forward, the temperature at the mid and front sensors reached 120°C at 1400 s (7:34:13 p.m.)

Figure 4-28. West showroom temperatures for 1.5 m (5 ft) above floor.
