Technical Study of the Sofa Super Store Fire - South Carolina, June 18, 2007

**Technical Study of the Sofa Super
Store Fire - South Carolina, June 18,
2007**

*Fire Research Division
Engineering Laboratory
National Institute of Standards and Technology*

March 2011

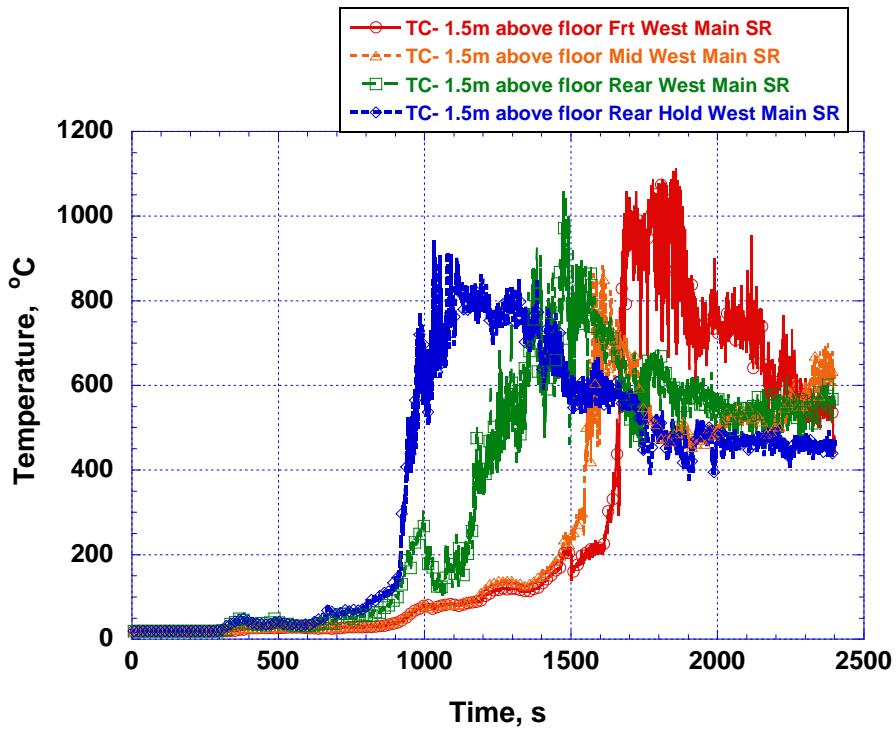
Figure 4-29 shows a temperature chart that displays data from sensors located on the west side of the main showroom. This chart contains a fourth data location, labeled Rear Hold, which was identified in Figure 4-25. Temperatures in the west side of the main showroom became elevated at an earlier point than in the other areas of the showroom because the fire moved across these sensors as it moved to the front of the showroom. The rear holding area location reached 120 °C at 864 s (7:25:17 p.m.); the rear location was roughly 30 s behind, reaching 120 °C at 900 s (7:25:53 p.m.). The mid and front locations reached 120 °C simultaneously at 1250 s (7:31:43 p.m.). Temperatures in the center and east areas of the main showroom showed similar trends.

Figure 4-29. Main showroom (west) temperatures for 1.5 m (5 ft) above floor.

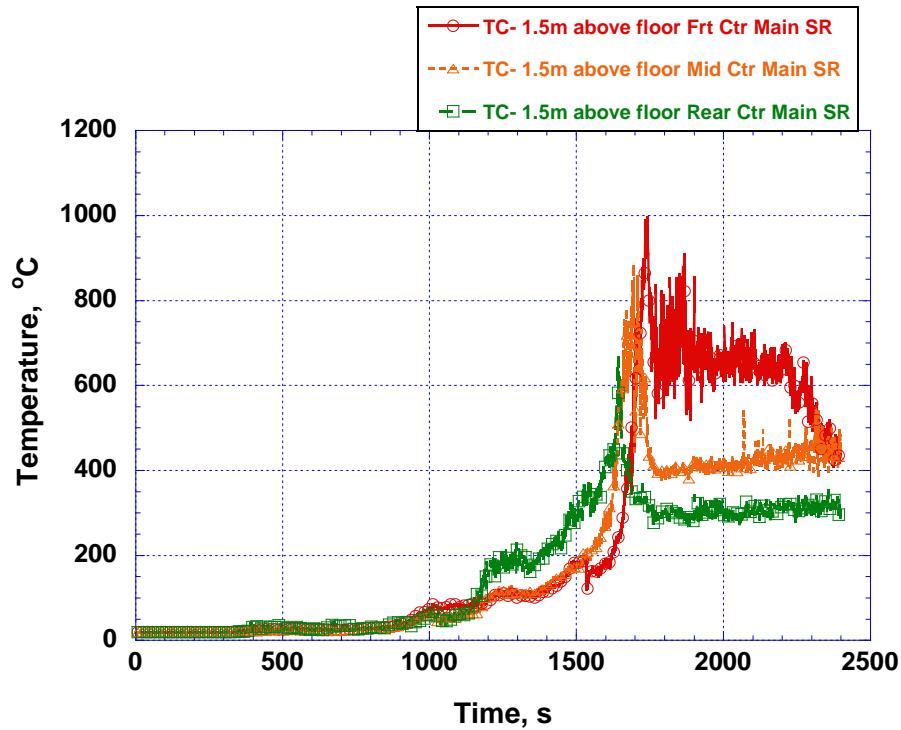
Figure 4-30. Main showroom (center) temperatures for 1.5 m (5 ft) from floor.

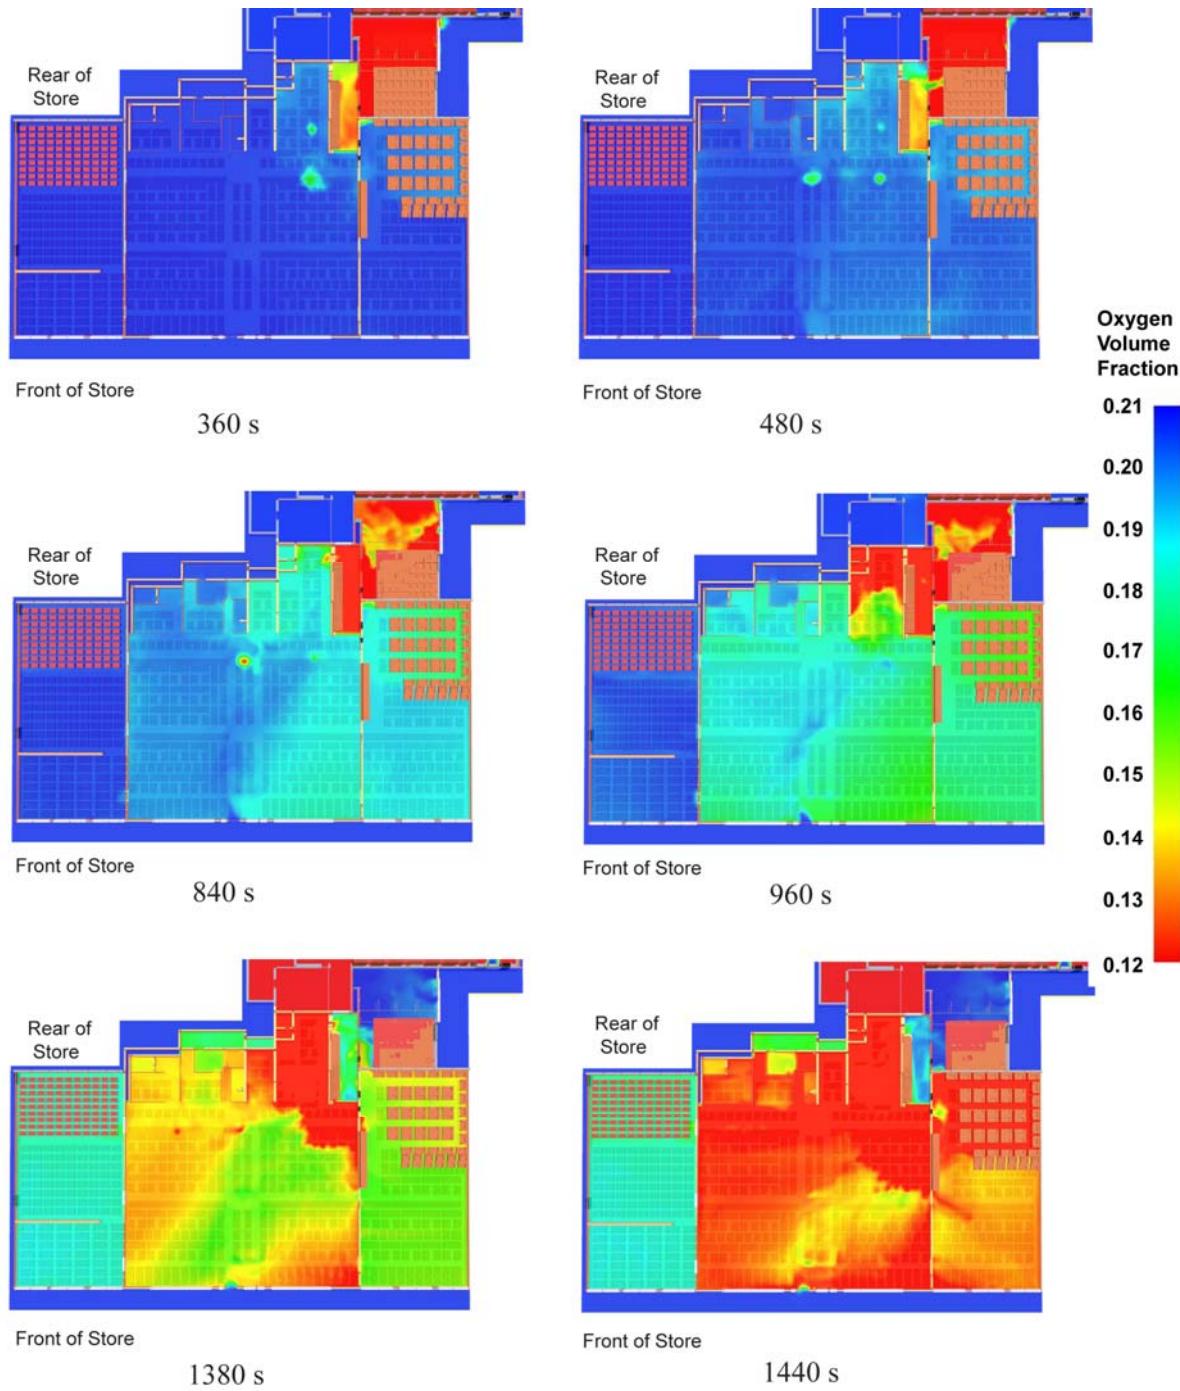
Figure 4-31 shows a series of images with an oxygen slice 1.5 m (5 ft) from the floor rendered at a range of times between 360 s and 1440 s (7:16:53 p.m. through 7:34:53 p.m.).

Figure 4-31. Oxygen volume fractions (slice images) for 1.5 m (5 ft) above the floor.

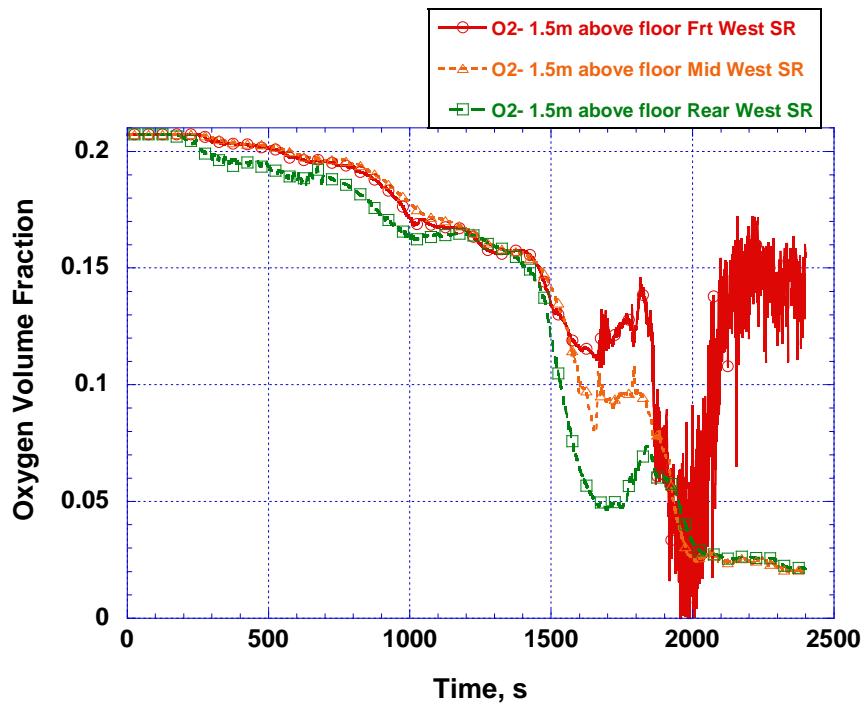
Figures 4-32 through 4-34 show charts of oxygen volume fraction recorded at several locations throughout the main and west showroom. All data in these charts were recorded 1.5 m (5 ft) above the floor. The locations correspond to those used for the temperature results shown in Figures 4-28 through 4-30. The oxygen volume fraction at the sensor in the rear of west showroom fell below 0.12 at 1500 s (7:35:53 p.m.). As the fire in the main showroom continued to move forward, the oxygen at both the mid and front sensors reached 0.12 volume fraction at 1600 s (7:37:33 p.m.).

Figure 4-32. West showroom oxygen volume fractions for 1.5 m (5 ft) above the floor.

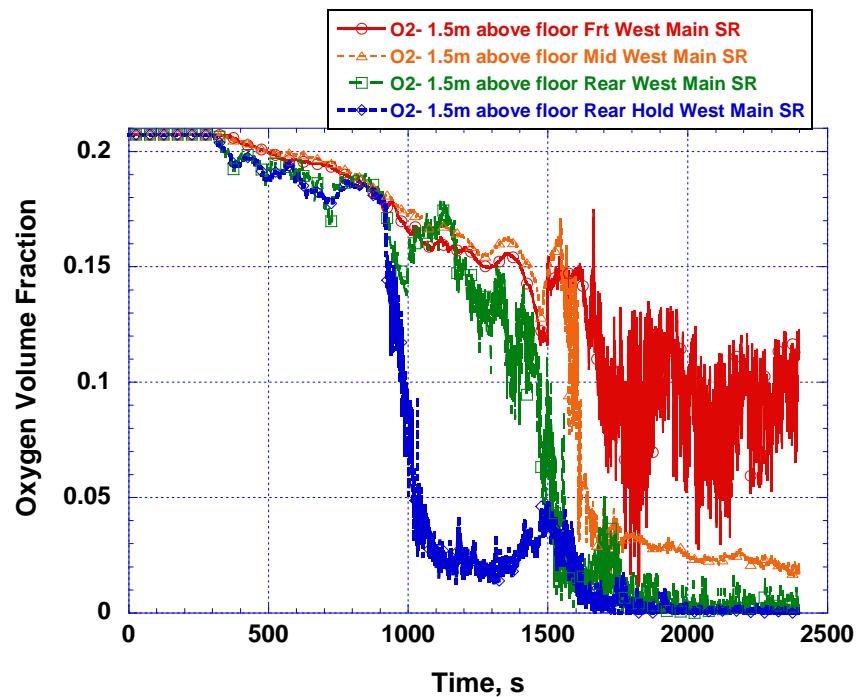
Figure 4-33 shows a chart that displays oxygen data from sensors located on the west side of the main showroom. Oxygen in the west side of the main showroom became depleted at an earlier point than in the other areas of the showroom because this was the path of the fire as it moved to the front of the showroom. The holding area location reached 0.12 volume fraction at 950 s (7:26:43 p.m.); the rear location was roughly six minutes behind, reaching 0.12 volume fraction at 1250 s (7:31:43 p.m.). The mid and front locations initially reached 0.12 volume fraction approximately the same time at 1400 s (7:34:13 p.m.). The mid and front locations then increased up to 0.15 volume fraction as the front windows were broken. Oxygen volume fractions in the center and east areas of the main showroom had similar trends.

Figure 4-33. Main showroom (west) oxygen volume fractions for 1.5 m (5 ft) above the floor.

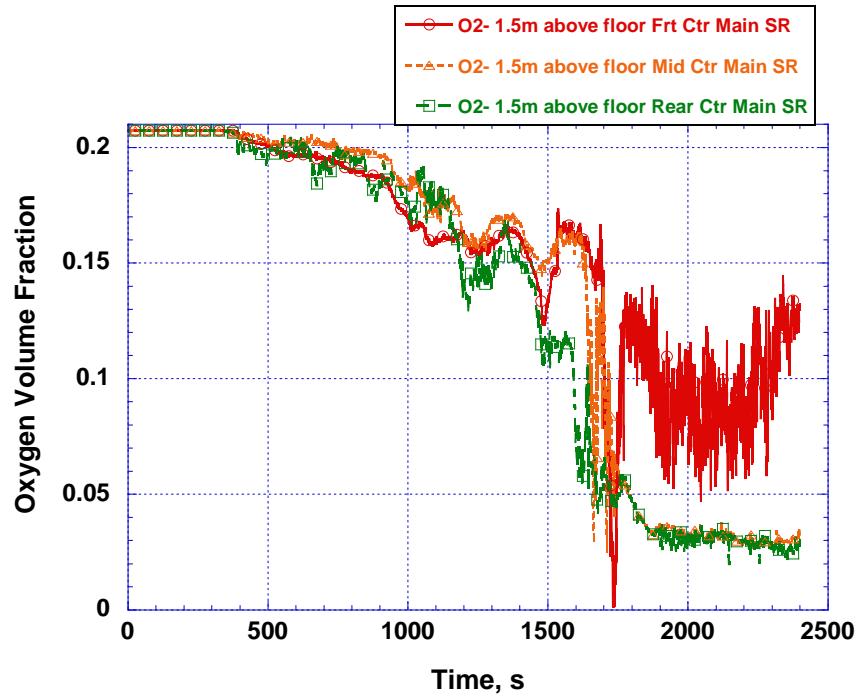
Figure 4-34. Main showroom (center) oxygen volume fractions for 1.5 m (5 ft) above the floor.

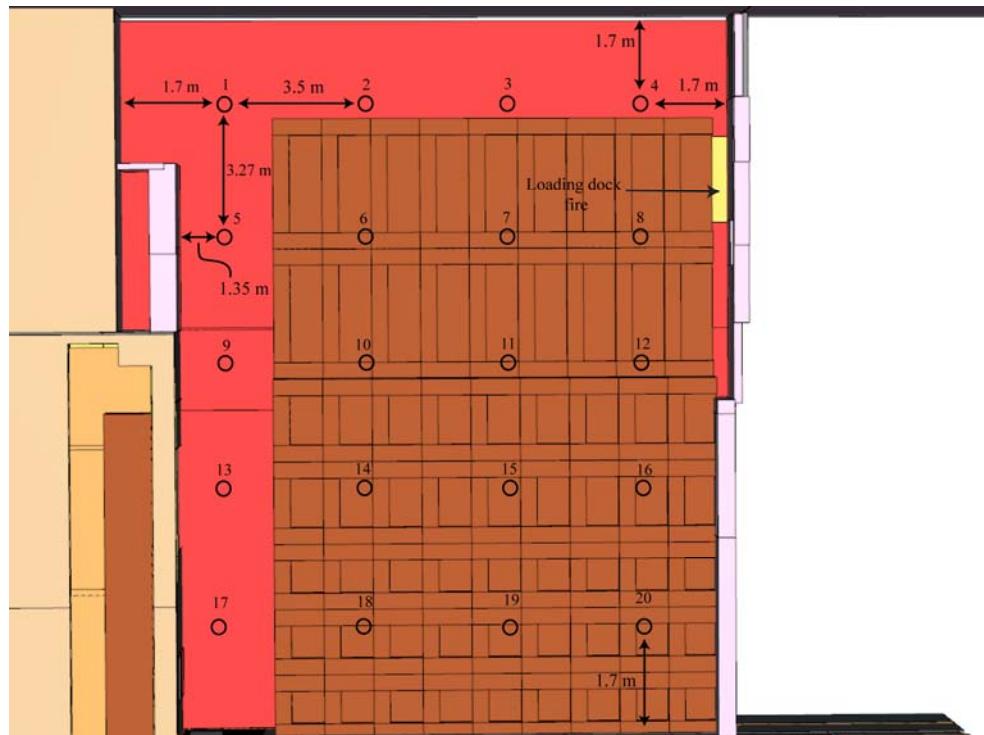
Figure 4-35. Sprinkler layout inside the enclosed loading dock.

Twenty sprinklers were placed inside the loading dock as shown by the black circles in Figure 4-35. The sprinkler specifications that were used in the simulation are detailed in Appendix K, Table K-6. In this configuration, the maximum protection area of coverage per sprinkler was approximately 11.9 m^2 (128 ft^2) with a water density of approximately $8.8 \text{ L min}^{-1} \text{ m}^{-2}$ (0.22 gpm/ft^2). Two sprinklers, labeled 4 and 8 in Figure 4-35, activated in the simulation. Sprinkler 8 was the first to activate, at 50 s, while sprinkler 4 activated at 75 s.

The sprinkler system layout was designed in accordance with NFPA 13, *Standard for the Installation of Sprinkler Systems* [17]. The system was designed as an Ordinary Hazard Group 2 wet pipe system, assuming that the enclosed loading dock area was heated. An Ordinary Hazard Group 2 sprinkler system was utilized in order to provide a more conservative estimate for the design area/water density as compared to an Extra Hazard design, for simulating the effects of sprinklers on fire conditions. The locations of the sprinklers within the enclosed loading dock are shown in Figure 4-35. Note that given the dimensions of the cells in the simulation, the locations of the sprinklers in the simulation vary up to 2 cm (0.8 in) from the layout shown. The specific locations of the sprinklers are given in the FDS input file. The sprinkler characteristics and operating parameters are given in Table K-8.

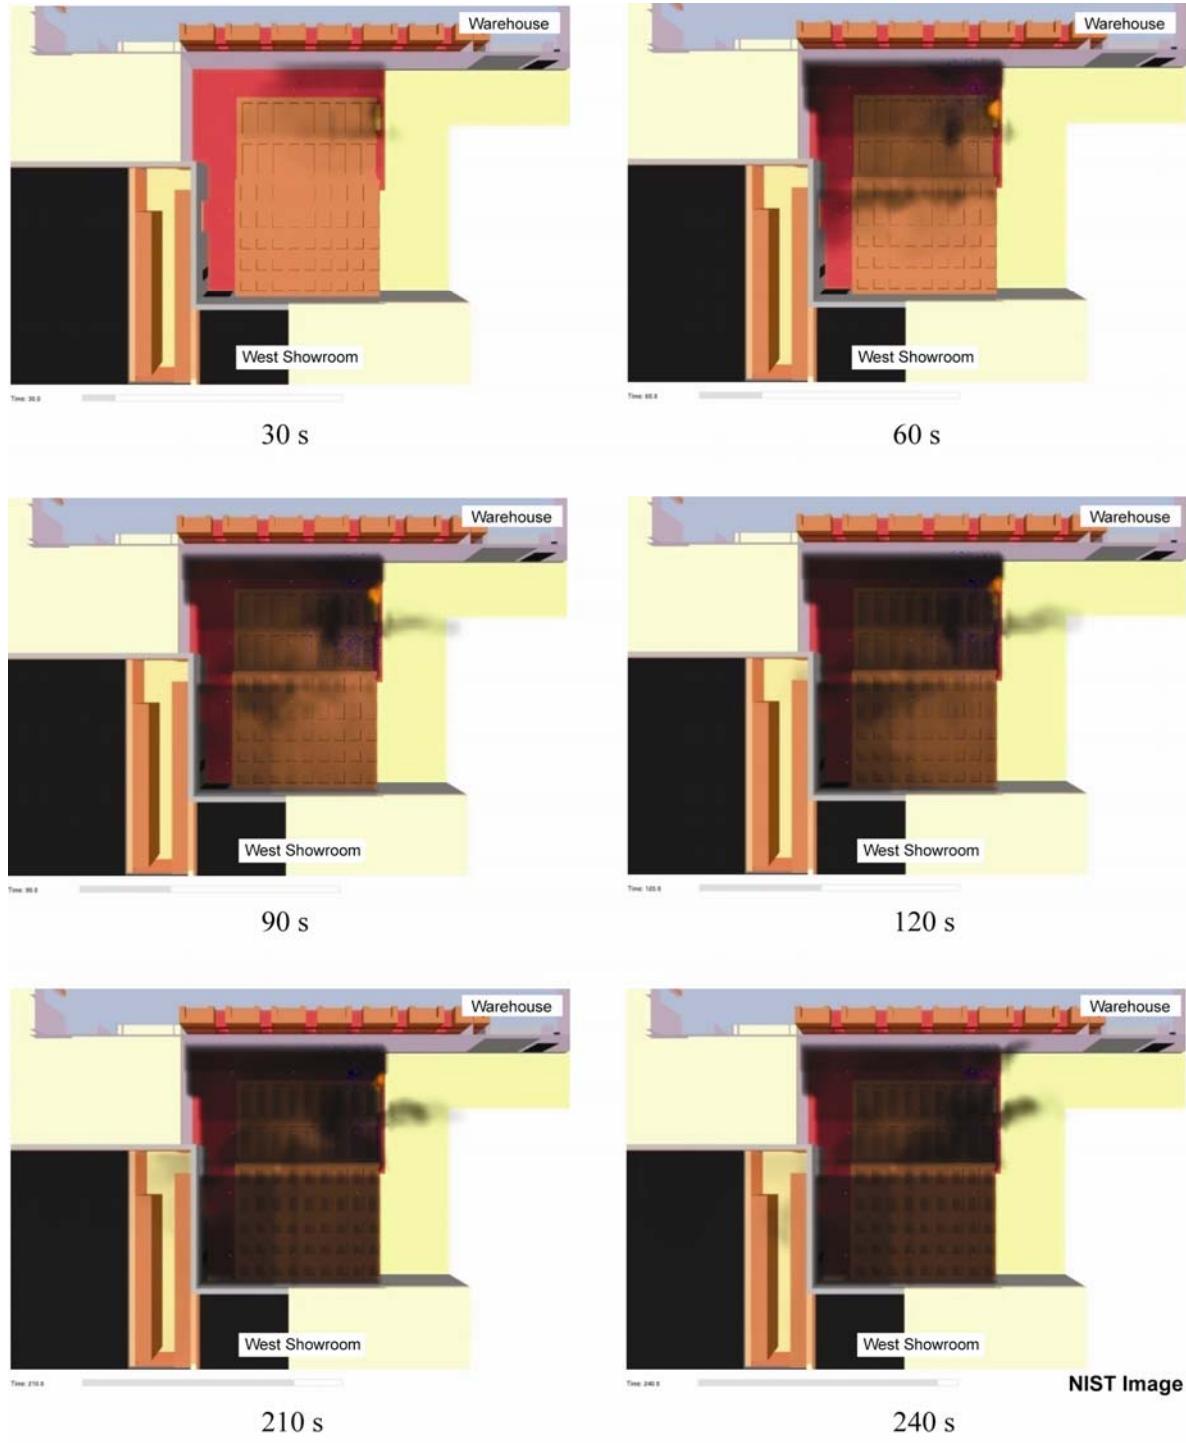
Figure 4-36 shows a series of images indicating the progression of fire and smoke in the loading dock during the sprinklered simulation. These images show an overhead view, centered on the loading dock (the area shaded in red). The north end of the warehouse is shown at the top of the images and the south end of the west showroom is at the bottom. The southwest corner of the main showroom (including the holding area) is shown in the lower left corner. In these images, the roof and walls of the loading dock were made invisible in order to facilitate viewing the loading dock interior. Additionally, the roofs over the main and west showrooms were clipped so that the interior of the holding area was visible. The areas colored black are the showroom ceilings. The west showroom ceiling is only partially revealed because this addition had a sloped roof and only the upper section was clipped away.

The quantity of fire generated smoke increases through the first five images in this sequence, from 30 through 210 s. Smoke spread across the underside of the loading dock roof and began to fill downward. At 210 s, the smoke layer was low enough to begin spilling into the holding area where there is access to the space above the showroom ceiling. By 240 s however, the fire is no longer burning and the smoke is beginning to dissipate.

Figure 4-36. Fire and smoke progression in the early stages of the sprinklered scenario. Sprinkler 8 was the first to activate, at 50 s, while sprinkler 4 activated at 75 s.

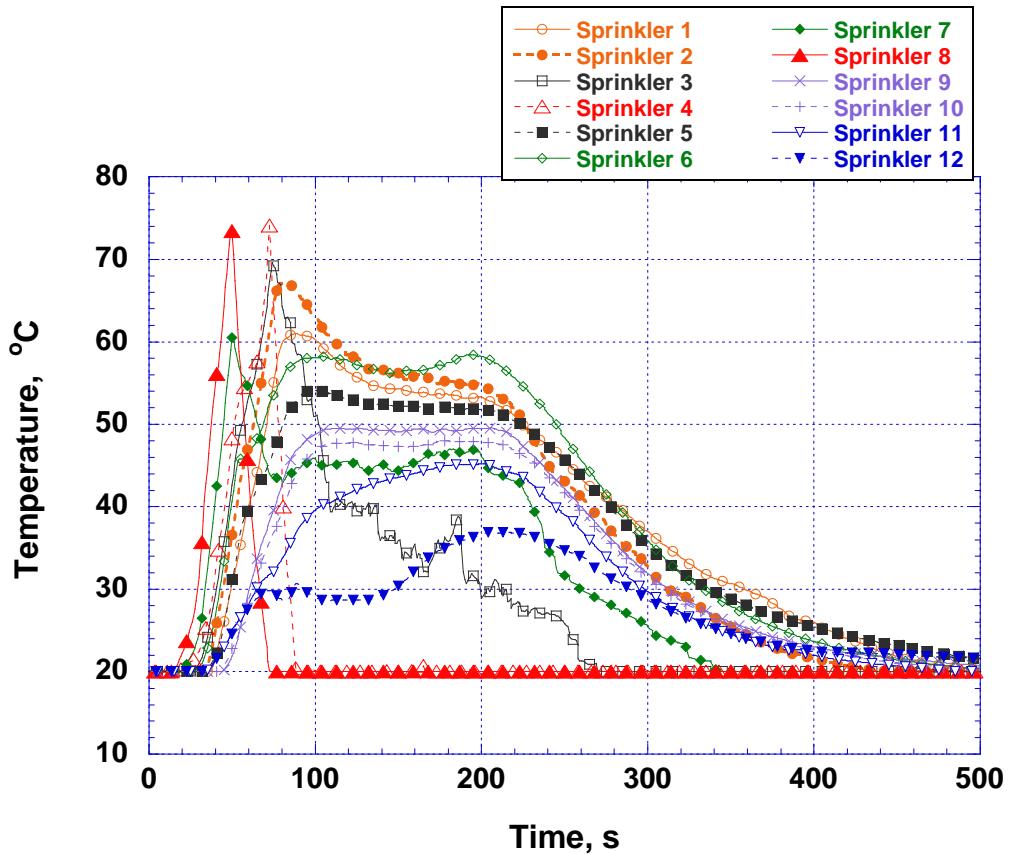
Figure 4-37 shows the sprinkler temperature at each of the sprinkler locations. The graph indicates that the temperature at locations 4 and 8 reached 74°C , at which point the sprinklers were activated in these locations. Temperatures at locations 1 and 2 peaked in the 60°C to 70°C range but never reached the threshold for activation.

Figure 4-37. Sprinkler temperatures inside the enclosed loading dock.

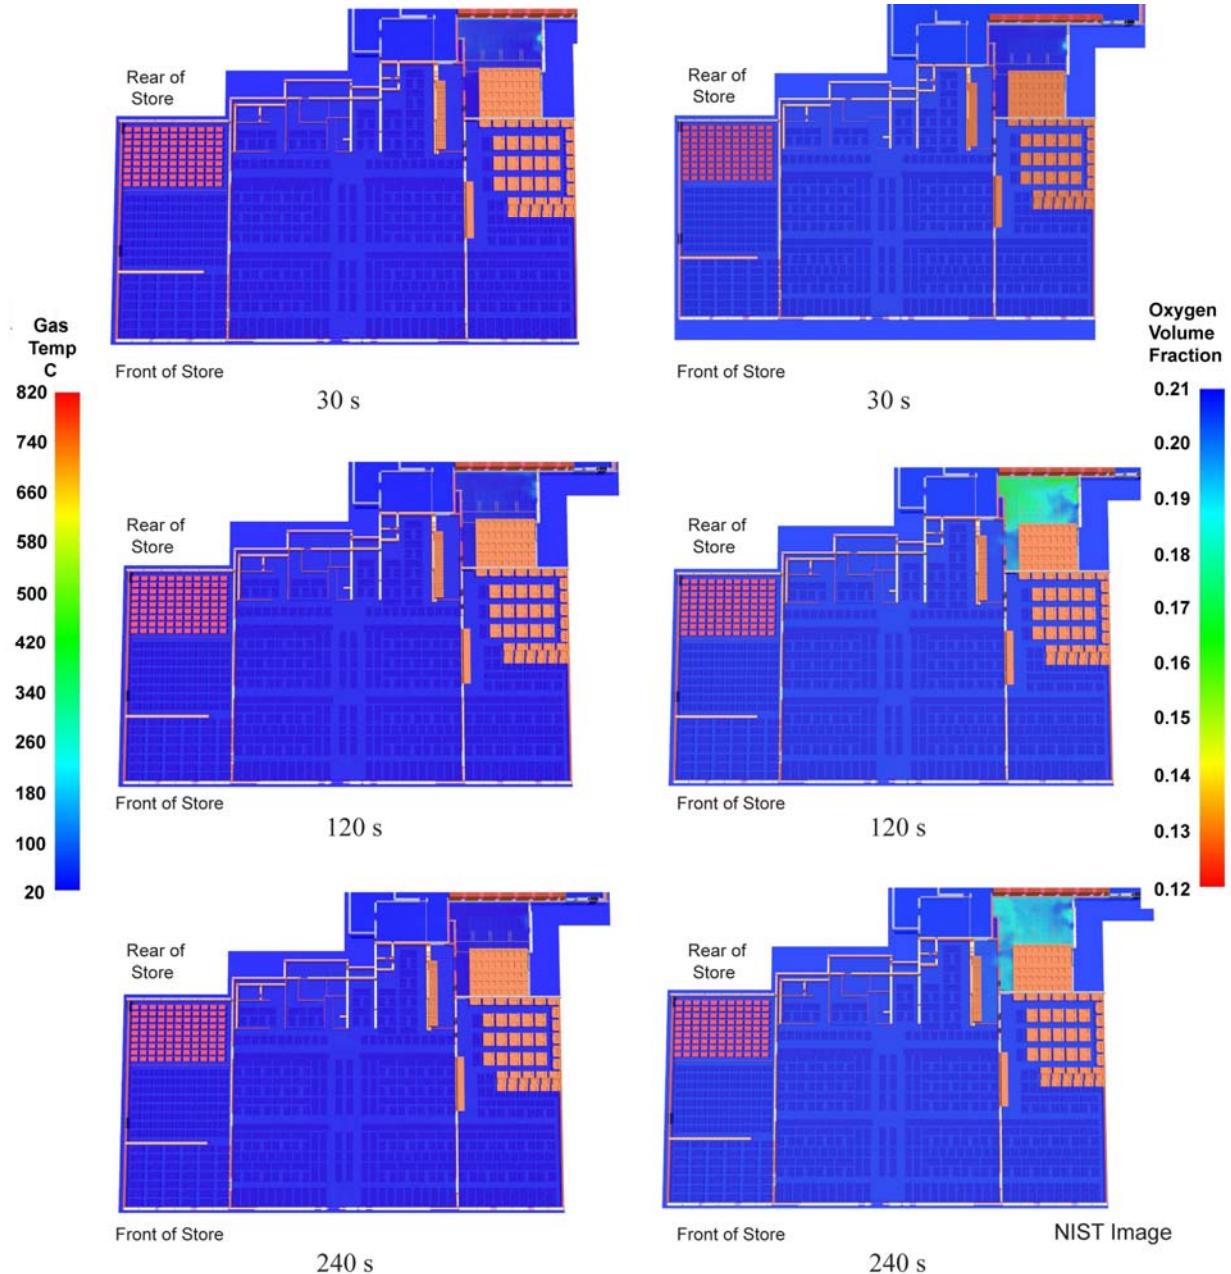
Figure 4-38 shows a series of images with a temperature slice 1.5 m (5 ft) from the floor rendered at a range of times between 30 s through 240 s. Note that the scale on these images is consistent with those in Figure 31. These images show that the area of elevated temperatures is limited to the immediate vicinity of the fire inside the loading dock.

Figure 4-38. Temperatures 1.5 m (5 ft) above the floor in the sprinklered simulation.

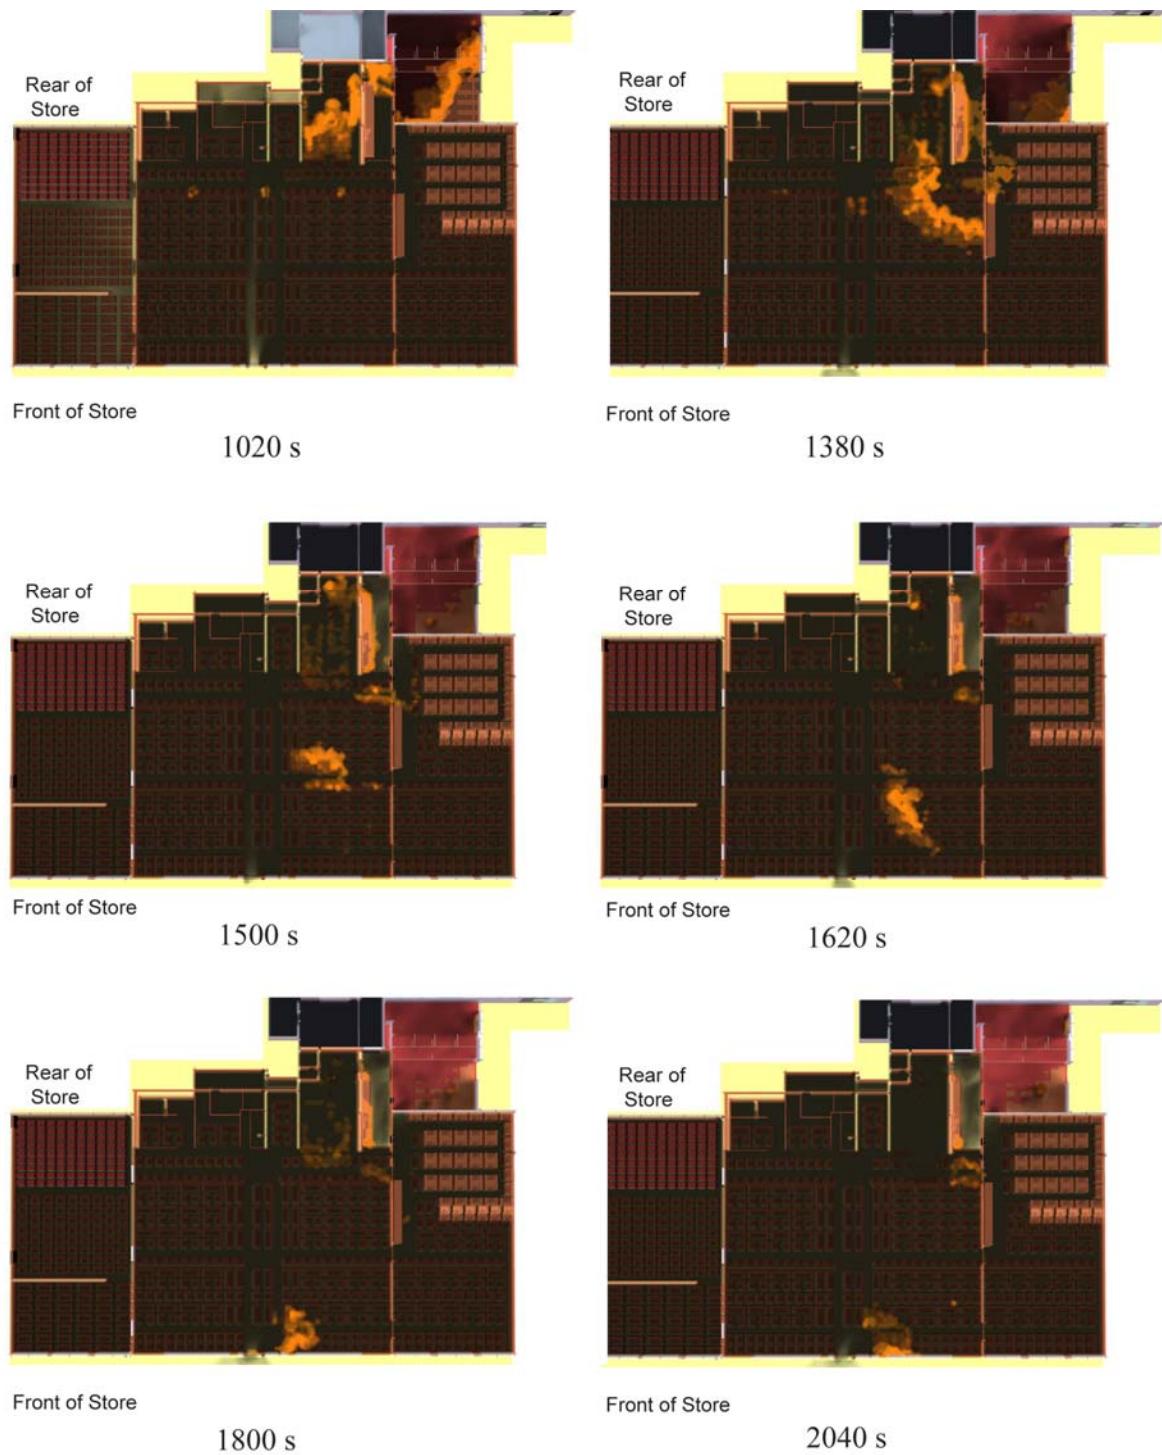
Figure 4-40 shows the progression of fire and smoke throughout the loading dock, holding area and showrooms between 1020 s and 2040 s (7:27:53 p.m. through 7:44:53 p.m.). The first three images in this figure are indistinguishable from the corresponding images in Figure 4-19 (the baseline simulation). The differences appear in the later images – 1500 s and beyond. Compared to Figure 4-19, Figure 4-40 shows far less burning in the northwest quadrant of the main showroom.

Figure 4-40. Fire and smoke progression in simulation with front windows intact.

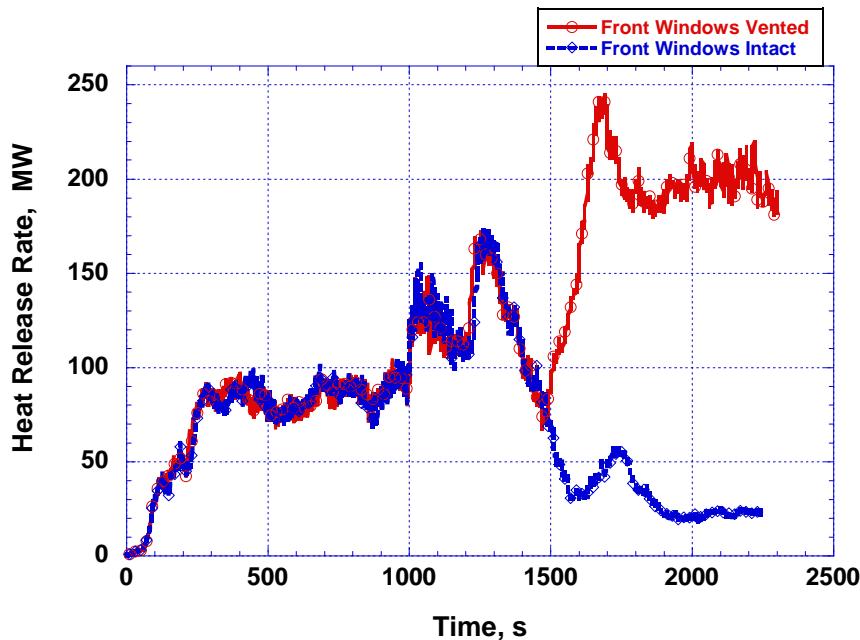
Figure 4-41 shows the change in HRR over time for this scenario and the baseline simulation. In both scenarios, HRR peaked at 120 MW at around 1300 s after which the HRR decreased. This would be consistent with the fire becoming underventilated. The venting of the front windows in the main showroom at 1457 s corresponds with the subsequent rapid increase in HRR for the base case. In the simulation with the windows intact, the HRR did not increase at approximately 1500 s, but continued to decrease until about 1600 s.

Figure 4-41. Comparison of the heat release rate in the simulations for front windows vented and front windows intact.

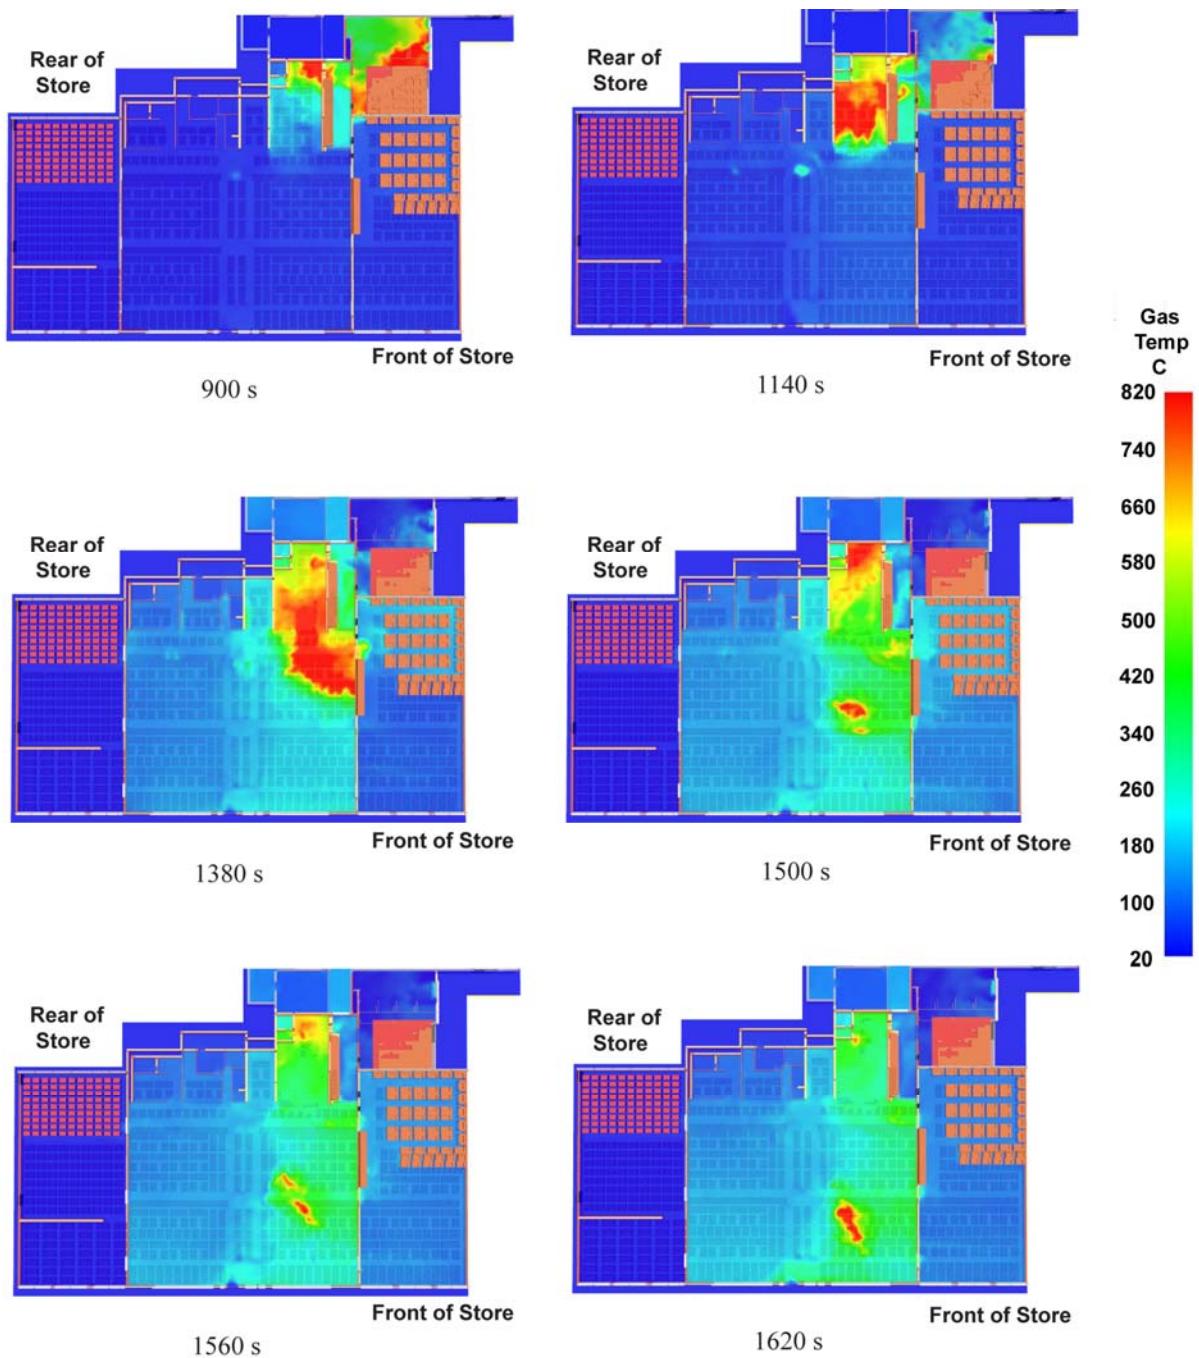
Figure 4-42 shows a series of images with a temperature slice 1.5 m (5 ft) from the floor rendered at a range of times between 900 s through 1620 s (7:25:53 p.m. through 7:37:53 p.m.). The trends in this figure are similar to those seen in Figure 4-28 for the baseline simulation. For the windows intact scenario the high temperature areas, shown in red, diminishes between 1380 s and 1500 s. After 1500 s the simulation displays less red areas in the windows intact case than for the same times in the baseline case (Figure 4-28).

Figure 4-42. Temperature slices located 1.5 m (5 ft) above the floor in simulation with front windows intact.

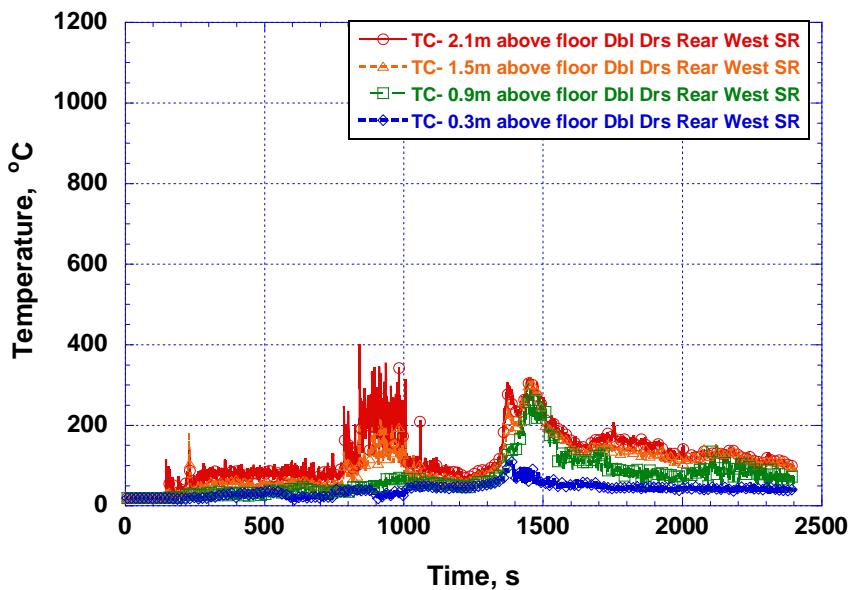
Figures 4-43 through Figure 4-46 show temperature data recorded at the same sensor locations used in Figure 4-25 for the baseline simulation. For comparison purposes, the scale in these figures was kept the same as the corresponding scale in Figure 4-27 through Figure 4-30. After 1500 s, the temperatures were lower in the scenario with the front windows intact as compared to the base case. The temperatures with the windows intact exceeded the 120 °C tenability threshold at each sensor location before the time at which the windows would have been broken out.

Figure 4-43. Temperatures at different elevations, 0.3 m (1 ft), 0.9 m (3 ft), 1.5 m (5 ft), and 2.1 m (7 ft) in rear of west showroom near double doors.

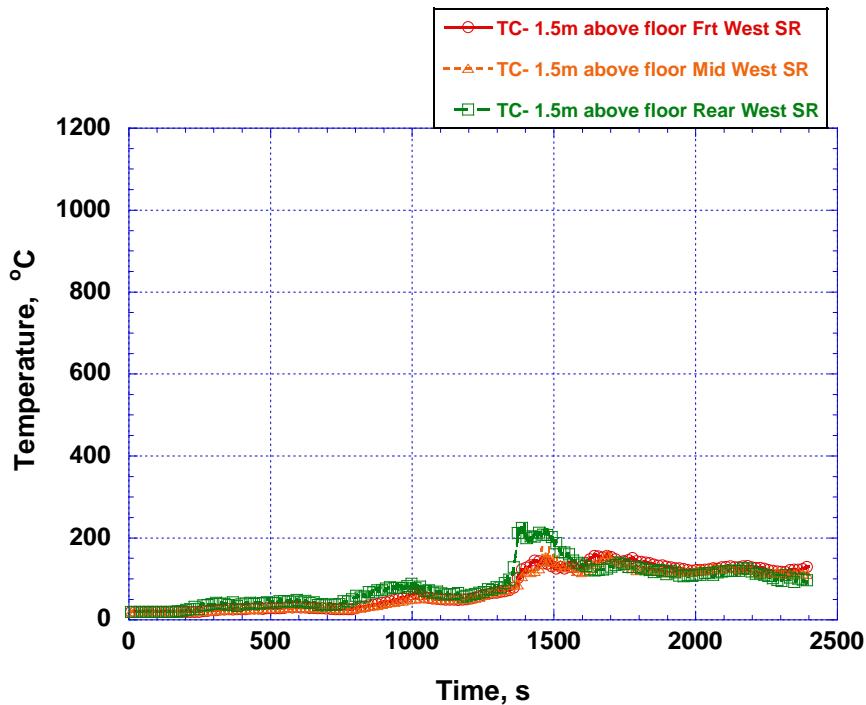
Figure 4-44. West showroom temperatures for 1.5 m (5ft) above the floor.

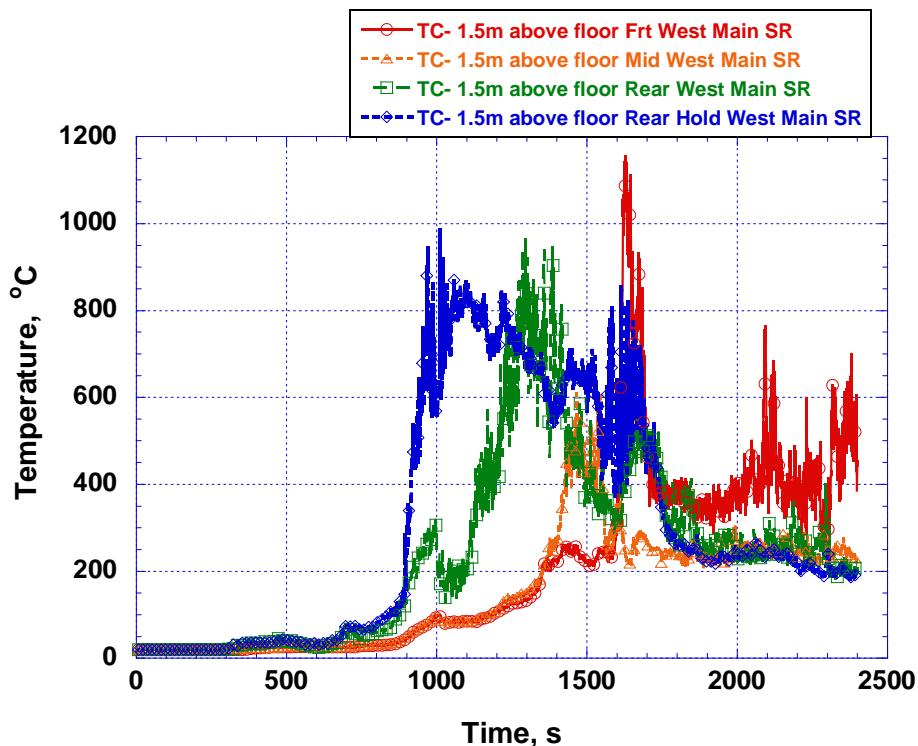
Figure 4-45. Main showroom (west) temperatures for 1.5 m (5 ft) above the floor.

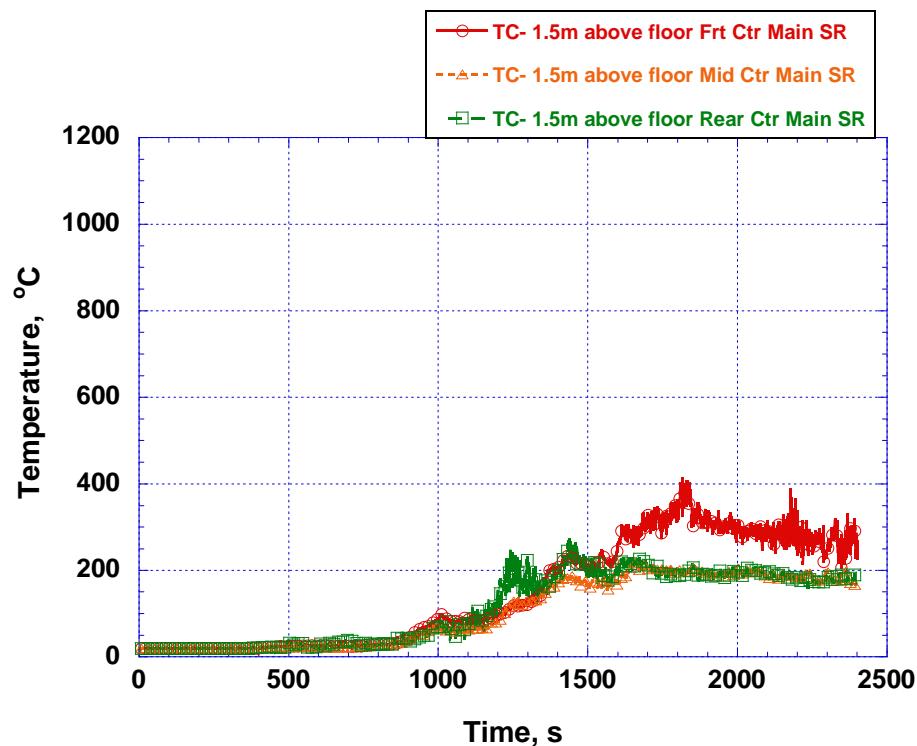
Figure 4-46. Main showroom (center) temperatures for 1.5 m (5 ft) above the floor.

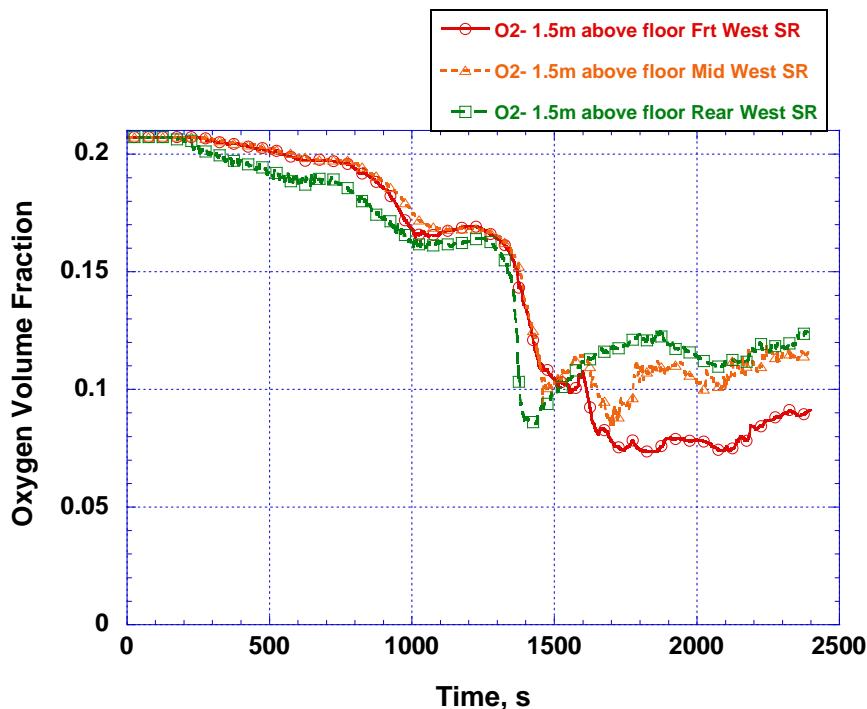
Figures 4-47 through 4-49 show oxygen volume fraction data for the front windows intact case that were recorded at the same sensor locations (Figure 4-25) as the baseline case. For the first 1000 s, the oxygen volume fraction in the west showroom (Figures 4-47 and 4-32) drops to about

0.16 for both cases. For about the next 400 s, the oxygen volume fraction decreases more slowly in both cases. By 1400 s the volume fraction drops below 0.1 for the windows intact case, but decreases to 0.15 for the base scenario. For the windows intact case, after the time when the windows would have been broken at 1457 s, the oxygen volume fraction in the rear of the west showroom begins to increase and peak at about 0.12 at 1850 s. The oxygen volume fractions in the mid and front of the west showroom decrease to 0.09 and 0.07, respectively. The oxygen volume fractions in the rear of the main showroom (Figures 4-48 and 4-33) show similar trends during the first 1300 s. For the windows intact case, the oxygen volume fraction became more steady between 0.07 and 0.09. The oxygen volume fraction for the same location in the base scenario continues to drop to less than 0.02. For the base case, after 1700 s, the oxygen volume fraction is less than 0.03 for the holding area, rear, and mid showroom. For the windows intact scenario, at about the same time, 1700 s, the oxygen volume fraction for the rear, mid, and front showroom locations are all above 0.07. Overall, the trends for both cases are similar during the early portion of the simulations, but after the time at which the windows were broken out in the base scenario, the oxygen volume fractions appear lower than in the front windows intact case for the rear holding, rear, and mid showroom locations.

Figure 4-47. West showroom oxygen volume fractions for 1.5 m (5 ft) above the floor.

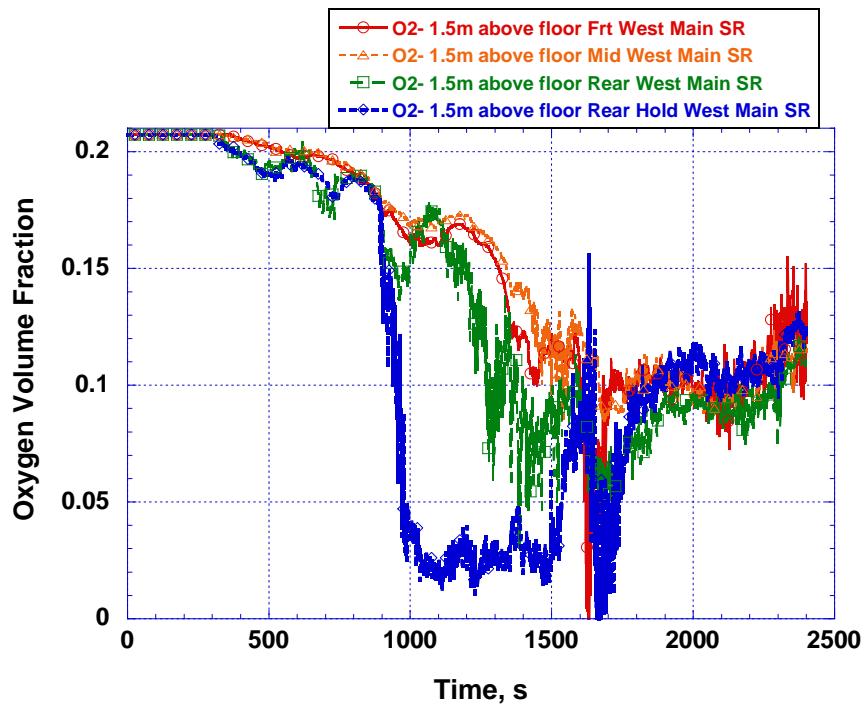
Figure 4-48. West main showroom oxygen volume fractions for 1.5 m (5 ft) above the floor.

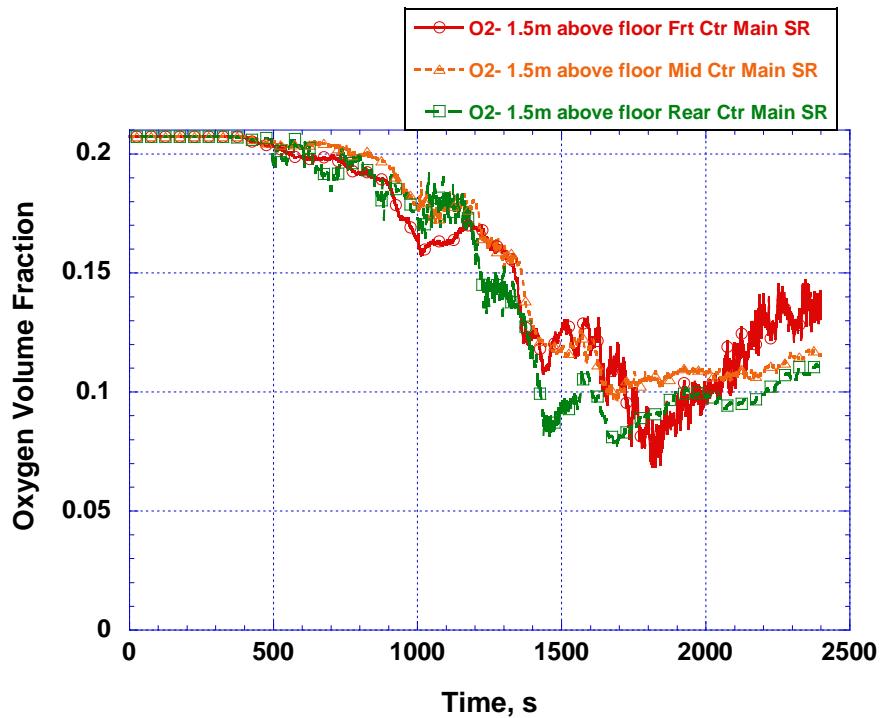
Figure 4-49. Main showroom (center) oxygen volume fractions for 1.5 m (5 ft) above the floor.

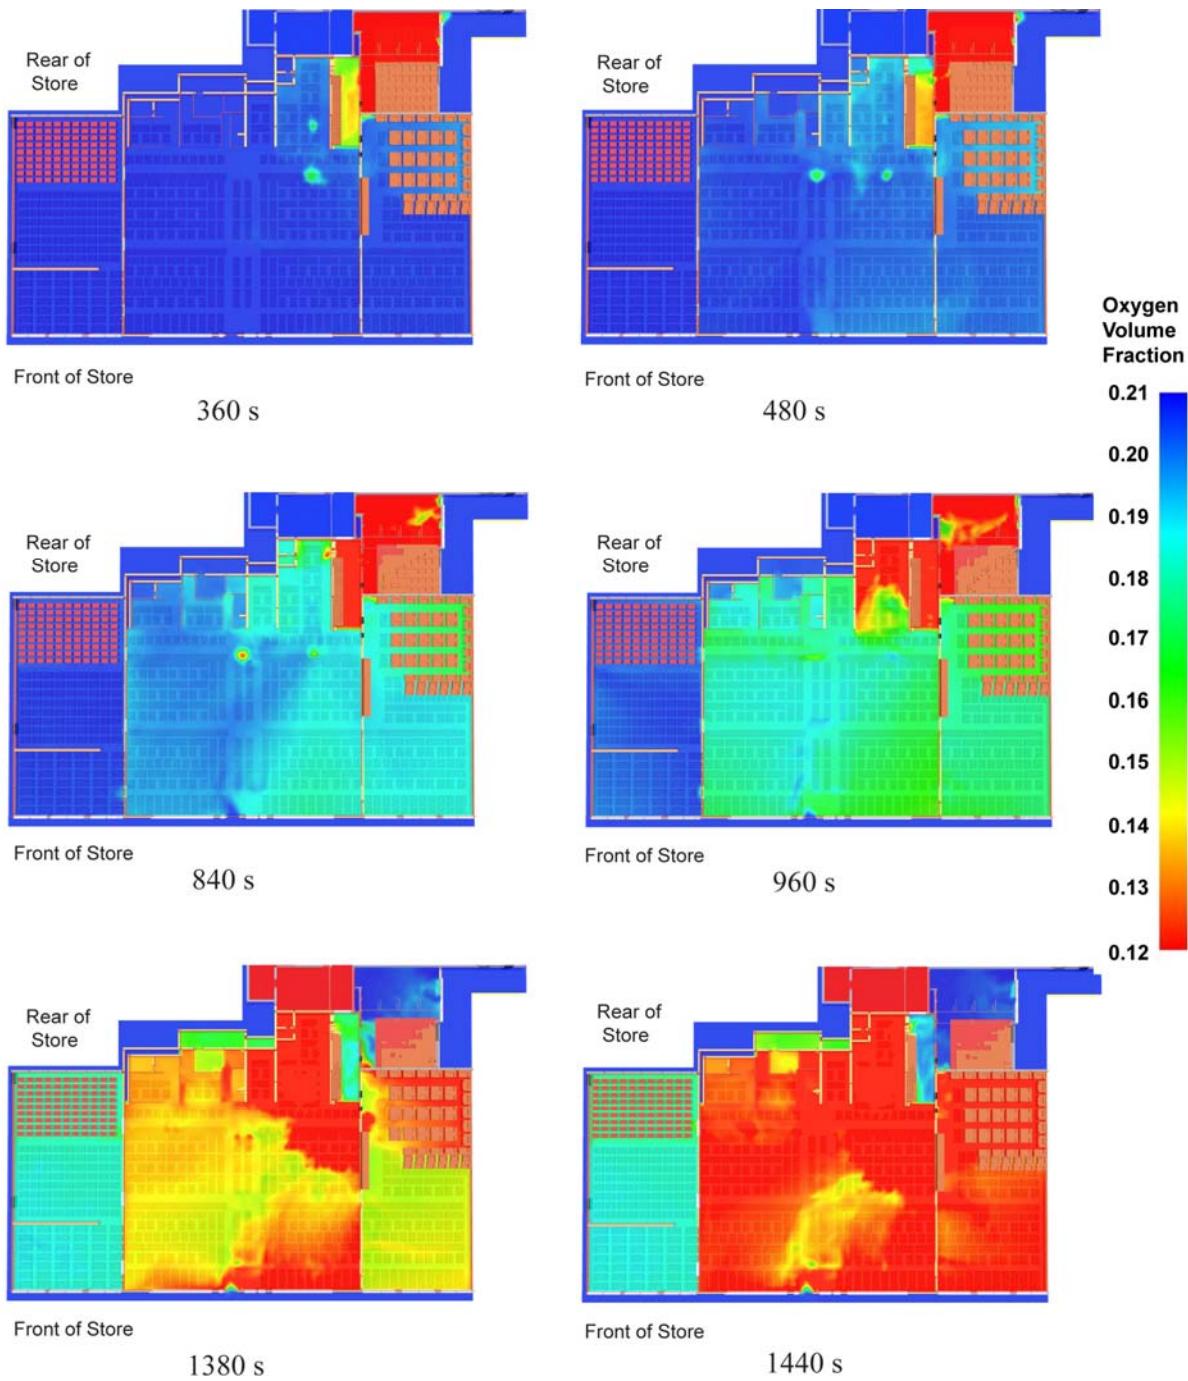
Figure 4-50 shows a series of images with an oxygen slice 1.5 m (5 ft) from the floor rendered at a range of times between 360 s and 1440 s. As was the case with temperature, the conditions in the main and west showrooms become untenable because of oxygen depletion prior to 1440 s (7:34:53 p.m.). While minimum oxygen volume fractions were not as low in the case with the windows intact, they nonetheless dropped below 0.12 (indicated by the red shaded areas in Figure 4-50) in the main and west showrooms.

Figure 4-50. Oxygen volume fractions (slice images) 1.5 m (5 ft) above the floor in simulation with front windows intact.
