NASA TM X-64086

TEST OF LOX COMPATIBILITY FOR ASPHALT
AND CONCRETE RUNWAY MATERIALS

John F. Kennedy Space Center
Kennedy Space Center, Fla. 32899

December 1973

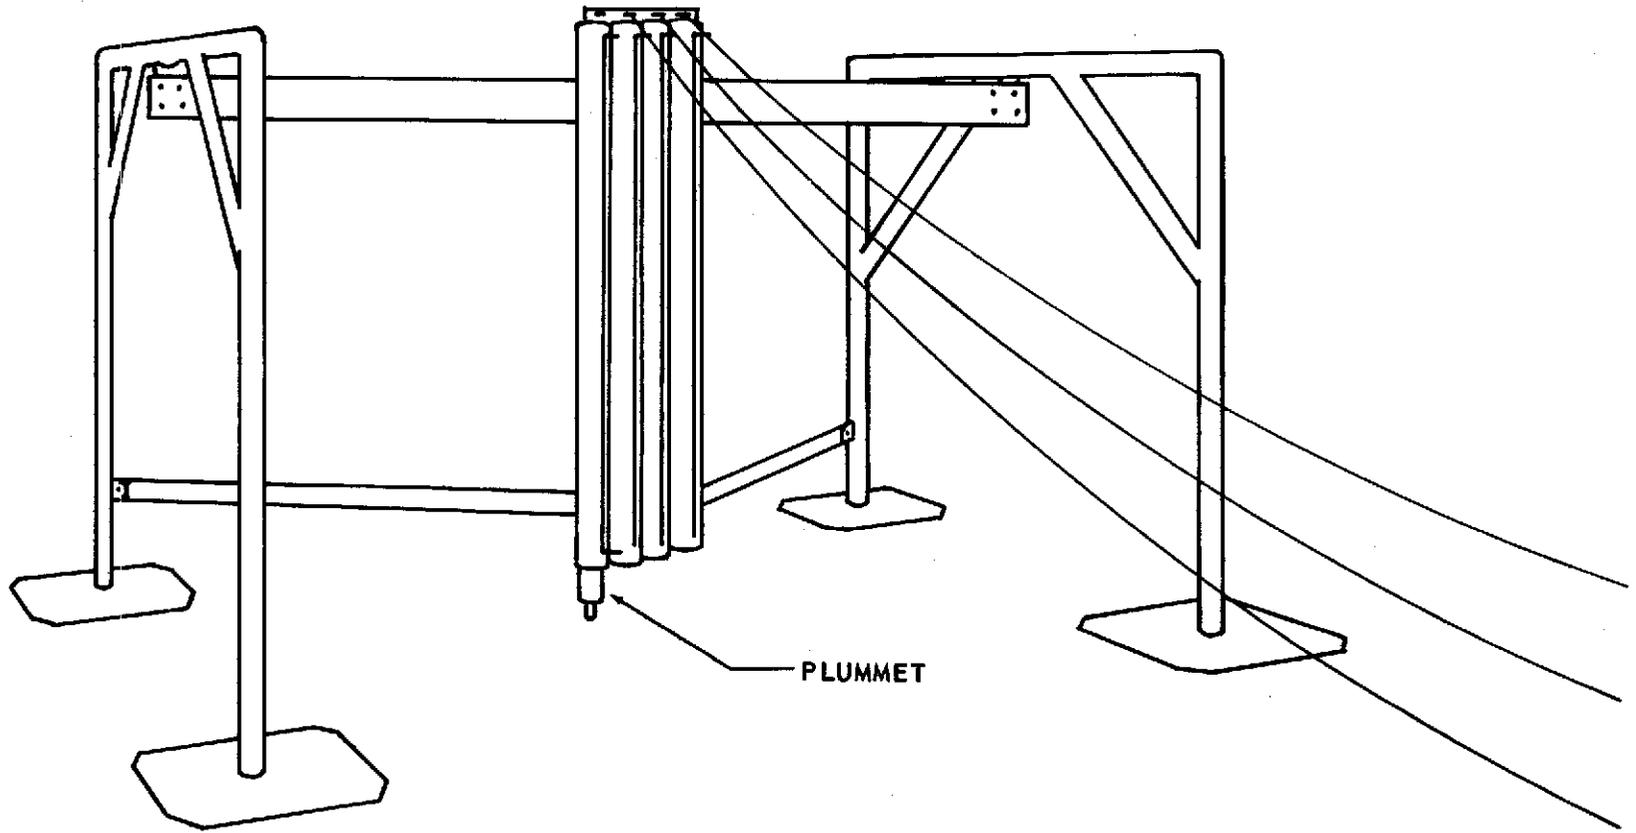
Figure 2. Impact Test Stand.

First Trial, Impact. - A test stand, shown in Figure 2, was fabricated to support four plummets, each held by a pin with a lanyard to permit remote individual release. The plummets weighed 9.07 kg and were 7.5 cm in diameter. Tips, 1.27 cm in diameter and approximately 3.8 cm long, were screwed into the bottom of each plummet. Each plummet was provided with a tube extending to within approximately 15 cm of the surface to be impacted. This prevented a plummet from falling over after being dropped and interfering with the impact of subsequent plummets. A rod screwed into the side of each plummet and extending through a vertical slot in each tube provided a handle by which the plummet could be raised to the top of its tube to be secured by a release pin. A slab of used asphalt pavement 2 meters square and approximately 5 cm thick was installed at the test site and an asphalt curb 7.5 cm high was built around its edge. The test stand was assembled over the slab with its feet level with the asphalt surface. A ring of flex line, perforated on the bottom, was coupled to the LO_2 delivery line and positioned over the middle of the slab. The slab was sponged dry to remove rainwater, and then a trial flow of LN_2 was performed. Three days later a 400 frame per second movie camera was installed, rainwater was again sponged from the slab, and 12 empty 0.5 liter aluminum beer cans were placed as shown in Figure 3 as blast

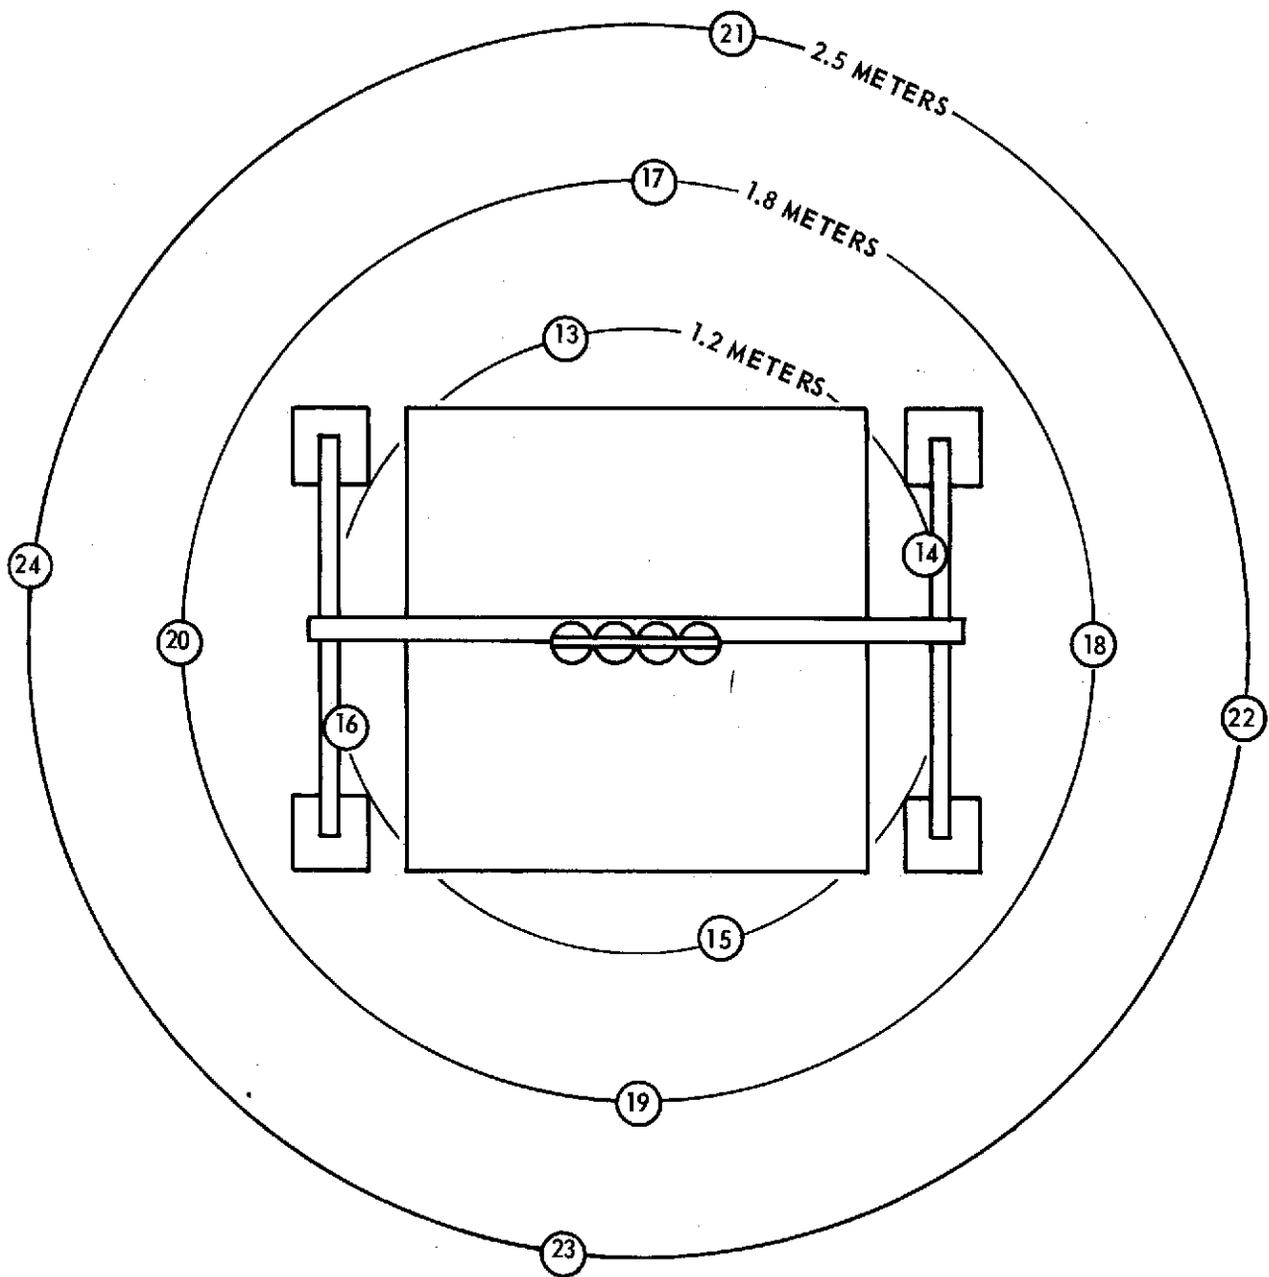
Figure 3. Blast Sensor Location, Impact.

sensors. The slab was then filled with LO_2 , which was allowed to flow for 10 minutes, and the four plummets were then dropped in succession with no detectable reaction.

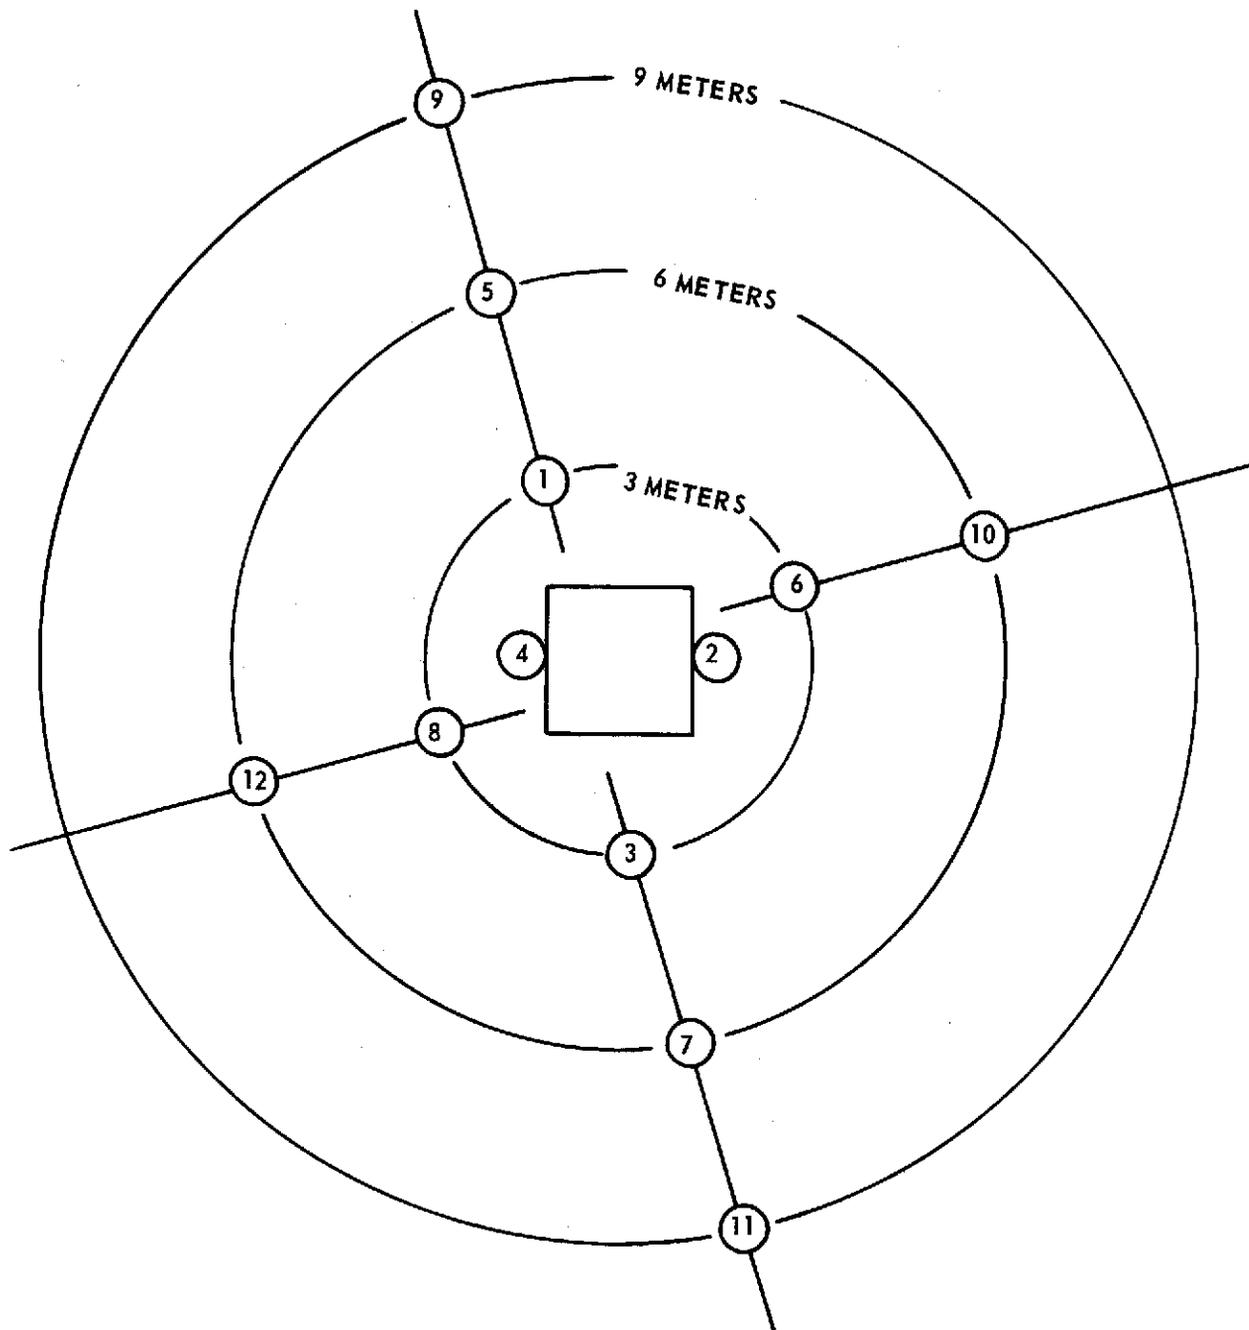
Figure 4. Blast Sensor Location, Blasting Cap.

Third Trial, Detonation. - The holes and the notch were repaired, the test fixture was removed, and rainwater was sponged from the slab. A No. 8 blasting cap with 15 cm of 21 gm per meter detonating cord was positioned on the slab. LO_2 was allowed to flow for 10 minutes; then the cap was detonated. Some smoke and flame occurred, but the reaction was confined to approximately a 2.5-cm depth of asphalt over an area of approximately 0.09 m^2 . Some beer cans, which were positioned as shown in Figure 4, had been overturned, but by the wind rather than the detonation. One can, No. 4, had been burned, and another, No. 3, had been struck by a small object which scratched the paint, but did not deform the can.

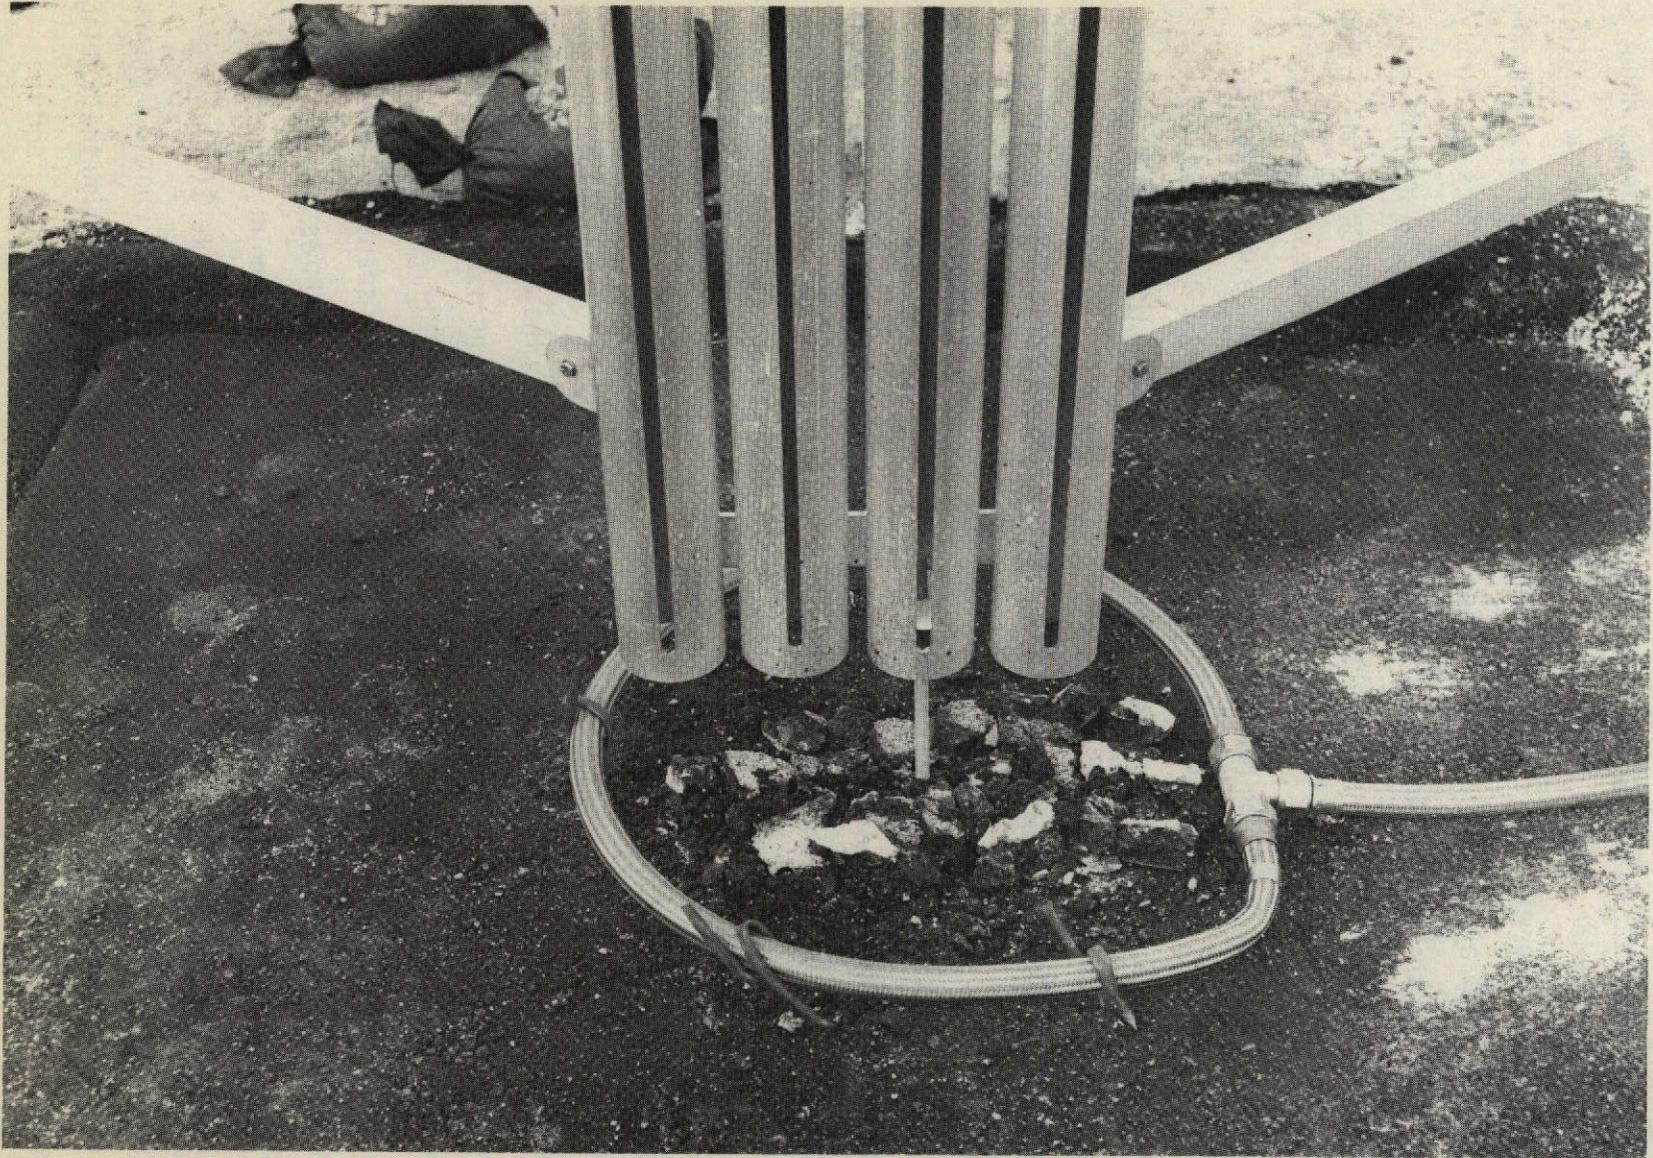
Figure 5. Points of Impact Prepared for Sixth Trial.

Sixth Trial, Impact. - The test stand was then removed, and a trench about 50 cm long, 10 cm wide, and 1.2 cm deep was chiseled in the asphalt. In the position where the second plummet would strike, an additional cavity was excavated to accommodate a 2.5-cm thick aluminum block, 9 cm wide and 10 cm long. The block was firmly seated with its top surface slightly below the level of the slab surface. A mixture of broken old and new asphalt pavement, ranging from small pea size to large nut size, was piled in the trench and tamped by foot. The pile was from 1 to 2 cm above the slab surface. The test stand was then repositioned. No change was made in the plummet tips, but a striker pin, consisting of a 1.2-cm threaded rod about 22 cm long, with a 7.5-cm teflon disc at the top was placed on the asphalt under the third plummet, with the disc inside the tube to support it. Figure 5 shows the impact points prepared for this trial. Beer cans were positioned as shown in Figure 2. LO_2 was allowed to flow for 10 minutes, the camera switch was activated, and the first plummet was released, with no reaction. The second plummet was then released, and a detonation occurred. The test stand was destroyed, and it is estimated that pieces of it rose 30 meters in the air. When the test site was inspected, it appeared that a reaction had occurred over the entire slab surface, but only a small proportion of its material has been consumed to an estimated depth of 2.5 cm. The reaction appeared to have initiated at two points, above and below the aluminum block. The plummet tip impression in the aluminum block was several times deeper than one made by simply dropping the plummet from the same height. A cavity was found in the asphalt under the position occupied by the aluminum block. It was found that the camera had not been actuated by the switch, and no film of the reaction is available. Still photographs were made of the debris in situ. Figures 6 and 7 show the impact site. In Figure 7, the outline of the asphalt slab can be seen. Fragments have been assigned identification numbers 1 through 33. Figure 8 shows fragments 16, 17, and 18 at a distance of approximately 30 meters from the impact point. Figure 9 shows fragment 15, approximately 9 meters from the impact point. Figure 10 shows a plummet, fragment 28, approximately 12 meters from the impact point. Figure 11 shows a leg, fragment 22, approximately 47 meters from the impact point. Although the holding pond was contaminated, two objects were retrieved from it: the first plummet, and the
