**Nine Career Fire Fighters Die in Rapid Fire Progression at Commercial Furniture Showroom — South Carolina**

Fire Fighter Fatality Investigation and Prevention Program

A summary of a NIOSH fire fighter fatality investigation

February 11, 2009

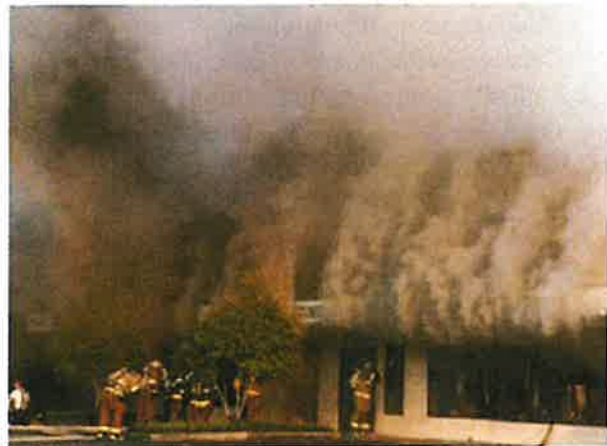
**Incident Scene**

He observed fire inside the structure when a *(Photo courtesy of Alexander Fox, Associated Press.)* door connecting the rear of the right showroom addition to the loading dock was opened. Within minutes, the fire rapidly spread into and above the main showroom, the right showroom addition, and the warehouse. The burning furniture quickly generated a huge amount of toxic and highly flammable gases along with soot and products of incomplete combustion that added to the fuel load. The fire overwhelmed the interior attack and the interior crews became disoriented when thick black smoke filled the showrooms from ceiling to floor. The interior fire fighters realized they were in trouble and began to radio for assistance as the heat intensified. One fire fighter activated the emergency button on his radio. The front showroom windows were knocked out and fire fighters, including a crew from a mutual-aid department, were sent inside to search for the missing fire fighters. Soon after, the flammable mixture of combustion by-products ignited, and fire raced through the main showroom. Interior fire fighters were caught in the rapid fire

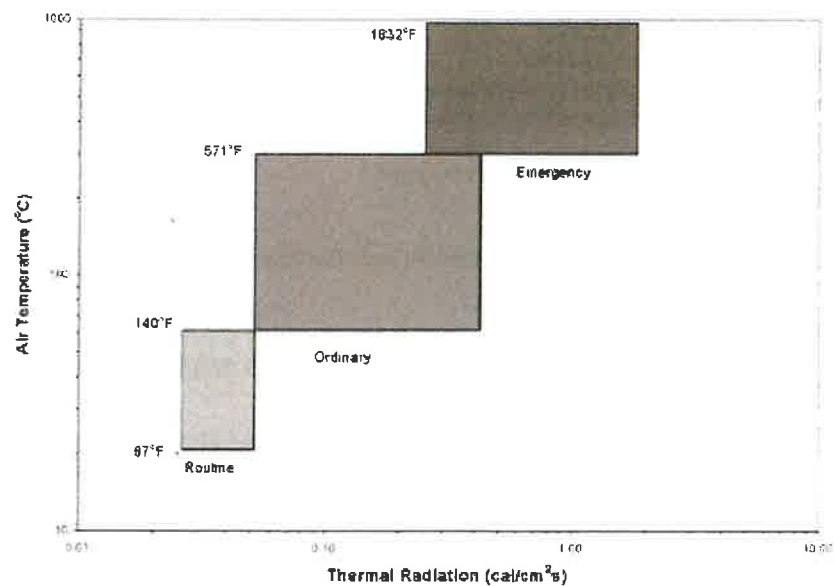
Figure 1-- Classification of Fireground Conditions

The relationship between increasing thermal radiation (expressed in  $\text{cal}/\text{cm}^2/\text{s}$ ) and the resulting rise in air temperature (expressed in degrees Celsius and degrees Fahrenheit) is presented in Figure 1. Possible structural fire fighting situations are illustrated in this figure:<sup>1,2</sup>

- The *Routine* region describes conditions where one or two objects, such as a bed or waste basket, are burning in a room. The thermal radiation and the air temperatures are virtually the same as those encountered on a hot summer day. As shown in Figure 161, *Routine* conditions are accompanied by a thermal radiation range of 0.025 to 0.05  $\text{cal}/\text{cm}^2/\text{s}$  and by air temperatures ranging from 68 to 140°F. Protective clothing for fire
